APPLUS-RTD EDMONTON, ALBERTA, CANADA T6P 1N5 Tel: (780) 440-6600 Fax: (780) 440-2538				GENERAL NDE REPORT A-3141304_06_21 2013 MT-Report-b					
					Date _June 20 , 2013					
					RTD Job #: 10-113249

A-3141304_21-06-2013_MT-Report-b

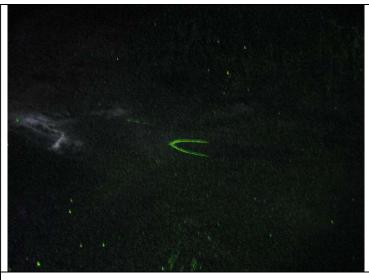
Туре		1 2		Level (dB)	Level (dB)		1	Travel	Value (dB)	
Scope:	Corry	out Magnatic	Dorticle Inc	INSPECTION pection on all in	N DETAILS	oregotions no	zzlos Inlot di	ffusor wolds	to shall	
scope.										
demister support cage to shell and manway weld to shell in the (High Pressure Inlet Separator- A-3141304).										
D 1:	(4)	\			e 1	11 10	1 1/44 / 1/44 *			
Results: (1) At East shell tee intersection the circumferential weld had (9) cracks ¼" to ½" in length running circumferentially.

View of crack above tee intersection

(2) All (8) lower Cracks were removed with light remedial grinding with 80Grit flapper, with										
substantial weld cap remaining.										
(3) The top crack at $\frac{1}{2}$ " length above tee intersection was removed with light remedial grinding with 80grit										
flapper flush with shell.

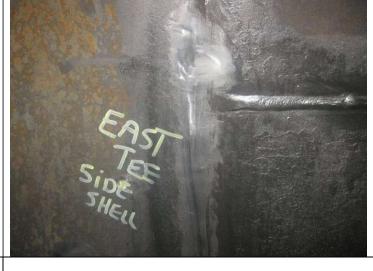
Over all view of location and area of cracks found

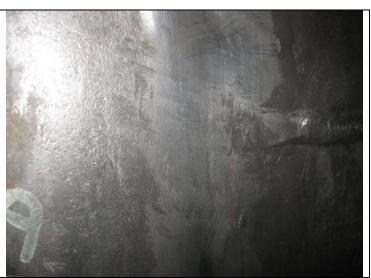
Final view above tee intersection after crack removed flush with shell

(4) All were re-inspected and found acceptable.										
Technician:	Jerry Hryn	kiw	CCCD /ACM	T/CMT Lovel. II	Start Time:	Stop	Tima:	ST	OT	
Signature:	Jerry Hryn	K1W		T/SNT Level: II MT #5709	Unit:	Stop	Km:	Travel Time:	- 01	
Assistant:				T/SNT Level:	I —	Subsistence required OT Meal				
Client Sign	ature:					Consumables:
