**Canadian Natural Resources Limited
GENERAL PRESSURE VESSEL INFORMATION**

Facility: Gold Creek Field	Location (LSD): 07-20-68-05W6M
-----------------------------------	---------------------------------------

Vessel Name Equipment Number: **Inlet Separator**

Date: May 4, 2010

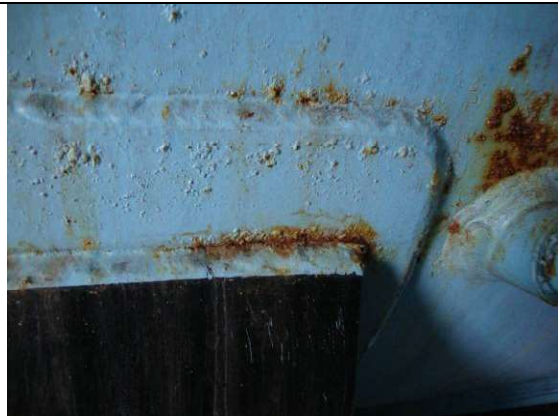
Crack at saddle attachment weld

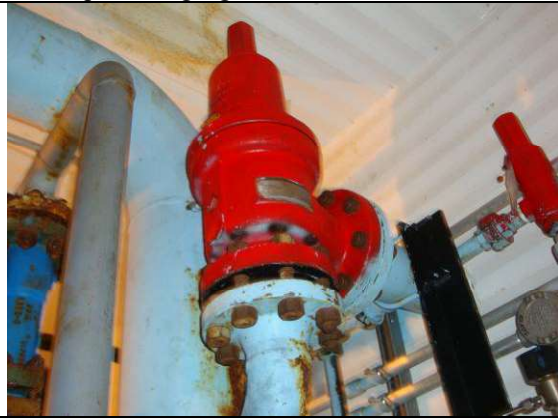
Vessel PSV

Valving Ensure no leaks are visible. Valves are properly supported and chained if necessary.	X				No leaks are visible- valves are supported properly.
PSV Ensure PSV is set at pressure at or below that of vessel.	X				Located on inlet piping to vessel. Set at MAWP of vessel – PSV seal in place. No block valve between vessel and PSV. Discharge piping is same size as valve outlet.
NDE methods Was UT/ MPI done on vessel (MI coordinator to review results)				X	None performed at this inspection time.
Other					
Recommendations or corrective actions : Vessel is Fit for Service or describe corrective actions required) (MIC to review corrective actions with Operations, discuss with Chief Inspector where necessary, and get remedial action implemented) Recommendations: No recommendations at this time. Summary: See internal inspection report. Vessel is fit for service.

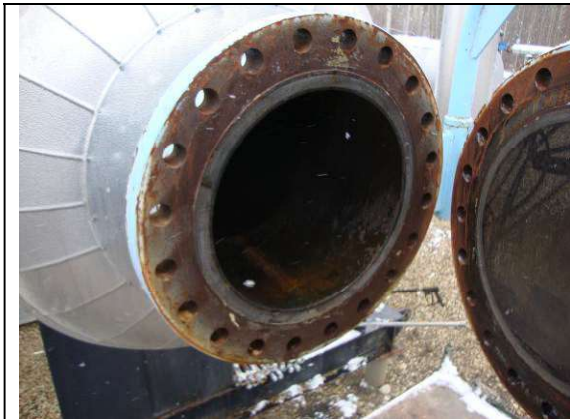
Vessel man way

Internal Inspection Items	G	F	P	N/A	Comments
Coating Assess coating. Describe area coated, general condition of coating.				X	Vessel not coated.
Anodes. How many, type, condition. % consumed. Are they being replaced?				X	No anodes in vessel.
Internal Piping Is there any? If so, carbon or stainless steel. Describe condition, dents, corrosion, erosion, etc. Ensure supports are secure and any bolts are suitable for future use.				X	No internal piping.
Trays How many? Type of material. Are valves in place. Check for erosion/ corrosion; wear on tray valve legs. Cleanliness?				X	No trays
Baffles, deflector plates, etc. If present, describe condition. Look closely at welds attached to vessel wall.	X				Inlet deflector plate: In good condition – no corrosion or pitting. No mechanical damage – no erosion.
South Head Note all corrosion, erosion or mechanical damage. (If vessel is horizontal identify direction of this head)	X				Man way access - Gasket seating face is clean and no mechanical or corrosion noted.

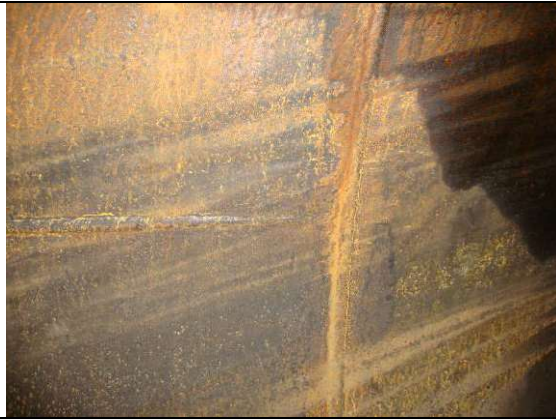
Shell tee weld

Welds Inspect all welds, including attachment welds. Record all service-related damages and if there is any discuss with Chief Inspector before closing.	X				Over all welds are in good condition – head to shell weld has no corrosion – no erosion or pitting. Attachment welds are in good condition no corrosion or erosion.
Repairs Required. If yes, ensure procedure and copy of AB 40 is on file, and one sent to local ABSA, and Chief Inspector				X	
NDE Was any NDE done. (MI coordinator to review results)				X	
<p>Recommendations or corrective actions : Vessel is Fit for Service or describe corrective actions required) (MIC to review corrective actions with Operations, discuss with Chief Inspector where necessary, and get remedial action implemented) Recommendations: Remove demister pad at next inspection frequency to view outlet piping and shell.</p> <p>Summary: Vessel in good overall condition, Visual external and internal visual inspection performed on vessel. No visible defects observed.</p> <p>Vessel is fit for service.</p>
