**Canadian Natural Resources Limited
GENERAL PRESSURE VESSEL INFORMATION**

Job # 10.110419

District: Ft. St. John B.C.	Skid No.
Facility: Currant Compressor St.	Location (LSD): b-09-C/94-A-16
Vessel Name Equipment Number: Glycol Contactor	
Orientation: Vertical	
Status: In Service	Regulatory Inspection

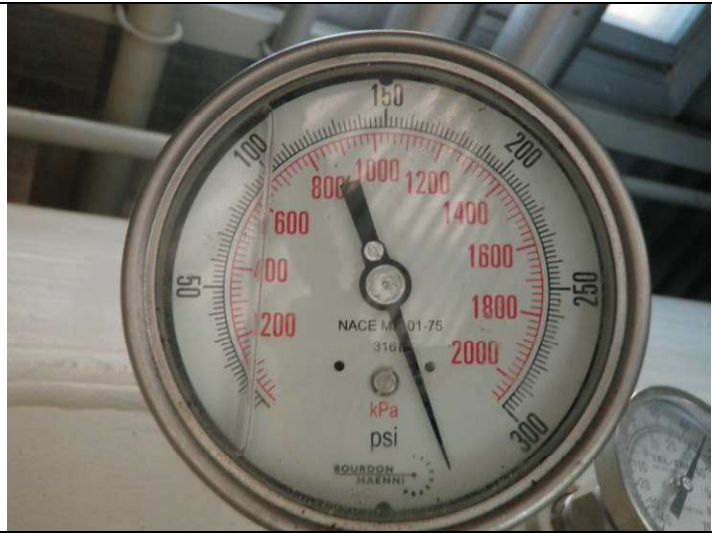
Pressure gauge does not meet MAWP
