**Canadian Natural Resources Limited  
GENERAL PRESSURE VESSEL INFORMATION**

**Job # 10.110419**

<b>District:</b> Ft. St. John B.C.	Skid No.
<b>Facility:</b> Currant Compressor St.	<b>Location (LSD):</b> b-09-C/94-A-16
<b>Vessel Name Equipment Number:</b> Glycol Contactor	
<b>Orientation:</b> Vertical	
<b>Status:</b> In Service	<b>Regulatory Inspection</b>

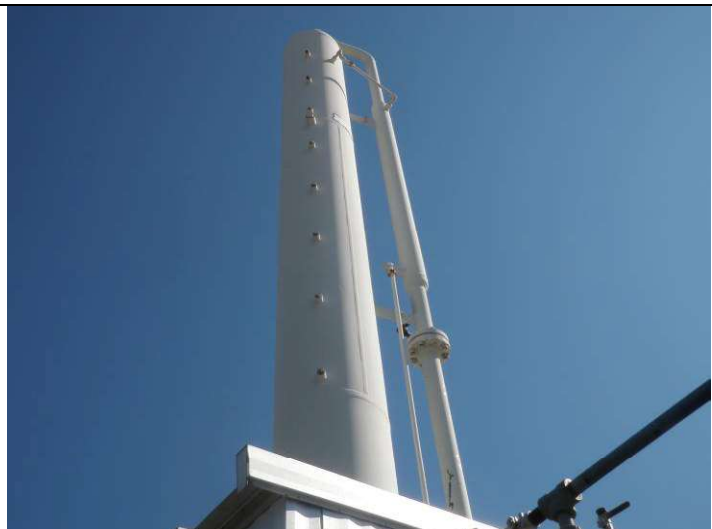
Overview (external)

<b>External Inspection Items</b>	G	F	P	N/A	<b>Comments</b>
<b>Insulation</b> Verify sealed around manways, nozzles, no damage present, and there is no egress of moisture.				X	Not insulated.
<b>External Condition</b> Assess paint condition, areas peeling, record any corrosion, damage, etc (record location, size and depth of corrosion or damage)	X				Paint is in good condition. No signs of damage or distortion.
<b>Leakage</b> Record any leakage at flanges, threaded joints, weep holes on repads, etc.	X				No signs of leaking.
<b>Saddle/skirt</b> Assess condition of paint, fire protection, and concrete. Look for corrosion, buckling, dents, etc. Look at vessel surface area near supports. Verify no signs of leakage at attachment to vessel and attachment welds are acceptable. Ground wire attached?	X				Skirt is welded to lower head. No signs of cracking or leaking at welds. No signs of leakage.  Vessel grounded through the skid package.
