**Canadian Natural Resources Ltd.
GENERAL PRESSURE VESSEL INFORMATION**

Job# 105.00390

District: Fort St John, BC	Skid No.
Facility: Ladyfern Compressor	Location (LSD): b-88-H/94-H-01
Vessel Name Equipment Number: Glycol Contactor	
Orientation: Vertical	
Status: In Service	Regulatory Inspection

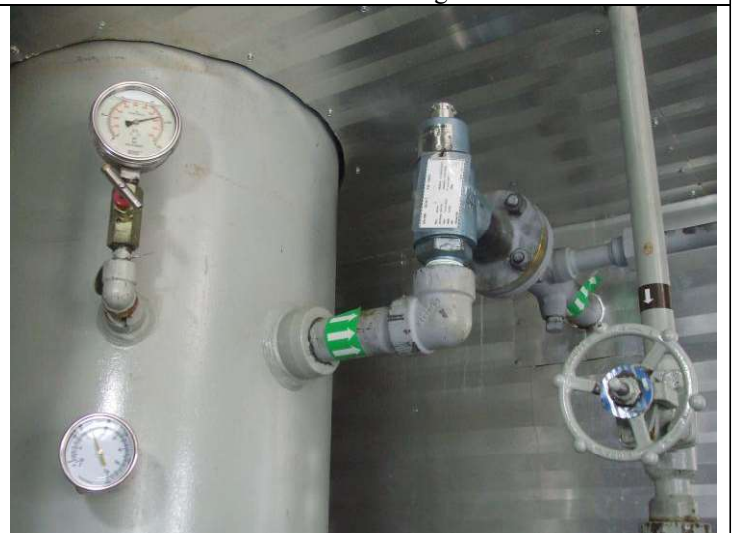
PSV location

Valving Ensure no leaks are visible. Valves are properly supported and chained if necessary.	X				Well supported – no leaks.
PSV Ensure PSV is set at pressure at or below that of vessel.	X				Located on the gas inlet piping - set at the Contactors MAWP. Discharge piping is the same size as the inlet to PSV. No block valve present. Seal is intact. PSV vents to Flare.
NDE methods Was UT/ MPI done on vessel (MI coordinator to review results)	X				Ultrasonic thickness survey carried out-no metal thickness detected below nominal minus corrosion allowance.
Other					
<p>Recommendations or corrective actions : Vessel is Fit for Service or describe corrective actions required) (MIC to review corrective actions with Operations, discuss with Chief Inspector where necessary, and get remedial action implemented)</p> <p>Recommendations: 1. No recommendations at this time.</p> <p>Summary: This vessel is in good over all condition, visual external and ultrasonic thickness survey carried out-no metal thickness detected below nominal minus corrosion allowance.</p> <p>Vessel is fit for service.</p>
