**Canadian Natural Resources Ltd.
GENERAL TANK INFORMATION**

Job # 10.110419

District: Ft. St. John B.C.	Skid No.
Facility: Currant Compressor St.	Location (LSD): b-09-C/94-A-16
Vessel Name Equipment Number: Knockout Drum	
Orientation: Horizontal	
Status: In service	Regulatory Inspection

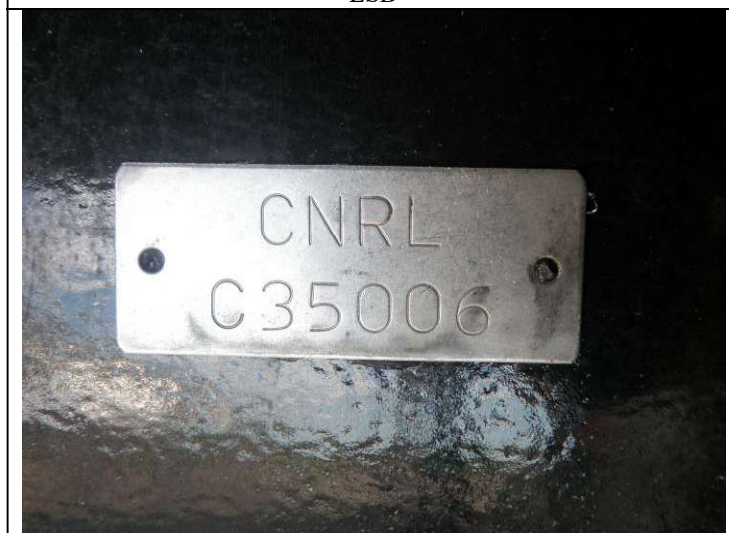
C Tag - **No Data Plate**

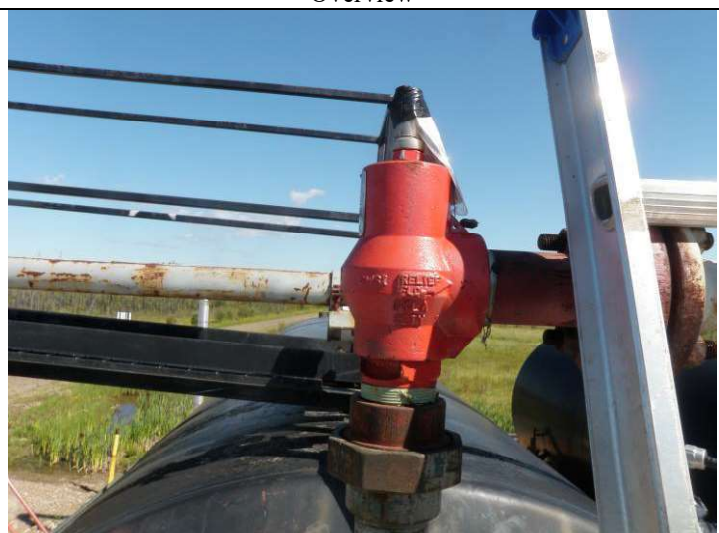
Valving Ensure no leaks are visible. Valves are properly supported and chained if necessary.	X				No leaks are visible at time of inspection. Valves are supported properly
PSV Ensure PSV is set at pressure at or below that of vessel. Some tanks have positive gas protection for cover – this may be a vacuum breaker – have a good look and check serviceability tag.	X				Located on top shell. Set pressure at 15 PSI Seal intact. No block valves. Discharge piping is same size as valve outlet.
