HORIZONTAL VESSEL - GENERAL INSPECTION FORM						
District: Grande Prairie, A.B.			Skid No.			
Facility: South Spirit River Battery Unit # 1			Location (LSD): 09-09-77-07 W6M			
Vessel Name & Equipment Number: Flare Knock Out Drum						
Orientation: Horizontal						
Status: In Service			Regulatory Inspection			
PRESSURE VESSEL NAMEPLATE DATA						
"A" or "G" or "S" (Sask.) or BC Registration Number. A 462576			CRN Number P 6520.2			
Vessel serial number: 11796			Size: 48 in x 12 ft			
Shell thickness: 9.5 mm			Shell material: SA-516-70N			
Head thickness: 7.9 mm			Head material: SA-516-70N			
Tube wall thickness:			Tube material:			
Tube diameter:			Tube length:			
Channel thickness:			Channel material:			
MAWP	Shell: 50 PSI		Operating pressure	Shell:		
	Tubes:			Tubes:		
Design Temp.	Shell: 300 Deg. F		Operating temperature	Shell:		
	Tubes:			Tubes:		
X-ray: RT-1			Heat treatment: Nil			
Code parameters: ASME VIII Div.1			Joint efficiency (if on nameplate):

Canadian Natural Resources Limited

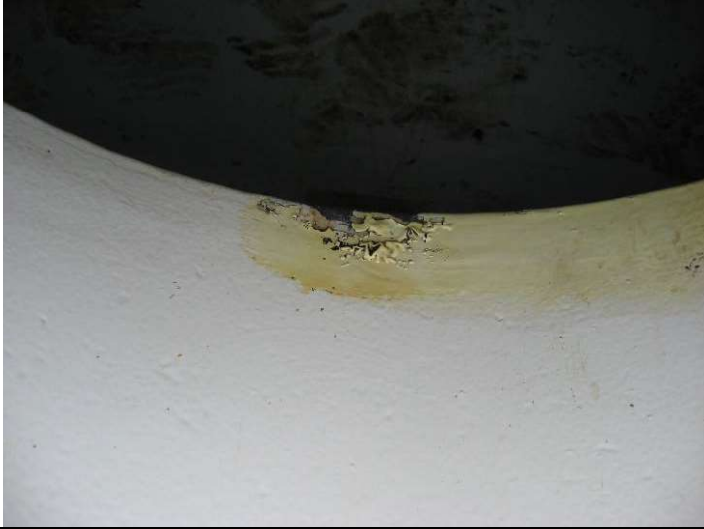
Internal Inspection Items	G	F	P	N/A	Comments
Coating Assess coating. Describe area coated, general condition of coating.	X				100 % internally coated – 1 small area of coating missing at 6:00 position o internal edge of man way nozzle – no corrosion.
Anodes. How many, type, condition. % consumed. Are they being replaced?				X	No anodes
Internal Piping Is there any? If so, carbon or stainless steel. Describe condition, dents, corrosion, erosion, etc. Ensure supports are secure and any bolts are suitable for future use.	X				Heat Medium coil x 2: Good condition – no scale, no corrosion.
Trays How many? Type of material. Are valves in place. Check for erosion/ corrosion; wear on tray valve legs. Cleanliness?				X	No trays.
Baffles, deflector plates, etc. If present, describe condition. Look closely at welds attached to vessel wall.	X				Inlet deflector x 2 - in place – no broken members – no exposed metal. Float intact. Vortex breaker attached.

Welds Inspect all welds, including attachment welds. Record all service-related damages and if there is any discuss with Chief Inspector before closing.	X				Good condition, viewed through coating - no previous corrosion or pitting.
Repairs Required. If yes, ensure procedure and copy of AB 40 is on file, and one sent to local ABSA, and Chief Inspector		X			1. Hand patch coating on man way access.
NDE Was any NDE done. (MI coordinator to review results)	X				No internal NDE carried out at this time – internal is coated with epoxy.
<p>Recommendations or corrective actions : Vessel is Fit for Service or describe corrective actions required) (MIC to review corrective actions with Operations, discuss with Chief Inspector where necessary, and get remedial action implemented) Other Observations: Recommendations: 1. Hand patch coating at man way access. Summary: This vessel is in good overall condition, visual internal and external carried out – 1 small area of coating failure – no corrosion or pitting detected. Vessel is fit for service</p>

Coating failure at man way access

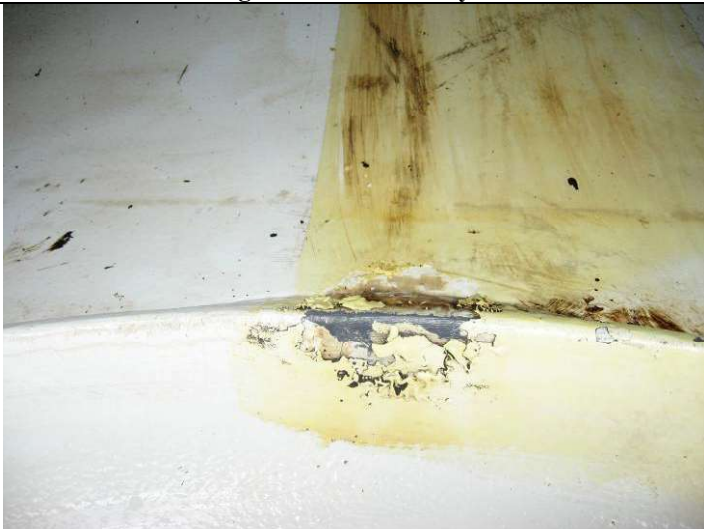
View from internal surface of coating failure
