**Canadian Natural Resources Limited  
GENERAL PRESSURE VESSEL INFORMATION**

**Job # 10.111479**

Facility: **South Spirit River Unit #1 Battery** Location (LSD): **08-09-77-07 W6M**

Vessel Name Equipment Number: **Flare Knock-Out Drum**

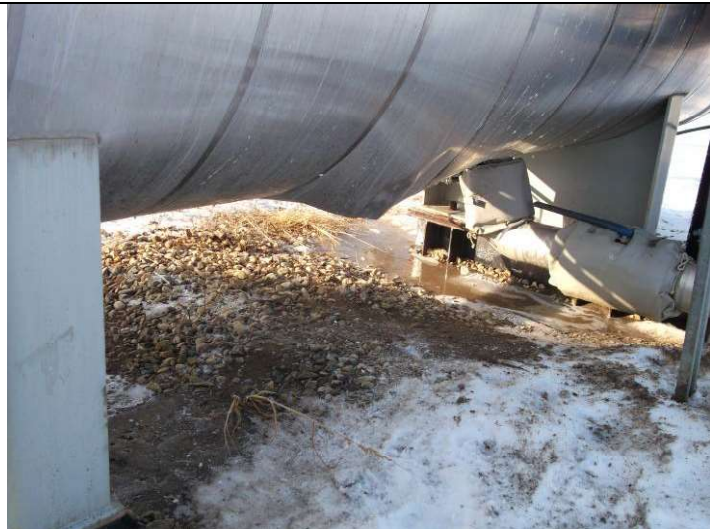
<b>External Inspection Items</b>	G	F	P	N/A	<b>Comments</b>
<b>Insulation</b> Verify sealed around manways, nozzles, no damage present, and there is no egress of moisture.	X				<b>Vessel is 100% insulated. One area of loose insulation approx 1 ft x 1 ft area at midshell 6:00 position.</b>
<b>External Condition</b> Assess paint condition, areas peeling, record any corrosion, damage, etc (record location, size and depth of corrosion or damage)	X				<b>No damage. No corrosion.</b>
<b>Leakage</b> Record any leakage at flanges, threaded joints, weep holes on repads, etc.	X				<b>No leaks observed.</b>
<b>Saddle/Skirt</b> Assess condition of paint, fire protection, concrete. Look for corrosion, buckling, dents, etc. Look at vessel surface area near supports. Verify no signs of leakage at attachment to vessel and attachment welds are acceptable. Ground wire attached?	X				<b>Vessel saddle is bolted to steel beams. No evidence of corrosion at shell to saddle weld – no leaks. Paint in good condition – no exposed metal. No distortion. No buckles. Vessel is mounted on I-beams above ground level. Vessel has ground wire attached.</b>

Loose insulation at bottom shell

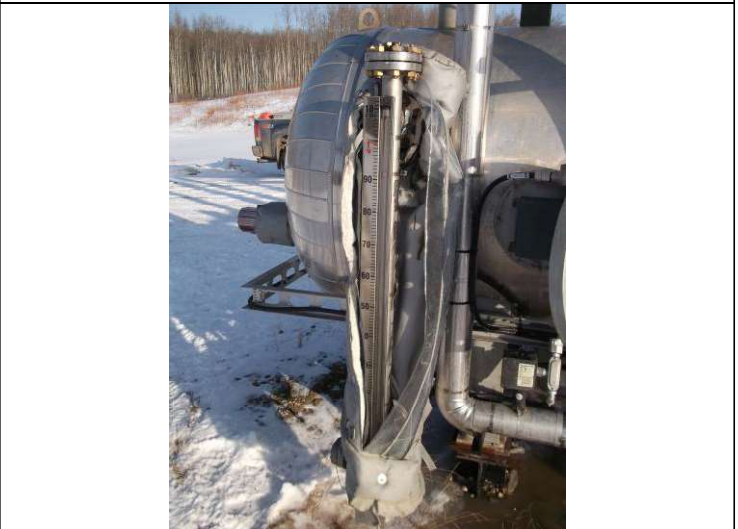
Liquid level gauge

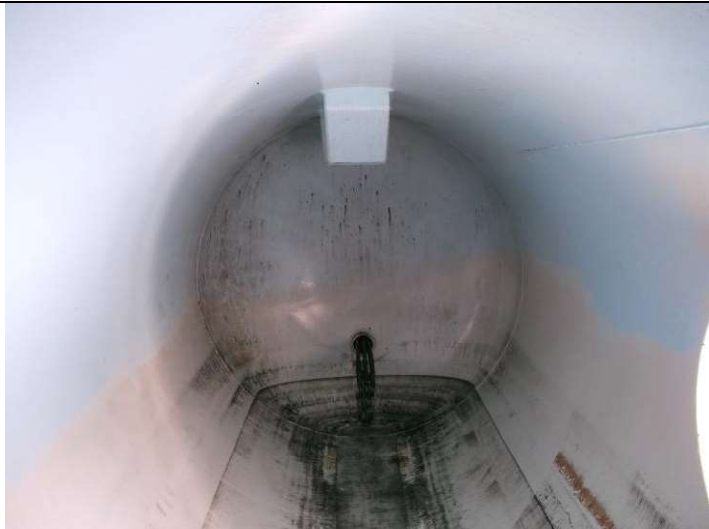
<b>East Head</b> Note all corrosion, erosion or mechanical damage. (If vessel is horizontal identify direction of this head)	X				<b>100% coated no areas of failed coating. No damage. No corrosion. Electric heating coil installed. Good condition- no damage.</b>
<b>Shell Sections</b> Record number of shell sections. Record location, size and depth of all erosion, corrosion or mechanical damage. Describe General condition.	X				<b>Two shell sections in good condition. No damage. No corrosion.</b>
<b>Demister pad</b> Is it in place? Is it clean? If any corrosion is apparent in vessel, lift pad and check top head for corrosion.				X	<b>None</b>
<b>Welds</b> Inspect all welds, including attachment welds. Record all service-related damages and if there is any discuss with Chief Inspector before closing.	X				<b>Welds are coated and are in good condition. No pitting. No corrosion.</b>
<b>Repairs Required.</b> If yes, ensure procedure and copy of AB 40 is on file, and one sent to local ABSA, and Chief Inspector				X	<b>None.</b>

**East head**

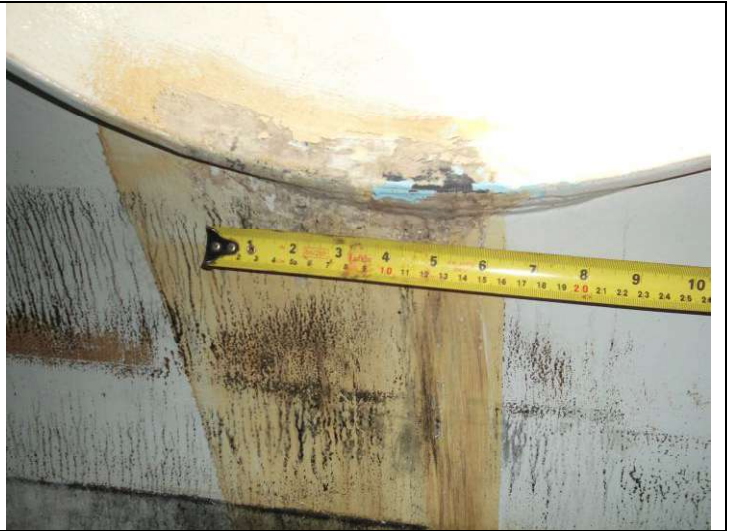
**Previous coating repair – no exposed metal**

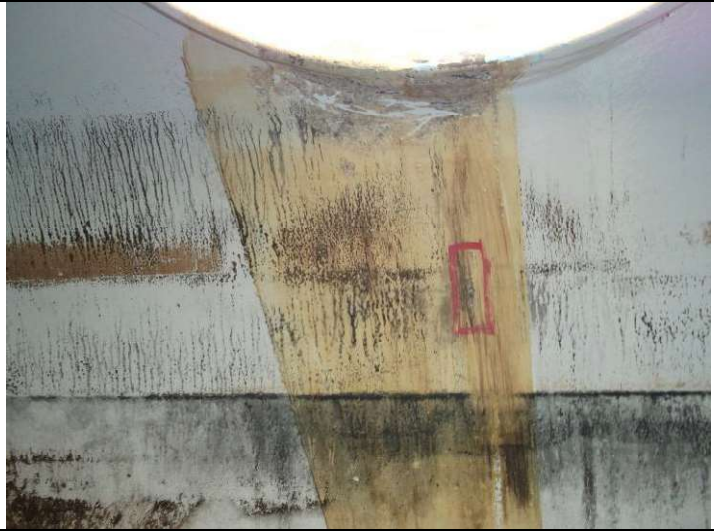
Internal Inspection Items	G	F	P	N/A	Comments
<b>Coating</b> Assess coating. Describe area coated, general condition of coating.	X				<b>Vessel is 100% epoxy coated. Several minor coating chips identified at manway and mid shell. Coating was repaired at time of inspection. One area of previous coating repair at manway. Repair remains intact.</b>
<b>Anodes.</b> How many, type, condition. % consumed. Are they being replaced?				X	<b>No anodes.</b>
<b>Internal Piping</b> Is there any?				X	<b>No internal piping.</b>
<b>Trays</b> How many? Type of material. Are valves in place. Check for erosion/ corrosion; wear on tray valve legs. Cleanliness?				X	<b>No trays.</b>
<b>Baffles, deflector plates, etc.</b> If present, describe condition. Look closely at welds attached to vessel wall.	X				<b>Two deflector plates and one vortex breaker in good condition. No corrosion. No damage.</b>
<b>West Head</b> Note all corrosion, erosion or mechanical damage. (If vessel is horizontal identify direction of this head)	X				<b>100% coated no areas of failed coating. No damage. No corrosion. Electric heating coil installed. Good condition –no damage.</b>

**Chipped coating at mid shell**

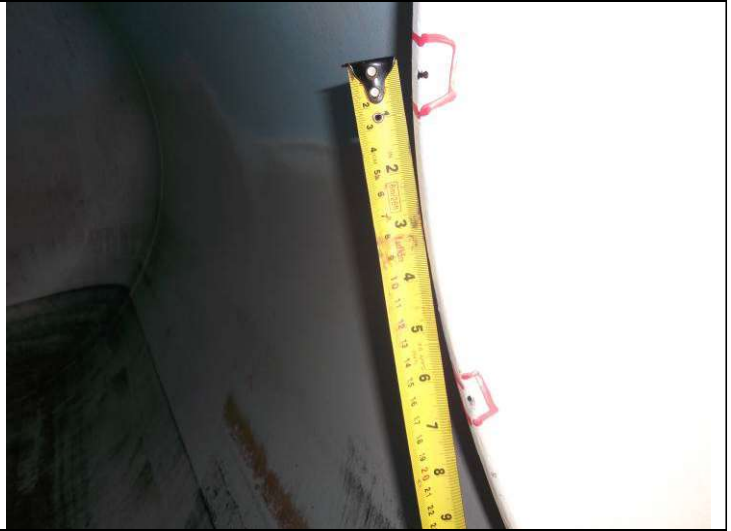
**Chipped coating at manway**

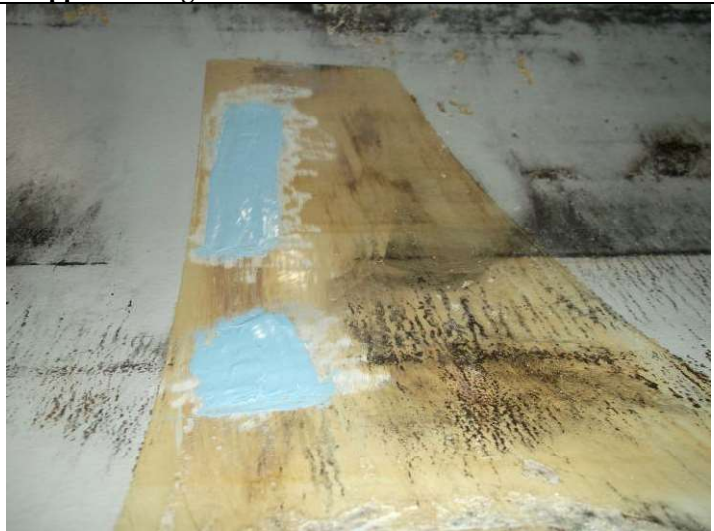
**Coating repair at mid shell**

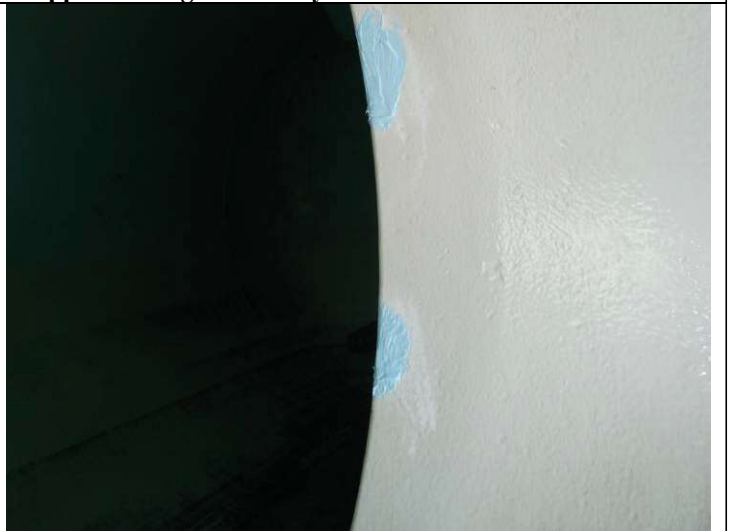
**Coating repairs at manway**
