CLIENT	CANADIAN NATURAL RESOURCES		
FACILITY	SOUTH SPIRIT RIVER BATTERY UNIT #1 LSD 08/09-09-77-07 W6M		
ITEM	FLARE KNOCKOUT DRUM		
BY: TR	DATE: 06/2007	DWG.# 2

HORIZONTAL VESSEL - GENERAL INSPECTION FORM						
District: Grande Prairie, A.B.			Skid No.			
Facility: South Spirit River Battery Unit # 1			Location (LSD): 09-09-77-07 W6M			
Vessel Name & Equipment Number: Flare Knock Out Drum						
Orientation: Horizontal						
Status: In Service			Regulatory Inspection			
PRESSURE VESSEL NAMEPLATE DATA						
"A" or "G" or "S" (Sask.) or BC Registration Number. A 462576			CRN Number P 6520.2			
Vessel serial number: 11796			Size: 48 in x 12 ft			
Shell thickness: 9.5 mm			Shell material: SA-516-70N			
Head thickness: 7.9 mm			Head material: SA-516-70N			
Tube wall thickness:			Tube material:			
Tube diameter:			Tube length:			
Channel thickness:			Channel material:			
MAWP	Shell: 50 PSI		Operating pressure	Shell:		
	Tubes:			Tubes:		
Design Temp.	Shell: 300 Deg. F		Operating temperature	Shell:		
	Tubes:			Tubes:		
X-ray: RT-1			Heat treatment: Nil			
Code parameters: ASME VIII Div.1			Joint efficiency (if on nameplate):

Inspected By: Dellas Wiedman

Date: June 19 – 2007

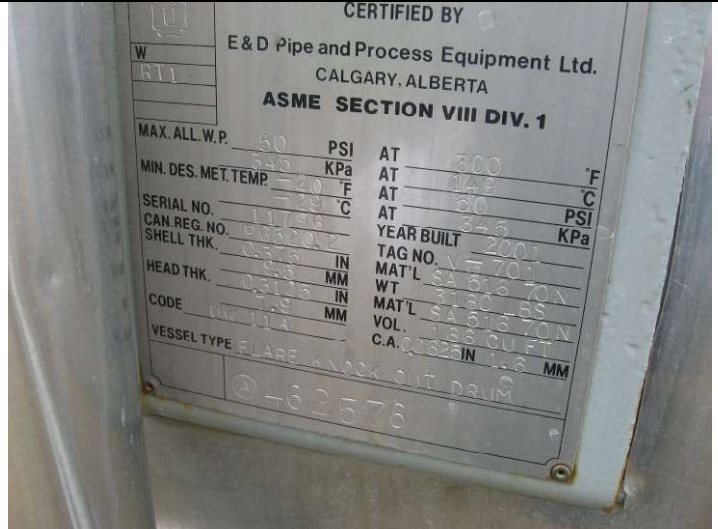
Name Plate

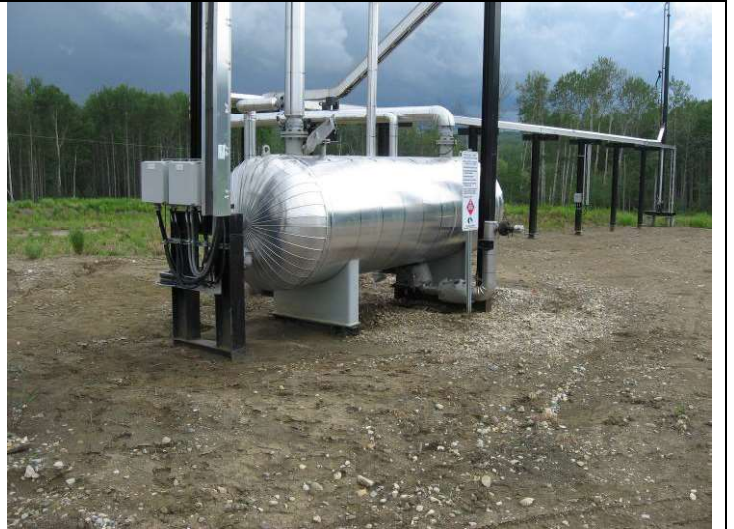
Vessel Overview

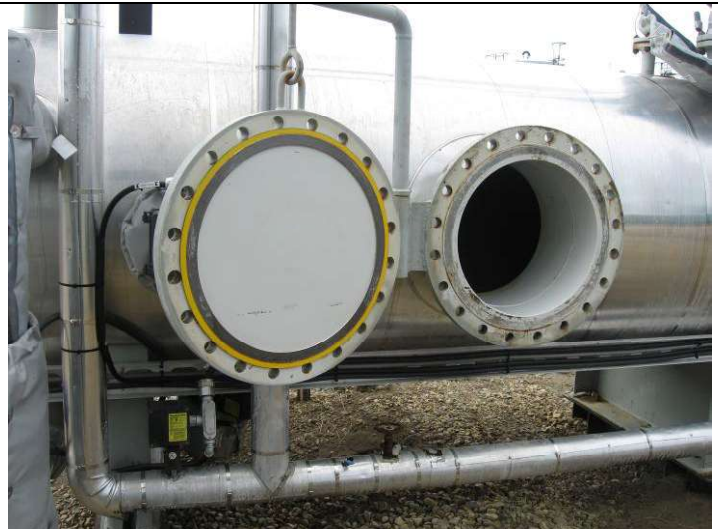
Man way access

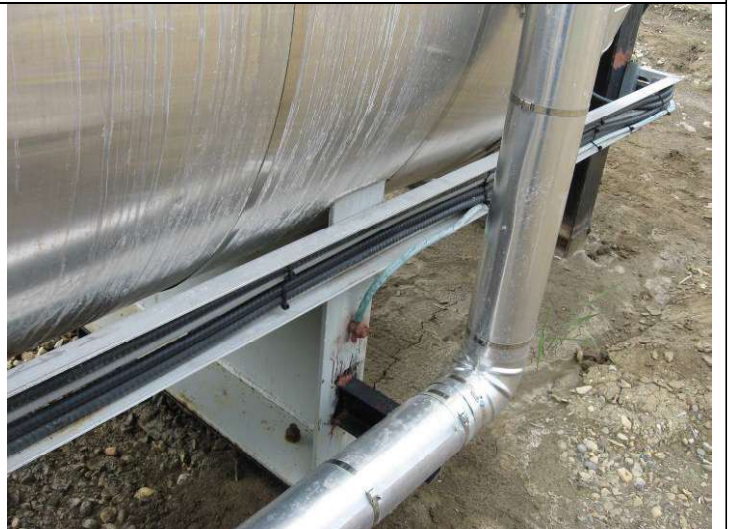
Anchor Bolts Hammer tap to ensure secure. Look for corrosion, cracking in threads or signs of deformation.	X				Firmly bolted to skid.
Concrete foundation Check for cracks, spalling, etc.				X	
Ladder / Platform Describe general condition, ensure support is secure to vessel, and describe any hazards.		X			No ladder
Nozzle Assess paint, look for leakage, and ensure stud threads are fully engaged. Record any damage, deflection, etc. Are nozzles gusseted? Inspect gussets for cracking.	X				Stud threads are fully engaged to nuts – no short bolts. No damage or deflections observed – no leaks. Insulation covers all - nozzles are not gusseted.
Gauges Ensure gauges are visible, working, no leakage, and suitable for range of MAWP/ Temp.				X	No gauges visible.
External Piping Ensure pipe is well supported. All clamps, supports, shoes, etc. in place. Look for evidence of structural overload, deflection, etc. Paint condition, external corrosion?	X				Inlet and Outlet piping is well supported, all clamps, supports, and shoes are in place. No structural overloads or deflections noted. Piping is insulated – no open or torn areas.

External piping and ground cable

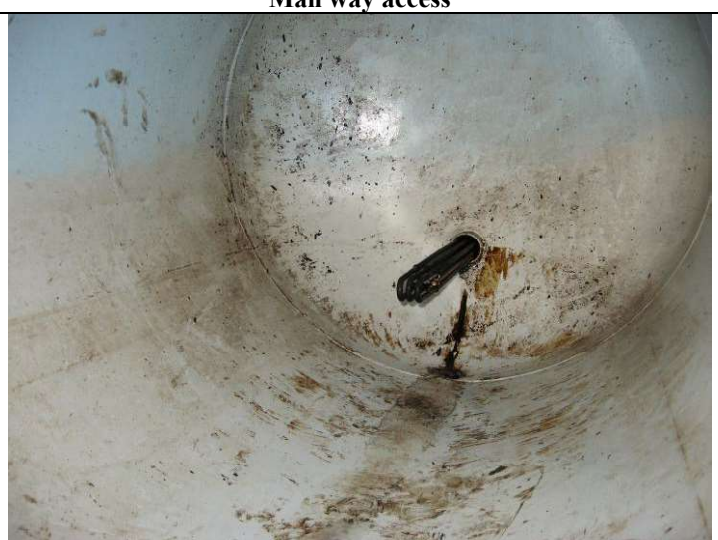
Heat coil in opposite head

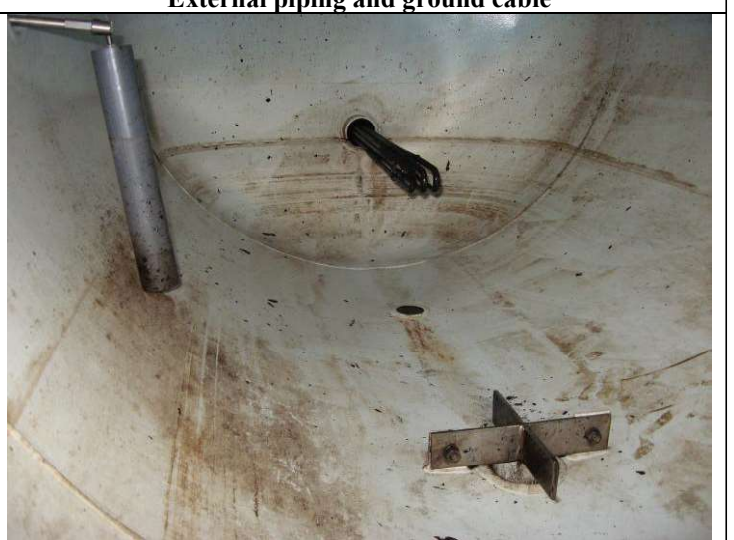
Specific gravity float, heat medium coil and vortex breaker.

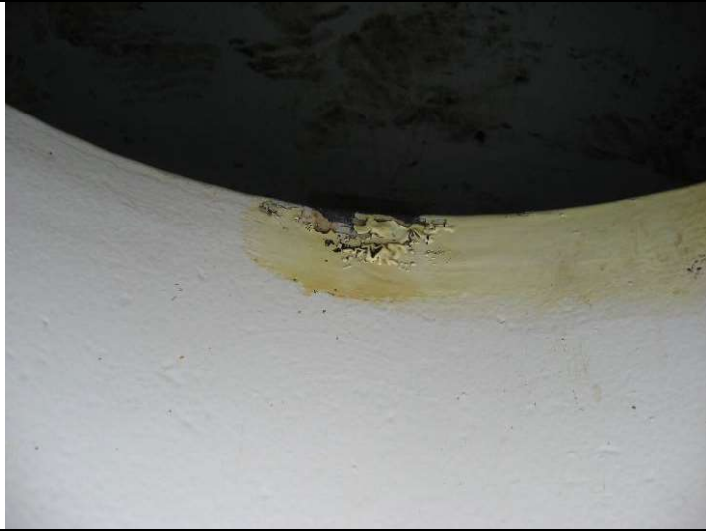
Internal Inspection Items	G	F	P	N/A	Comments
Coating Assess coating. Describe area coated, general condition of coating.	X				100 % internally coated – 1 small area of coating missing at 6:00 position o internal edge of man way nozzle – no corrosion.
Anodes. How many, type, condition. % consumed. Are they being replaced?				X	No anodes
Internal Piping Is there any? If so, carbon or stainless steel. Describe condition, dents, corrosion, erosion, etc. Ensure supports are secure and any bolts are suitable for future use.	X				Heat Medium coil x 2: Good condition – no scale, no corrosion.
Trays How many? Type of material. Are valves in place. Check for erosion/ corrosion; wear on tray valve legs. Cleanliness?				X	No trays.
Baffles, deflector plates, etc. If present, describe condition. Look closely at welds attached to vessel wall.	X				Inlet deflector x 2 - in place – no broken members – no exposed metal. Float intact. Vortex breaker attached.

Coating failure at man way access

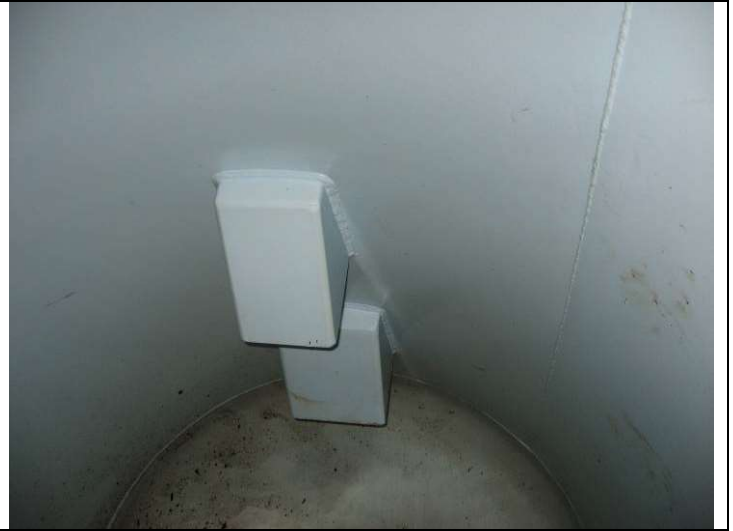
Inlet Diffusers

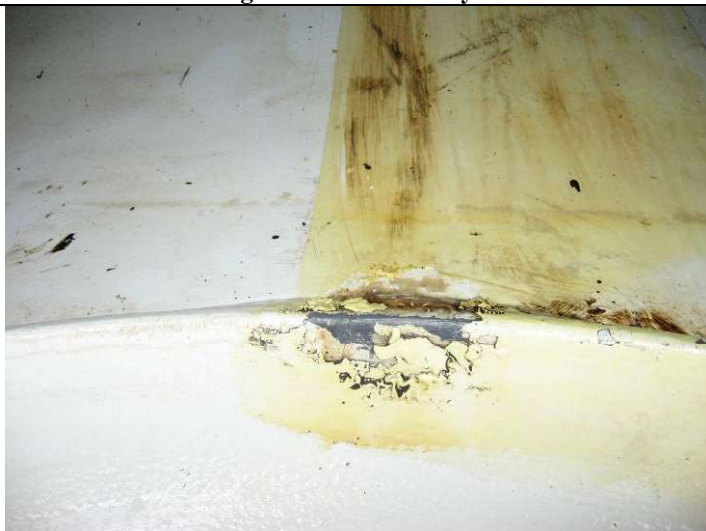
View from internal surface of coating failure
