**Canadian Natural Resources Limited
GENERAL PRESSURE VESSEL INFORMATION Job# 10.110451**

District: Fort St John, BC	Skid No.
Facility: Flatrock Battery	Location (LSD): 17-20-85-17 W6M
Vessel Name Equipment Number: Flare Knockout	
Orientation: Horizontal	
Status: In Service	Regulatory Inspection

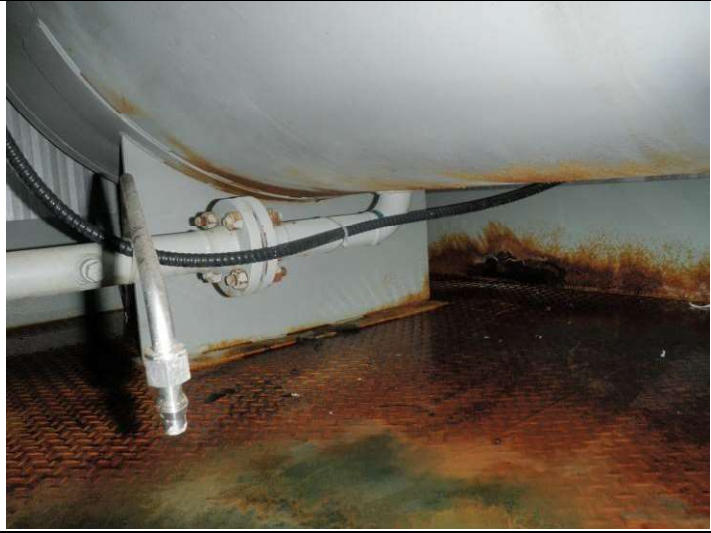
External Inspection Items	G	F	P	N/A	Comments
Insulation Verify sealed around manways, nozzles, no damage present, and there is no egress of moisture.		X			No insulation. Vessel is located in a building. Standing water in building.
External Condition Assess paint condition, areas peeling, record any corrosion, damage, etc (record location, size and depth of corrosion or damage)		X			Paint has burnt off of head where Heater is located. Surface corrosion is evident on lower shell from standing water. Floor of building is starting to corrode due to high humidity.
Leakage Record any leakage at flanges, threaded joints, weep holes on repads, etc.	X				No leaking detected.
Saddle/skirt Assess condition of paint, fire protection, and concrete. Look for corrosion, buckling, dents, etc. Look at vessel surface area near supports. Verify no signs of leakage at attachment to vessel and attachment welds are acceptable. Ground wire attached?	X				Saddles are in good condition – no buckles or distortion. Paint intact – with minor surface corrosion. Vessel is grounded.

Standing water - **Surface corrosion**

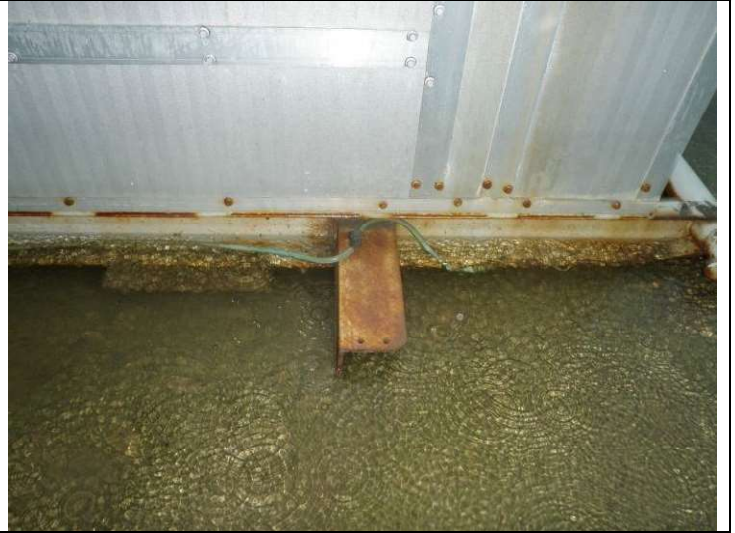
Ground wire attached

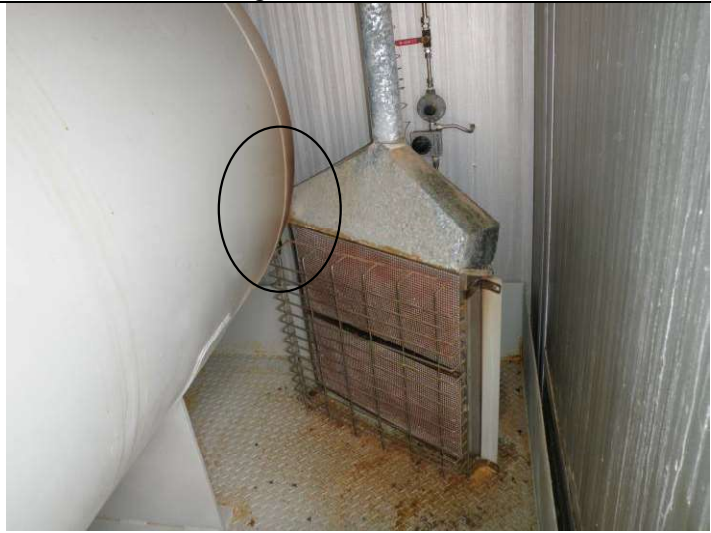
Catadyne Heater – close proximity to vessel

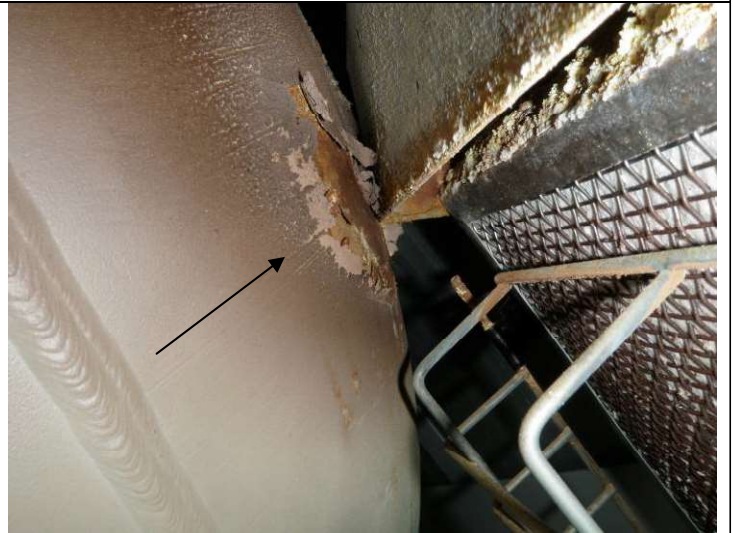
Heat damage to head

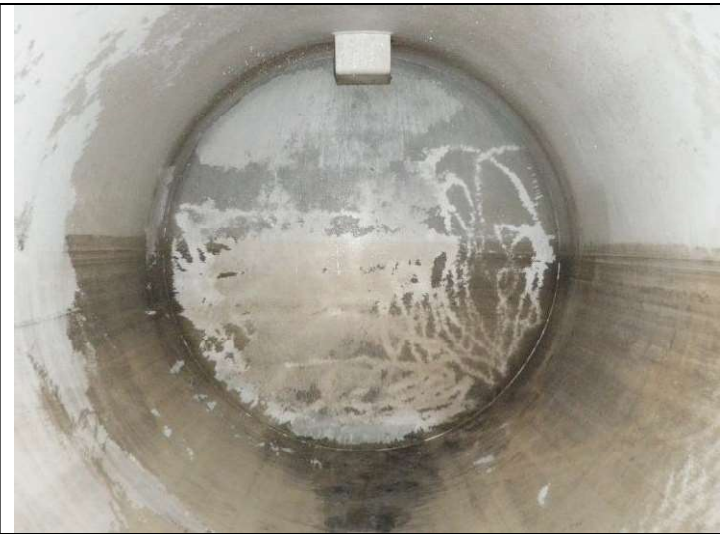
North Head Note all corrosion, erosion or mechanical damage. (If vessel is horizontal identify direction of this head)	X				Head is in good condition. No corrosion or no pitting. No signs of damage or distortion.
Shell Sections Record number of shell sections. Record location, size and depth of all erosion, corrosion or mechanical damage. Describe general condition. If any corrosion greater than corrosion allowance is observed in either shell or head, discuss with Chief Inspector before closing vessel.	X				Shell sections are in good condition. No signs of damage or distortion. No signs of erosion or corrosion. Product scale on lower half of shell and heads. No signs of attack behind product.
Demister pad Is it in place? Is it clean? If any corrosion is apparent in vessel, lift pad and check top head for corrosion.				X	None
Welds Inspect all welds, including attachment welds. Record all service-related damages and if there is any discuss with Chief Inspector before closing.	X				Good condition, no corrosion or pitting.

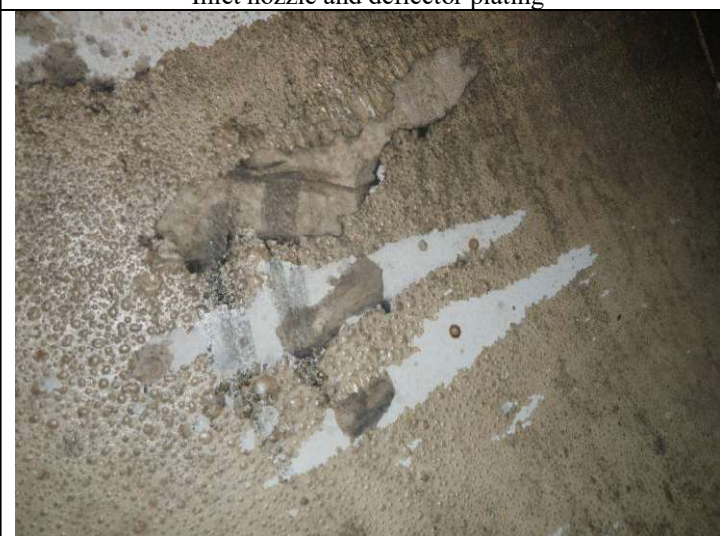
Scale on shell
