**Canadian Natural Resources Limited
GENERAL PRESSURE VESSEL INFORMATION**

District: Fort St John, BC		Skid No.				
Facility: Graham Compressor Station		Location (LSD): C-76-K/94-B-8				
Vessel Name & Equipment Number: H.P. Flare Knockout						
Orientation: Horizontal						
Status: In service		Regulatory Inspection				
PRESSURE VESSEL NAMEPLATE DATA						
Registration Number C 34219		CRN Number P-6164.2				
Vessel serial number: 04-94-M051-1		Size: 6 ft x 20 ft				
Shell thickness: 9.5 mm		Shell material: SA 516 70				
Head thickness: 9.5 mm		Head material: SA 516 70				
Tube wall thickness:		Tube material:				
Tube diameter:		Tube length:				
Channel thickness:		Channel material:				
Design pressure	Shell: 14 PSI	Operating pressure	Shell:			
	Tubes:		Tubes:			
Design Temp.	Shell: 150 deg F	Operating temperature	Shell:			
	Tubes:		Tubes:			
X-ray: NIL		Heat treatment: NIL				
Code parameters: ASME VIII Div I		Coated: n/s				
Manufacturer: Pyramid		Built: 1994				
Corrosion allowance: NIL		Manway: No

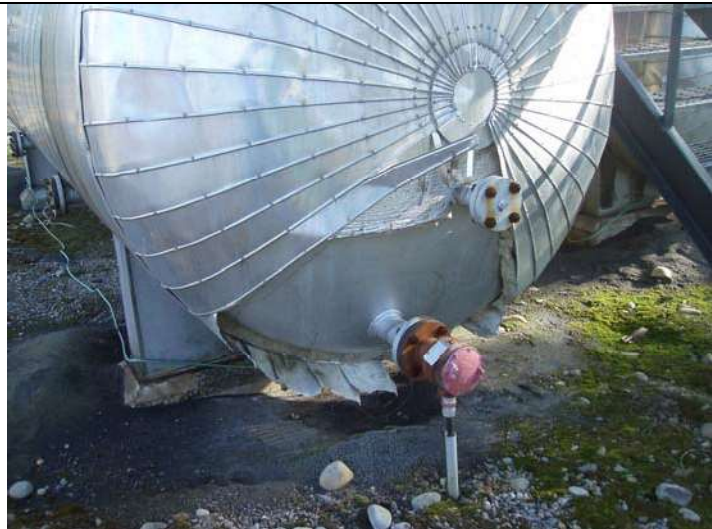
External Inspection Items	G	F	P	N/A	Comments
Insulation Verify sealed around manways, nozzles, no damage present, and there is no egress of moisture.	X				Damage to outlet piping insulation and head of vessel.
External Condition Assess paint condition, areas peeling, record any corrosion, damage, etc (record location, size and depth of corrosion or damage)	X				Exposed areas of vessel show paint in good condition. No exposed metal.
Leakage: Record any leakage at flanges, threaded joints, weep holes on repads, etc.	X				No leakages at flanges or threaded joints.
Saddle: Assess condition of paint, fire protection, concrete. Look for corrosion, buckling, dents, etc. Look at vessel surface area near supports. Verify no signs of leakage at attachment to vessel and attachment welds are acceptable. Ground wire attached?	X				Saddle is securely bolted to supports Paint in good condition No Buckling or dents present. No signs of leaking. Ground is connected to skid.

Damaged cladding
