**Canadian Natural Resources Limited
GENERAL PRESSURE VESSEL INFORMATION**

Job # 05.003373

District: Fort St John, BC		Skid No.				
Facility: Graham Compressor Station		Location (LSD): C-76-K/94-B-8				
Vessel Name & Equipment Number: H.P. Flare Knockout						
Orientation: Horizontal						
Status: In service		Regulatory Inspection				
PRESSURE VESSEL NAMEPLATE DATA						
Registration Number C 34219		CRN Number P-6164.2				
Vessel serial number: 04-94-M051-1		Size: 6 ft x 20 ft				
Shell thickness: 9.5 mm		Shell material: SA 516 70				
Head thickness: 9.5 mm		Head material: SA 516 70				
Tube wall thickness:		Tube material:				
Tube diameter:		Tube length:				
Channel thickness:		Channel material:				
Design pressure	Shell: 14 PSI	Operating pressure	Shell:			
	Tubes:		Tubes:			
Design Temp.	Shell: 150 deg F	Operating temperature	Shell:			
	Tubes:		Tubes:			
X-ray: NIL		Heat treatment: NIL				
Code parameters: ASME VIII Div I		Coated: Yes				
Manufacturer: Pyramid		Built: 1994				
Corrosion allowance: NIL		Manway: No

C34219

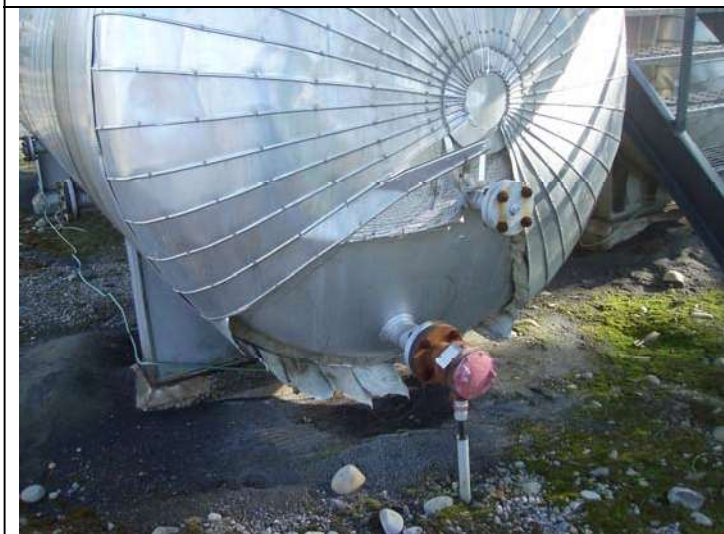
External Inspection Items	G	F	P	N/A	Comments
Insulation Verify sealed around manways, nozzles, no damage present, and there is no egress of moisture.	X				Damage to outlet piping insulation and head of vessel.
External Condition Assess paint condition, areas peeling, record any corrosion, damage, etc (record location, size and depth of corrosion or damage)	X				Exposed areas of vessel show paint in good condition. No exposed metal.
Leakage: Record any leakage at flanges, threaded joints, weep holes on repads, etc.	X				No leakages at flanges or threaded joints.
Saddle: Assess condition of paint, fire protection, concrete. Look for corrosion, buckling, dents, etc. Look at vessel surface area near supports. Verify no signs of leakage at attachment to vessel and attachment welds are acceptable. Ground wire attached?	X				Saddle is securely bolted to supports Paint in good condition No Buckling or dents present. No signs of leaking. Ground is connected to skid.

Damaged cladding

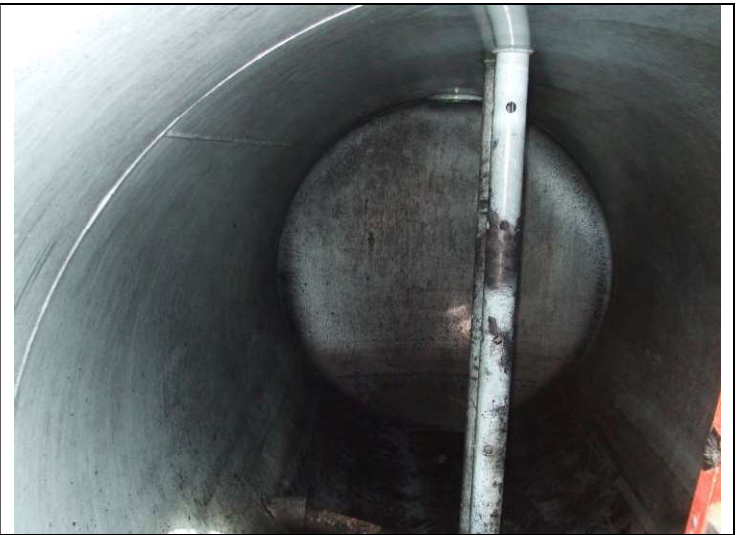
East Head Note all corrosion, erosion or mechanical damage. (If vessel is horizontal identify direction of this head)	X				No mechanical damage, corrosion or erosion was found. Good overall condition.
Shell Sections Record number of shell sections. Record location, size and depth of all erosion, corrosion or mechanical damage. Describe general condition. If any corrosion greater than corrosion allowance is observed in either shell or head, discuss with Chief Inspector before closing vessel.	X				Two can sections were found to form the vessel & it is 100% internally coated and is in good overall condition. No mechanical damage, corrosion or erosion was noted.
Demister pad Is it in place? Is it clean? If any corrosion is apparent in vessel, lift pad and check top head for corrosion.				X	None.
Welds Inspect all welds, including attachment welds. Record all service-related damages and if there is any discuss with Chief Inspector before closing.	X				All visible welds are 100% coated & appear to be in good overall condition.

East Head

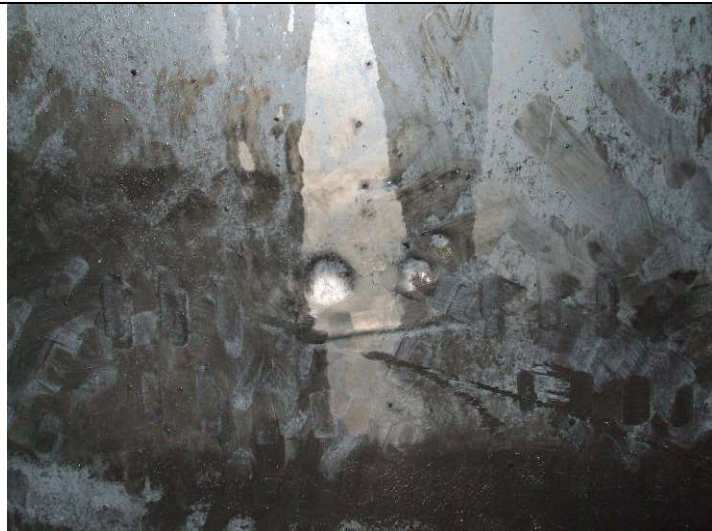
Lower Shell coated previous pitting overview

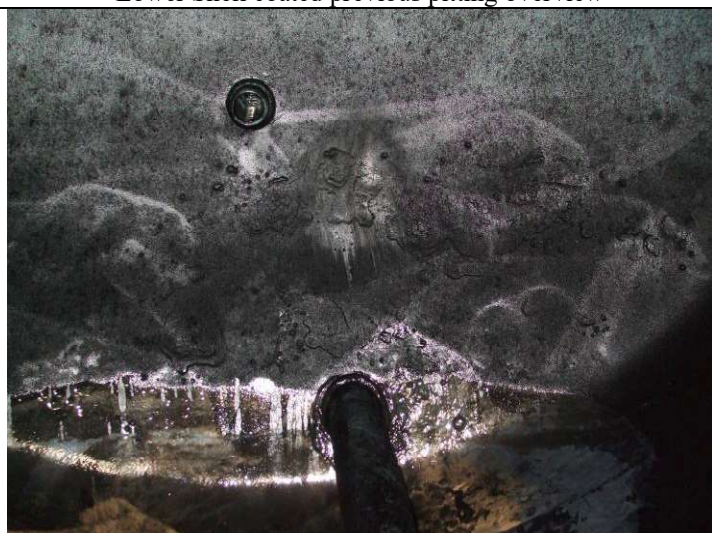
Lower West end head coated with previous pitting

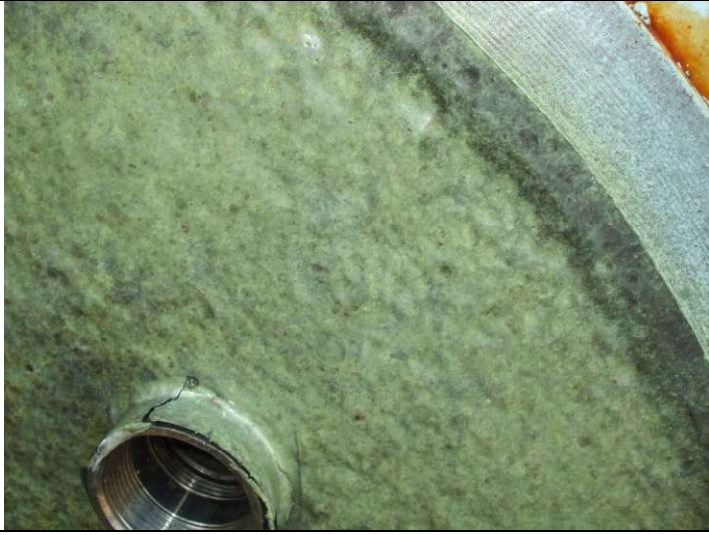
Manway cover previous pitting
