**Canadian Natural Resources Limited
GENERAL PRESSURE VESSEL INFORMATION**

Job # 05.003373

District: Fort St John, BC		Skid No.				
Facility: Graham Compressor Station		Location (LSD): C-76-K/94-B-8				
Vessel Name & Equipment Number: H.P. Flare Knockout						
Orientation: Horizontal						
Status: In service		Regulatory Inspection				
PRESSURE VESSEL NAMEPLATE DATA						
Registration Number C 34219		CRN Number P-6164.2				
Vessel serial number: 04-94-M051-1		Size: 6 ft x 20 ft				
Shell thickness: 9.5 mm		Shell material: SA 516 70				
Head thickness: 9.5 mm		Head material: SA 516 70				
Tube wall thickness:		Tube material:				
Tube diameter:		Tube length:				
Channel thickness:		Channel material:				
Design pressure	Shell: 14 PSI	Operating pressure	Shell:			
	Tubes:		Tubes:			
Design Temp.	Shell: 150 deg F	Operating temperature	Shell:			
	Tubes:		Tubes:			
X-ray: NIL		Heat treatment: NIL				
Code parameters: ASME VIII Div I		Coated: Yes				
Manufacturer: Pyramid		Built: 1994				
Corrosion allowance: NIL		Manway: No

C34219

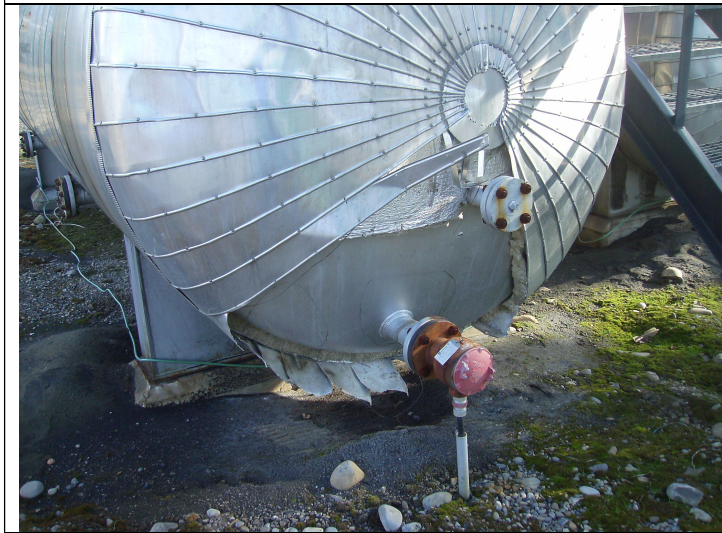
External Inspection Items	G	F	P	N/A	Comments
Insulation Verify sealed around manways, nozzles, no damage present, and there is no egress of moisture.	X				Damage to outlet piping insulation and head of vessel.
External Condition Assess paint condition, areas peeling, record any corrosion, damage, etc (record location, size and depth of corrosion or damage)	X				Exposed areas of vessel show paint in good condition. No exposed metal.
Leakage: Record any leakage at flanges, threaded joints, weep holes on repads, etc.	X				No leakages at flanges or threaded joints.
Saddle: Assess condition of paint, fire protection, concrete. Look for corrosion, buckling, dents, etc. Look at vessel surface area near supports. Verify no signs of leakage at attachment to vessel and attachment welds are acceptable. Ground wire attached?	X				Saddle is securely bolted to supports Paint in good condition No Buckling or dents present. No signs of leaking. Ground is connected to skid.

Damaged cladding

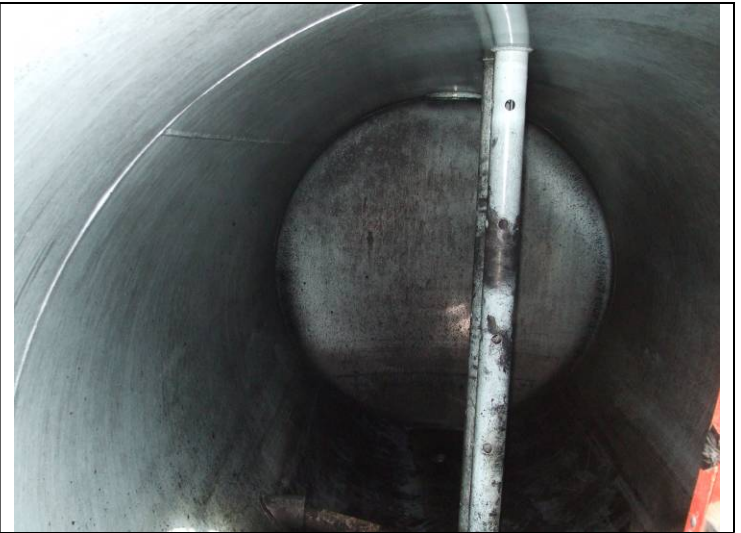
East Head Note all corrosion, erosion or mechanical damage. (If vessel is horizontal identify direction of this head)	X				No mechanical damage, corrosion or erosion was found. Good overall condition.
Shell Sections Record number of shell sections. Record location, size and depth of all erosion, corrosion or mechanical damage. Describe general condition. If any corrosion greater than corrosion allowance is observed in either shell or head, discuss with Chief Inspector before closing vessel.	X				Two can sections were found to form the vessel & it is 100% internally coated and is in good overall condition. No mechanical damage, corrosion or erosion was noted.
Demister pad Is it in place? Is it clean? If any corrosion is apparent in vessel, lift pad and check top head for corrosion.				X	None.
Welds Inspect all welds, including attachment welds. Record all service-related damages and if there is any discuss with Chief Inspector before closing.	X				All visible welds are 100% coated & appear to be in good overall condition.

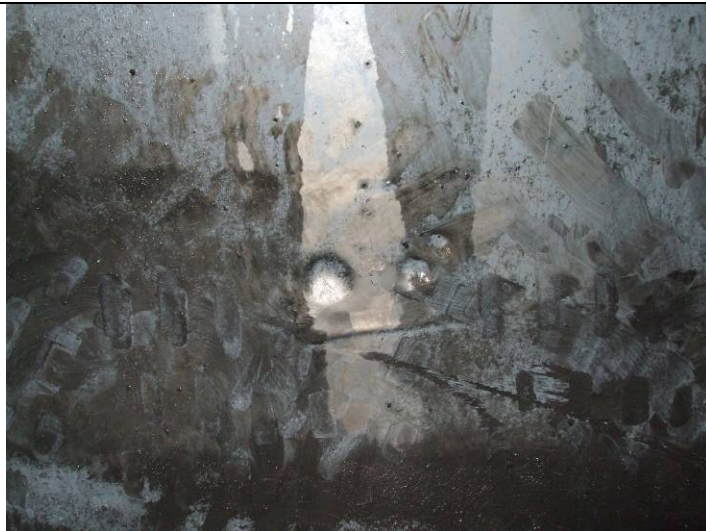
Lower Shell coated previous pitting overview

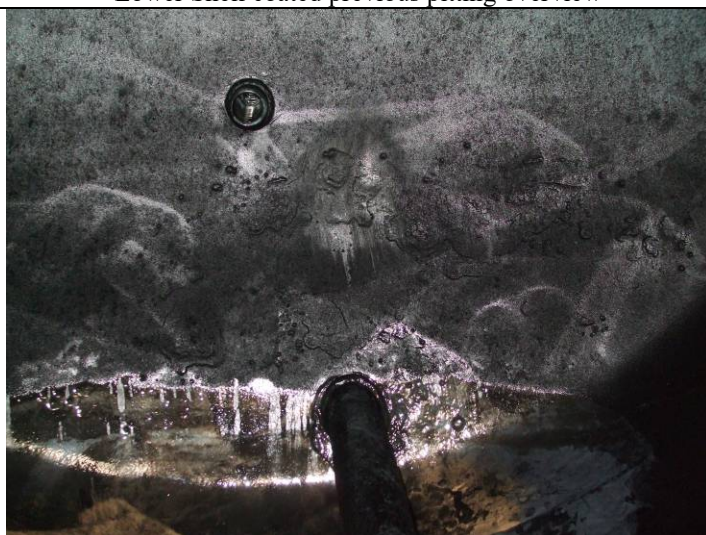
Lower West end head coated with previous pitting

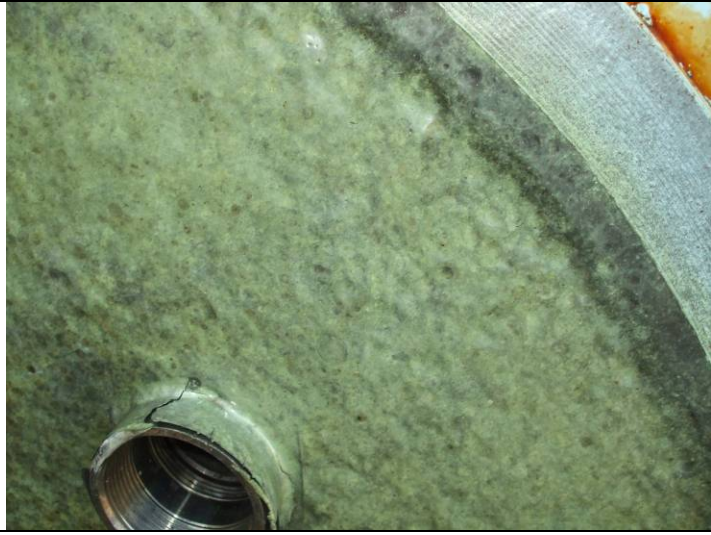
Manway cover previous pitting
