PRESSURE EQUIPMENT DATA REPORT

District:	Fort St John		
Facility:	Graham		
Location /LSD:	C-076-K/094-B-08	Operating Province:	British Columbia
Equipment Name:	LOW PRESSURE FLARE KNOCKOUT		
Equipment Status:	Operating	Orientation:	Horizontal
Skid No.:	Unit:

External Inspection

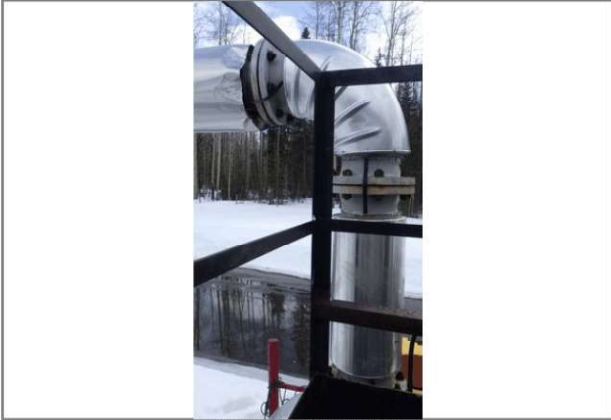
OUTLET INSULATION

Type	Findings	
Vessel	Insulated	None Tearing, None Denting, Accept Banding, Accept Seals/Joints	Accept
Inlet Piping	Insulated	None Tearing, None Denting, Accept Banding, Accept Seals/Joints	Accept
Outlet Piping	Insulated	None Tearing, None Denting, Accept Banding, Some Broken Seals/Joints	Accept
