**Canadian Natural Resources Limited  
GENERAL PRESSURE VESSEL INFORMATION**

**Job: 10.113559**

District: <b>Fort St. John BC</b>	Skid No.
Facility: <b>Graham Gas Plant</b>	Location (LSD): <b>c-76-K-94-B-08</b>
Vessel Name Equipment Number: <b>Low Pressure Flare Knockout Drum</b>	
Orientation: <b>Horizontal</b>	
Status: <b>In Service</b>	<b>Regulatory Inspection</b>

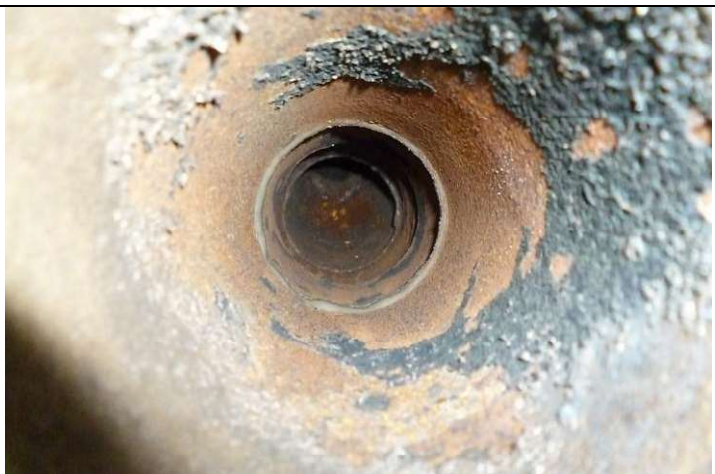
<b>Internal Inspection Items</b>	<b>G</b>	<b>F</b>	<b>P</b>	<b>N/A</b>	<b>Comments</b>
<b>Coating</b> Assess coating. Describe area coated, general condition of coating.		X			Blisters and peeling around man way attachment weld to top of vessel. Peeling and corrosion on head to shell welds. Coating peeling in side man way – corrosion to attachment welds – cap weld corroded – 12 “ of root weld exposed and pitting. Peeling coating on inlet nozzle and outlet nozzle.
<b>Anodes.</b> How many, type, condition. % consumed. Are they being replaced?	X				2 anodes – being replaced.
<b>Internal Piping</b> Is there any? If so, carbon or stainless steel. Describe condition, dents, corrosion, erosion, etc. Ensure supports are secure and any bolts are suitable for future use.	X				Level gauge piping in place – no mechanical damage. Drain piping elbow corroded- pitting on apex. Elbow on exterior is corroded with scaling.

Drain corrosion in elbow

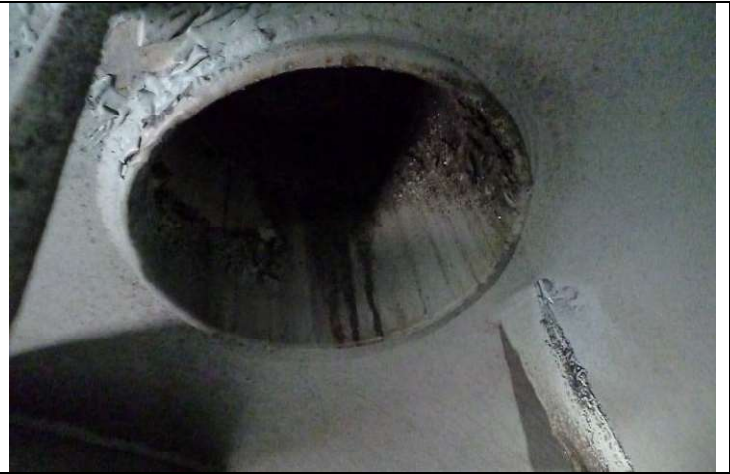
Inlet nozzle peeling

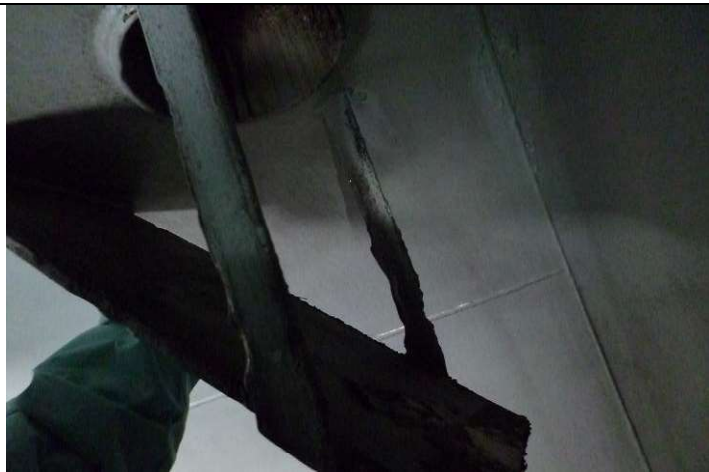
<b>Trays</b> How many? Type of material. Are valves in place? Check for erosion/ corrosion; wear on tray valve legs. Cleanliness?				X	
<b>Baffles, deflector plates, etc.</b> If present, describe condition. Look closely at welds attached to vessel wall.		X			Inlet deflector plate welded to top shell – corrosion to support braces and plate – coating peeling.
<b>Top Head</b> Note all corrosion, erosion or mechanical damage. (If vessel is horizontal identify direction of this head)	X				No mechanical damage – corrosion to attachment welds to shell –corrosion staining on coating. Coating bonded to head.
<b>Bottom Head</b> Note all corrosion, erosion or mechanical damage. (If vessel is horizontal identify direction of this head)	X				No mechanical damage or peeling coating on head – head attachment welds peeling corrosion under coating.
<b>Shell Sections</b> Record number of shell sections. Record location, size and depth of all erosion, corrosion or mechanical damage. Describe general condition. If any corrosion greater than corrosion allowance is observed in either shell or head, discuss with Chief Inspector before closing vessel.	X				1 sheet sections- nozzles are clean – Man way on top shell – corrosion and peeling coating on attachment welds. Pitting under coating on bottom shell - .170” above coating. Coating bonded in pits. Outlet nozzle coating peeling – surface corrosion on exposed metal.

Corroded inlet deflector

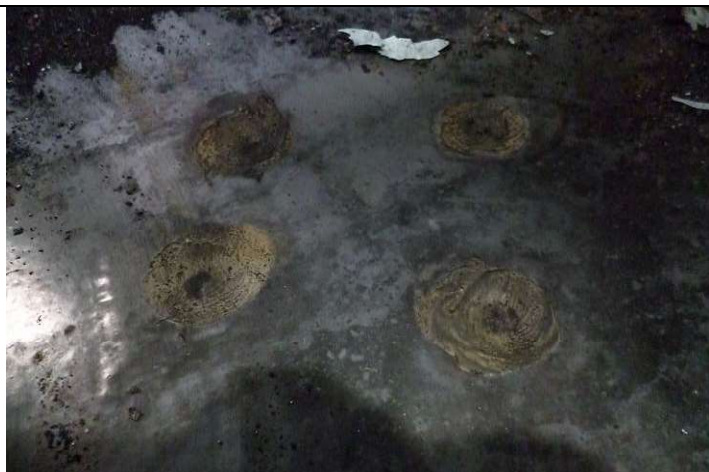
Pit corrosion on floor coated

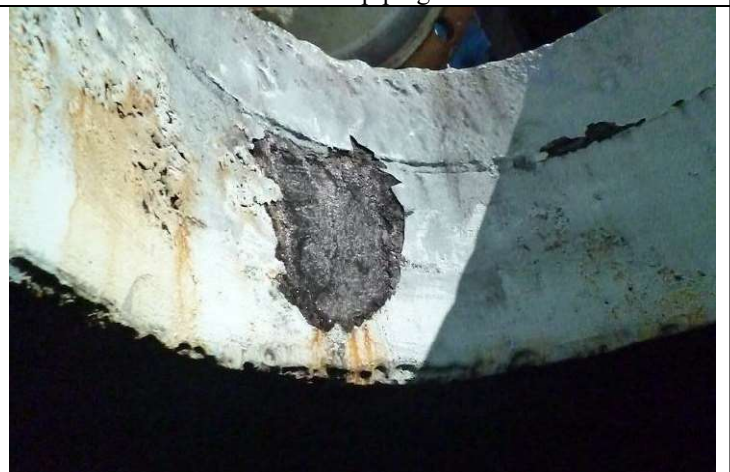
Peeling in man way

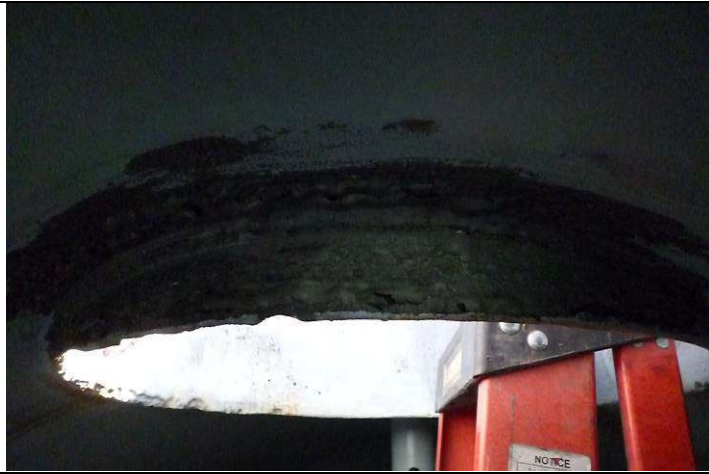
Man way peeling

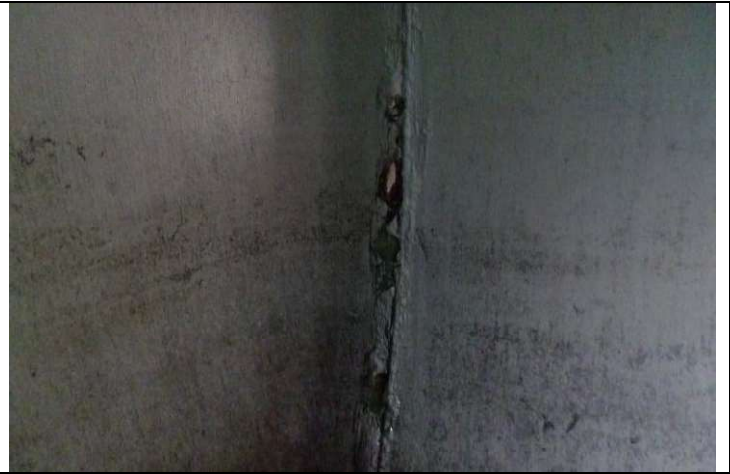
Head to shell weld blistered and peeling

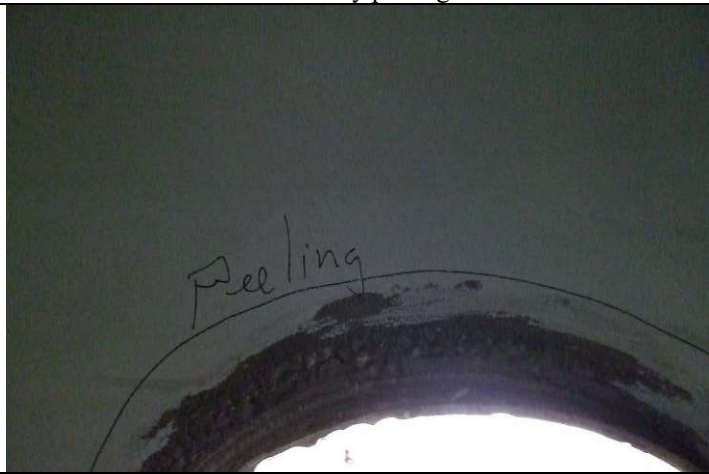
Man way attachment weld peeling coating

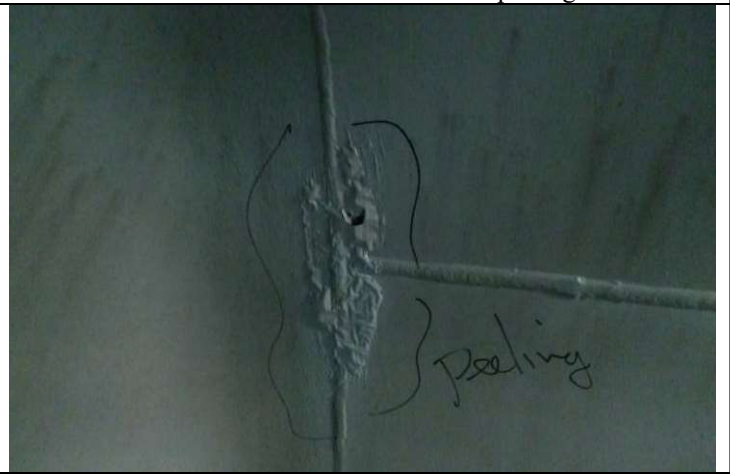
Blisters and peeling on shell weld

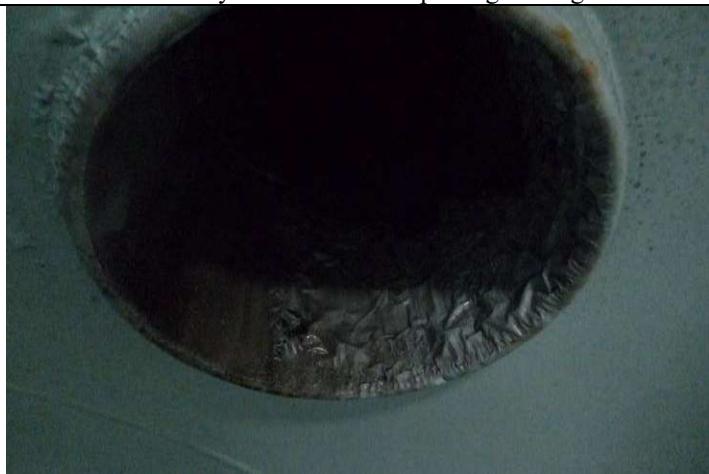
Outlet nozzle peeling

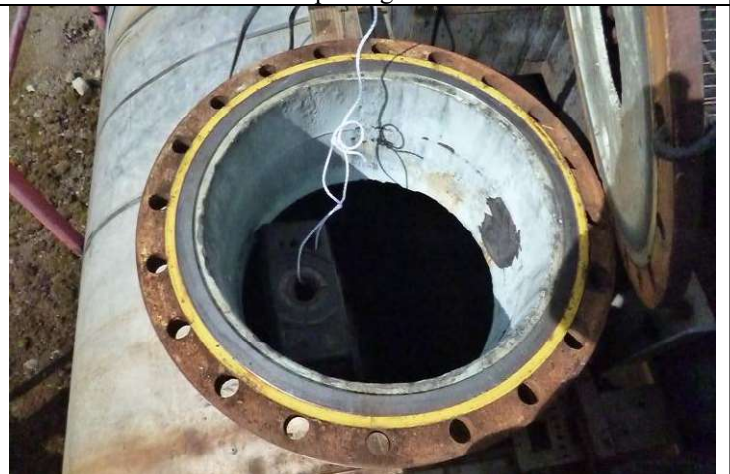
Peeling coating in man way
