Canadian Natural Resources Limited
GENERAL PRESSURE VESSEL INFORMATION **Job # 05.003373**

District: Fort St John, BC		Skid No.				
Facility: Graham Compressor Station		Location (LSD): C-76-K/94-B-8				
Vessel Name & Equipment Number: L.P. Flare Knockout						
Orientation: Horizontal						
Status: In service		Regulatory Inspection				
PRESSURE VESSEL NAMEPLATE DATA						
Registration Number C 34220		CRN Number P 6164.2				
Vessel serial number: 04-94-M051-2		Size: 6 ft x 20 ft				
Shell thickness: 9.5 mm		Shell material: SA 516 70				
Head thickness: 9.5 mm		Head material: SA 516 70				
Tube wall thickness:		Tube material:				
Tube diameter:		Tube length:				
Channel thickness:		Channel material:				
Design pressure	Shell: 14 PSI	Operating pressure	Shell:			
	Tubes:		Tubes:			
Design Temp.	Shell: 150 deg F	Operating temperature	Shell:			
	Tubes:		Tubes:			
X-ray: NIL		Heat treatment: NIL				
Code parameters: ASME VIII Div I		Coated: Yes				
Manufacturer: Pyramid		Built: 1994				
Corrosion allowance: NIL		Manway: No

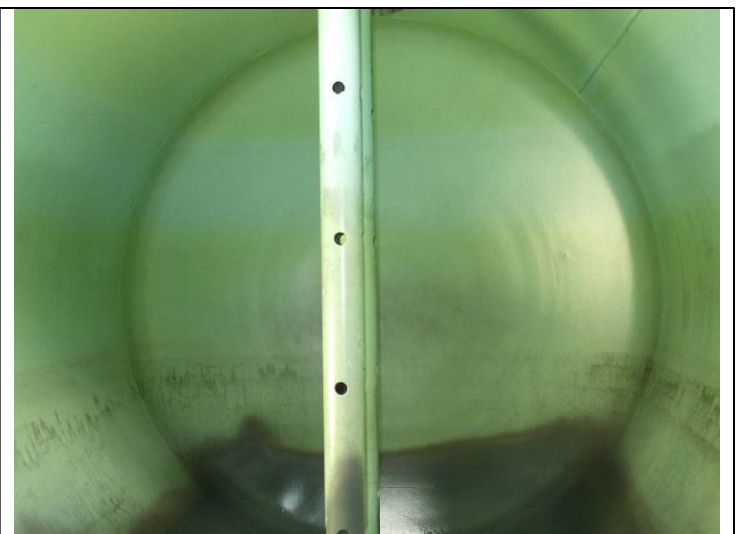
West Head Note all corrosion, erosion or mechanical damage. (If vessel is horizontal identify direction of this head)	X				No mechanical damage, corrosion or erosion was found. Good overall condition.
East Head Note all corrosion, erosion or mechanical damage. (If vessel is horizontal identify direction of this head)	X				No mechanical damage, corrosion or erosion was found. Good overall condition.
Shell Sections Record number of shell sections. Record location, size and depth of all erosion, corrosion or mechanical damage. Describe general condition. If any corrosion greater than corrosion allowance is observed in either shell or head, discuss with Chief Inspector before closing vessel.		X			One shell sections was found to form the vessel & it is in good overall condition. Shell is 100% internally coated and is in good overall condition, except for five 1” diameters previously repaired pits on the bottom shell & the manway throat – both of these areas were hand patched. No mechanical damage, corrosion or erosion was noted.

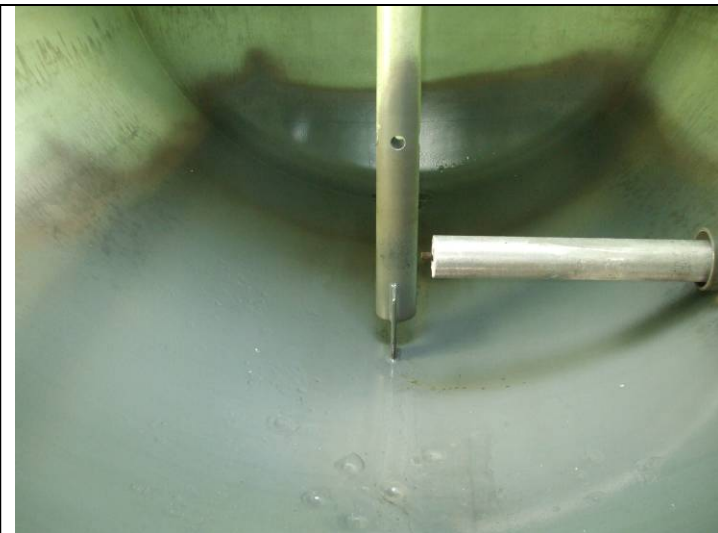
Lower Shell overview

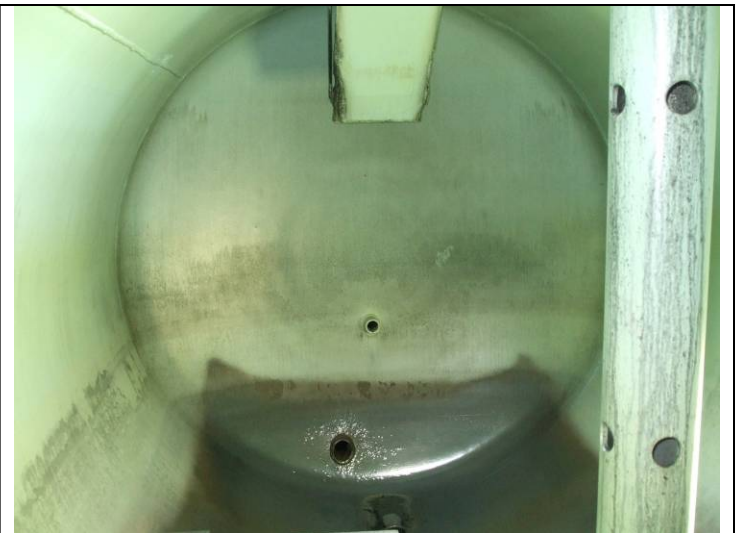
West Head Overview

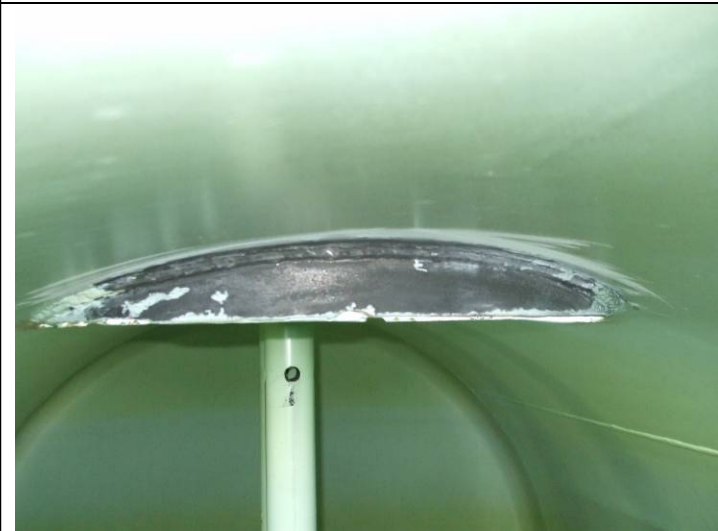
Internal Inspection Items	G	F	P	N/A	Comments
Coating Assess coating. Describe area coated, general condition of coating.	X				This Vessel is 100% internally coated and is in good overall condition – Note the manway throat coating failed to 10% repairs were made by hand patching.
Anodes. How many, type, condition. % consumed. Are they being replaced?	X				Two anodes were found both were in good condition – less than 2% consumed.
Internal Piping Is there any? If so, carbon or stainless steel. Describe condition, dents, corrosion, erosion, etc. Ensure supports are secure and any bolts are suitable for future use.	X				Good overall condition, clean and coated, no visible pitting, or corrosion noted that time of inspection.
Trays How many? Type of material. Are valves in place? Check for erosion/ corrosion; wear on tray valve legs. Cleanliness?				X	None.
Baffles, deflector plates, etc. If present, describe condition. Look closely at welds attached to vessel wall.	X				None.

Coating failure

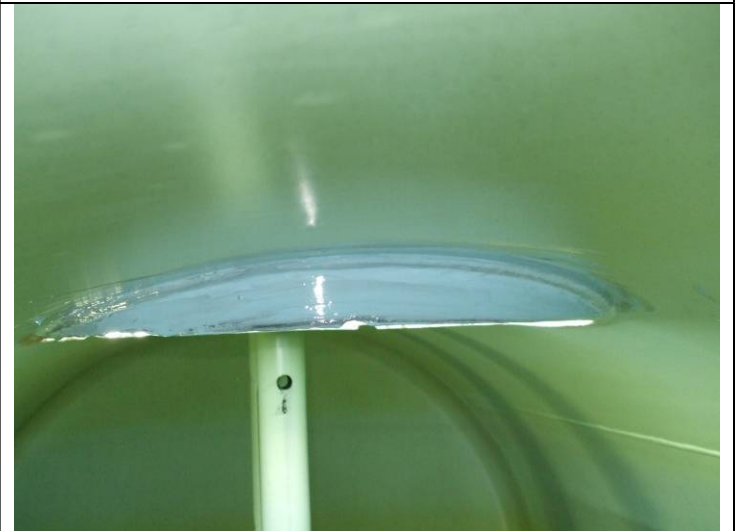
Coating repaired

Demister pad Is it in place? Is it clean? If any corrosion is apparent in vessel, lift pad and check top head for corrosion.				X	None.
Welds Inspect all welds, including attachment welds. Record all service-related damages and if there is any discuss with Chief Inspector before closing.	X				All visible welds appear to be in good overall condition.
Repairs Required. If yes, ensure procedure and copy of AB 40 is on file, and one sent to local ABSA, and Chief Inspector				X	None.
NDE Was any NDE done. (MI coordinator to review results)	X				None at this time.
<p>Recommendations or corrective actions : Vessel is Fit for Service or describe corrective actions required) (MIC to review corrective actions with Operations, discuss with Chief Inspector where necessary, and get remedial action implemented)</p> <p>Recommendations: 1. Repair all failed coating – coating was hand patched July-08-2009. Summary: This vessel is in good overall condition, visual internal inspection carried out – internal is coated with epoxy – 5 small areas of exposed metal at man way access – hand patched with epoxy grout. No corrosion or pitting. Vessel is fit for service.</p>

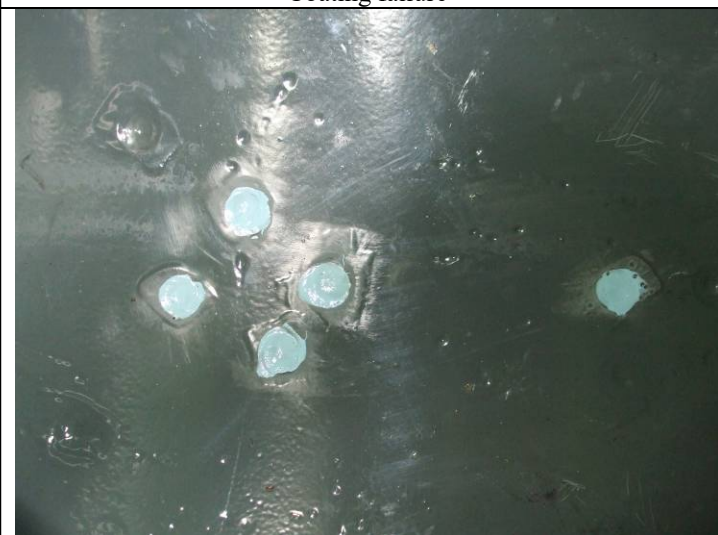
Coating repairs bottom shell / Previous coating repairs

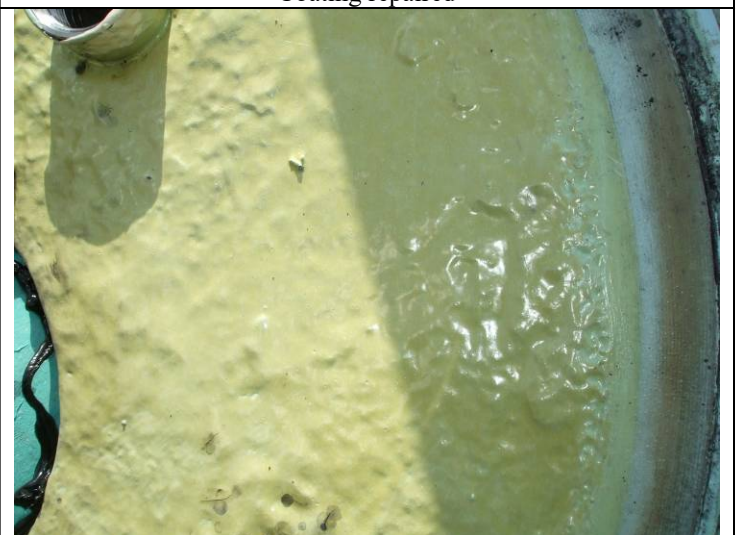
Manway cover previous pitting
