**Canadian Natural Resources Limited
GENERAL PRESSURE VESSEL INFORMATION**

Job # 05.001958

District: Ft St John B.C.						
Facility: Halfway Battery		Location (LSD): 05 – 12 – 87 – 25 – W6M				
Vessel Name & Equipment Number: High Pressure Flare Knock Out Drum						
Orientation: Horizontal						
Status: Operating		Regulatory Inspection				
PRESSURE VESSEL NAMEPLATE DATA						
"A" or "G" or "S" (Sask.) or BC Registration Number. C 23425		CRN Number Non Code				
Vessel serial number: 001891		Size : 72 in. x 20 ft.				
Shell thickness: 9.5 mm		Shell material: SA 36				
Head thickness: 9.5 mm		Head material: SA 516 70 N				
Tube wall thickness:		Tube material:				
Tube diameter:		Tube length:				
Channel thickness:		Channel material:				
Design pressure	Shell: Atmos.	Operating pressure	Shell:			
	Tubes:		Tubes:			
Design Temp.	Shell:	Operating temperature	Shell:			
	Tubes:		Tubes:			
X-ray: Nil		Heat treatment: Nil				
Code parameters: Non Code		Coated: No				
Manufacturer: NUSCO		Year built: 1998

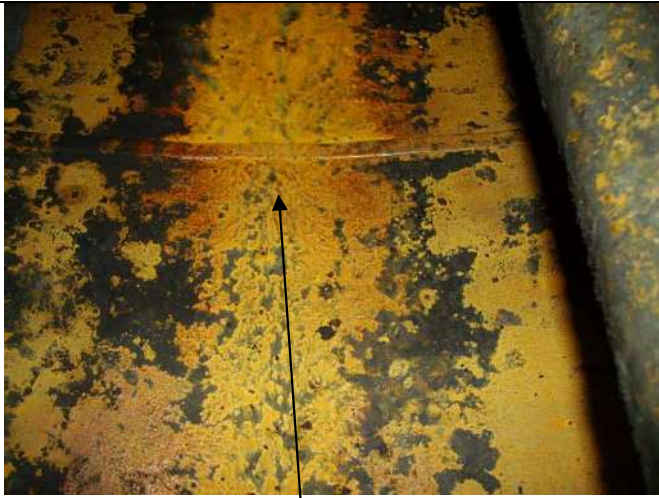
NDE methods: Was UT/ MPI done on vessel (MI coordinator to review results)	X				Ultrasonic thickness inspection carried out to determine remaining thickness of metal – shell metal thickness detected below nominal – visual internal in 2004 revealed general corrosion – subsequent UT inspection shows increased corrosion rate – still sufficient metal for containment.
<p>Recommendations or corrective actions: Vessel is Fit for Service or describe corrective actions required) (MIC to review corrective actions with Operations, discuss with Chief Inspector where necessary, and get remedial action implemented)</p> <p>Recommendations: Carry out internal on next outage.</p> <p>Summary: This vessel is in very good condition, visual external and ultrasonic thickness inspection carried out – shell metal thickness detected below nominal – general corrosion detected over full surface – still sufficient remaining metal thickness for containment.</p> <p>Vessel is fit for service.</p>

Pitting to 0.040" deep
