Canadian Natural Resources Limited
GENERAL PRESSURE VESSEL INFORMATION Job # 105.00774 / 10.110433

District: Ft St John B.C.	
Facility: Halfway Battery	Location (LSD): 05-12-87-25-W6M.

Vessel Name & Equipment Number: High Pressure Flare Knock Out Drum

Status: Operating	Regulatory Inspection
--------------------------	------------------------------

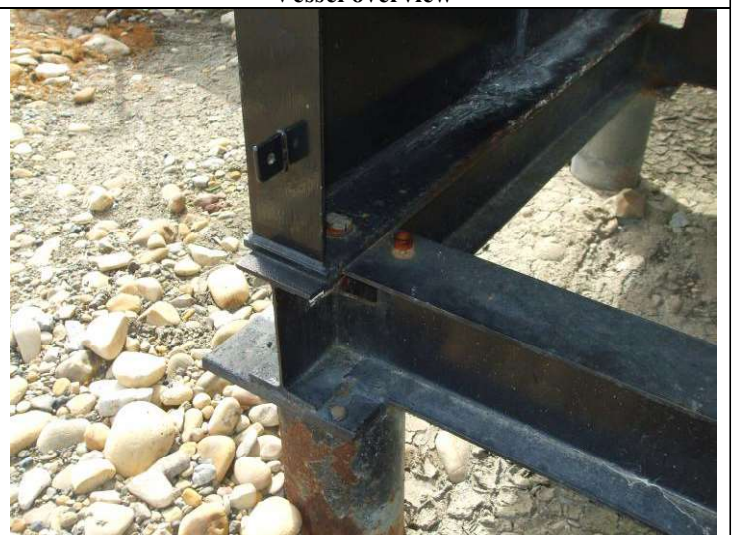
Anchor Bolts Hammer tap to ensure secure. Look for cracking in treads or signs of deformation.	X				Vessel is firmly welded to skid pilings.
Concrete foundation Check for cracks, spalling, etc.				X	None.
Ladder / Platform Describe general condition, ensure support is secure to vessel, and describe any hazards.				X	None.
Nozzle Assess paint, look for leakage, and ensure stud threads are fully engaged. Record any damage, deflection, etc. Are nozzles gusseted?	X				No leakage, stud threads are fully engaged Paint is in good condition – no corrosion. Nozzles are not gusseted
Gauges Ensure gauges are visible, working, no leakage, and suitable for range of MAWP/ Temp.				X	No Pressure gauge: No Temperature gauge:
External Piping Ensure pipe is well supported. All clamps, supports, shoes, etc. in place. Look for evidence of structural overload, deflection, etc. Paint condition, external corrosion?	X				Piping is well supported all clamps, supports and shoes are in place. No structural overloads or deformation. Piping is insulated and in good condition – no exposed metal or surface corrosion found.

Base anchored securely

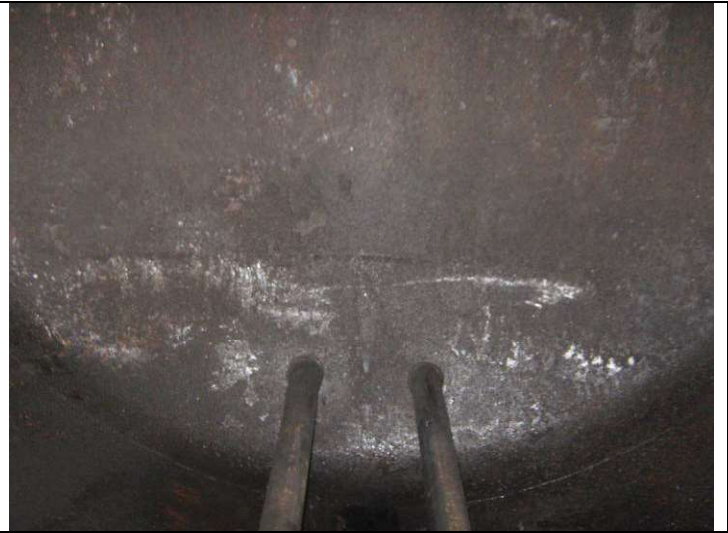
East head overview

Internal Inspection Items	G	F	P	N/A	Comments
Coating Assess coating. Describe area coated, general condition of coating.				X	Vessel is not coated.
Anodes. How many, type, condition. % consumed. Are they being replaced?				X	No anodes.
Internal Piping	X				2 inch carbon steel heat medium piping – not in service. Minor surface corrosion. No mechanical damage.
Trays How many? Type of material. Are valves in place. Check for erosion/ corrosion; wear on tray valve legs. Cleanliness?				X	No trays.
Baffles, deflector plates, etc. If present, describe condition. Look closely at welds attached to vessel wall.	X				Inlet baffle intact and in place. Tight product scale with minor corrosion.
West Head (Manway) Note all corrosion, erosion or mechanical damage. (If vessel is horizontal identify direction of this head)	X				Tight product scale. Minor corrosion. No pitting.
East Head Note all corrosion, erosion or mechanical damage. (If vessel is horizontal identify direction of this head)	X				Tight product scale. Minor corrosion. No pitting.

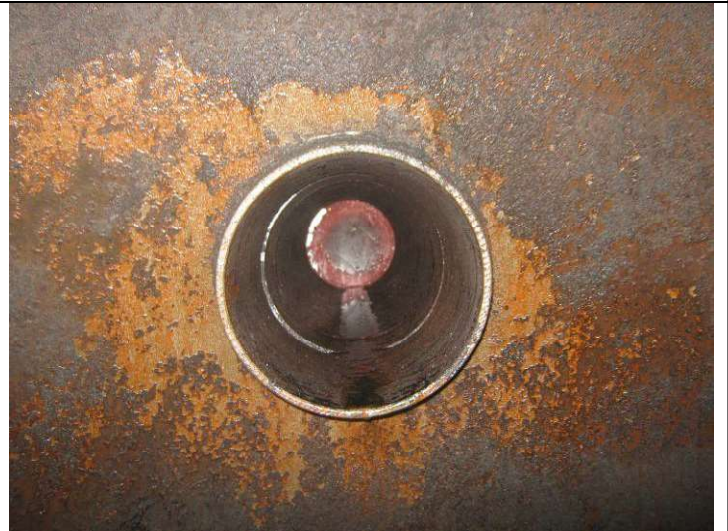
Tight scale at outlet nozzle

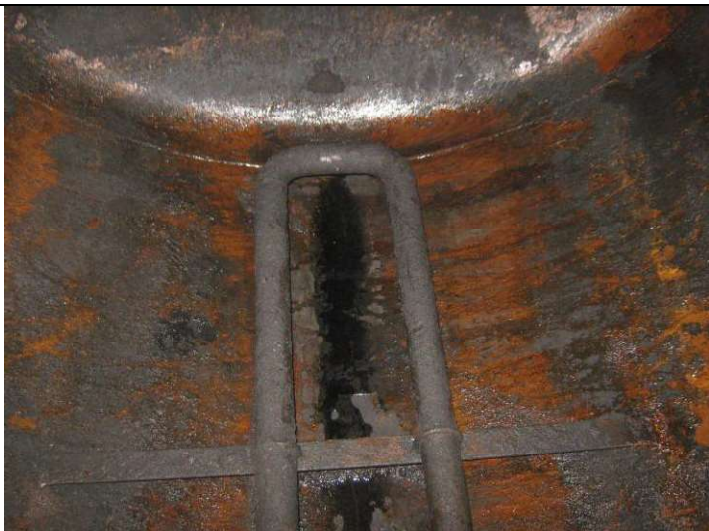
Shell Sections Record number of shell sections. Record location, size and depth of all erosion, corrosion or mechanical damage. Describe General condition.	X				Two shell section in good condition. Heavy product scale to 50% surface area. Minor flash corrosion. No damage.
Demister pad Is it in place? Is it clean? If any corrosion is apparent in vessel, lift pad and check top head for corrosion.				X	None.
Welds Inspect all welds, including attachment welds. Record all service-related damages and if there is any discuss with Chief Inspector before closing.	X				Good condition. No corrosion. No pitting.
Repairs Required. If yes, ensure procedure and copy of AB 40 is on file, and one sent to local ABSA, and Chief Inspector	X				None at this time.
Other	X				
NDE Inspections	X				None at this time.
Recommendations or corrective actions (indicate if fit for service)					
Recommendations: None at this time.

Lower shell and heat medium piping
