**Canadian Natural Resources Limited
GENERAL PRESSURE VESSEL INFORMATION**

Facility: **Saddle Hills Gas Gathering** Location (LSD): **04-23-75-07 w6m**

Vessel Name Equipment Number: **Line Heater**

Status: **In Service** **Regulatory Inspection**

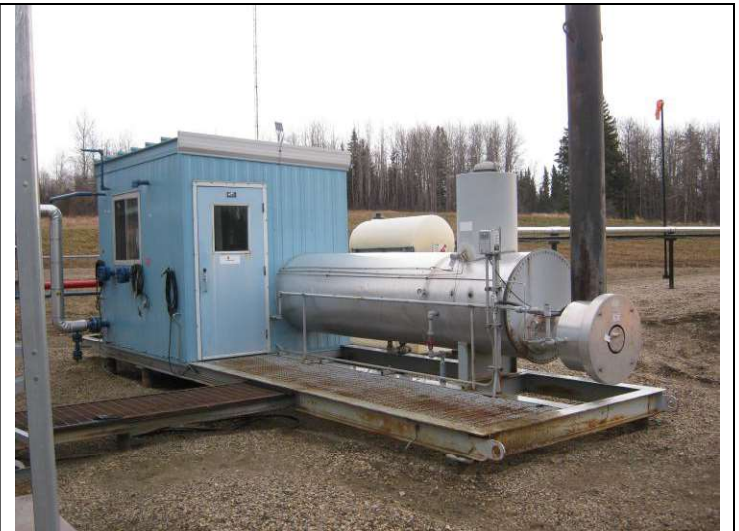
Overview – Skid

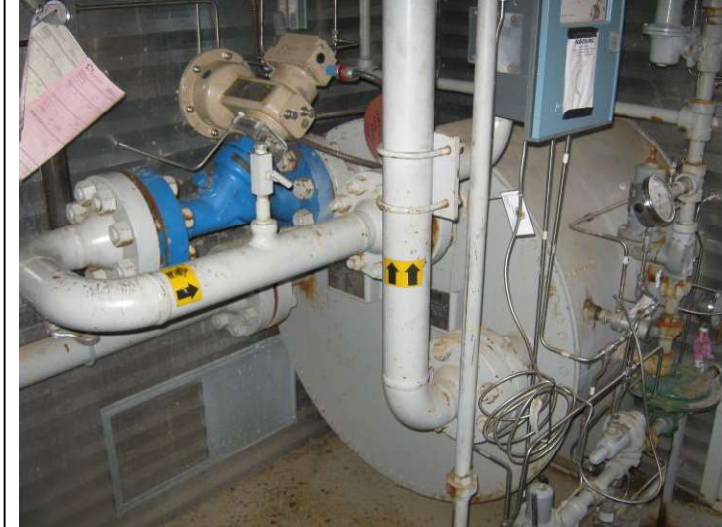
Overview – Vessel

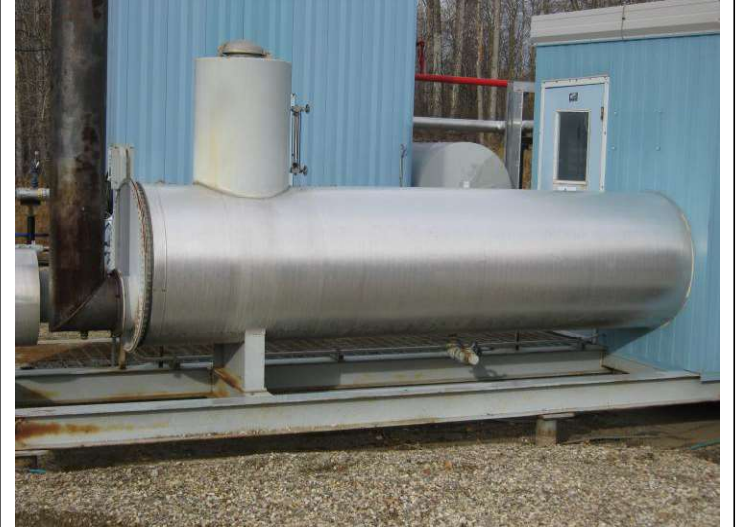
Overview - Vessel

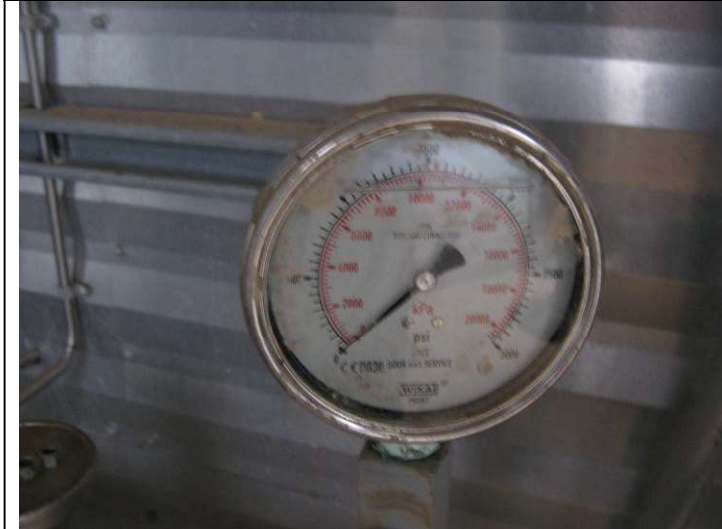
Inlet pressure gauge

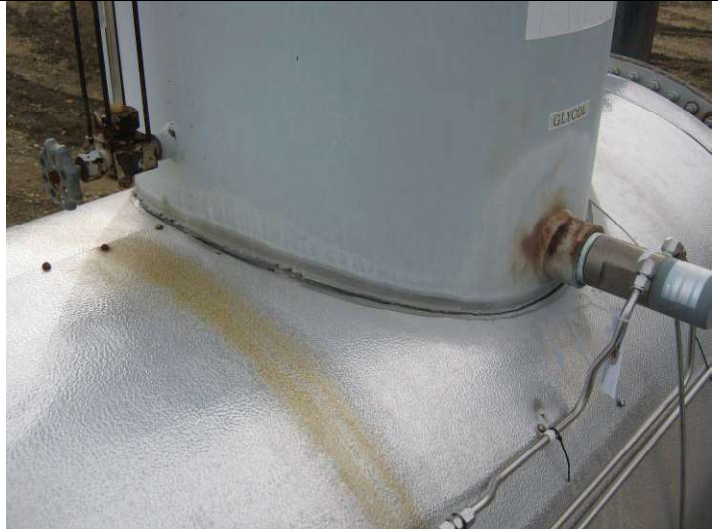
External Inspection Items	G	F	P	N/A	Comments
Insulation Verify sealed around manways, nozzles, no damage present, and there is no egress of moisture.		X			Vessel is 80% insulated. Cladding is securely fastened. No open or loose sections Wall closure sealed – no egress of moisture. Cladding not sealed at expansion tank.
External Condition Assess paint condition, areas peeling, record any corrosion, damage, etc (record location, size and depth of corrosion or damage)	X				Paint chipped to 5% exposed metal – no corrosion. No damage. No corrosion.
Leakage Record any leakage at flanges, threaded joints, weep holes on repads, etc.	X				No leaks observed.
Saddle/Skirt Assess condition of paint, fire protection, concrete. Look for corrosion, buckling, dents, etc. Look at vessel surface area near supports. Verify no signs of leakage at attachment to vessel and attachment welds are acceptable. Ground wire attached?	X				Vessel saddle is bolted to skid. No evidence of corrosion at shell to saddle weld – no leaks. Paint in good condition – no exposed metal. No distortion. No buckles. Skid package is mounted to pilings above ground level. Skid package has ground wire attached.

Closure not sealed around expansion tank

Other					
Recommendations or corrective actions : Vessel is Fit for Service or describe corrective actions required) (MIC to review corrective actions with Operations, discuss with Chief Inspector where necessary, and get remedial action implemented) Recommendations: 1. Reseal cladding at expansion tank. Summary: Vessel is in overall good condition, visual external inspection and ultrasonic corrosion survey performed – pipe metal thickness detected below nominal minus corrosion allowance. Thickness calculations carried out to ensure sufficient metal exists for safe operation. Vessel is fit for service.
