**Canadian Natural Resources Limited
GENERAL PRESSURE VESSEL INFORMATION**

Facility: Saddle Hills Gas Gathering	Location (LSD): 04-23-75-07 w6m
---	--

Vessel Name Equipment Number: **Line Heater**

Status: In Service	Regulatory Inspection
---------------------------	------------------------------

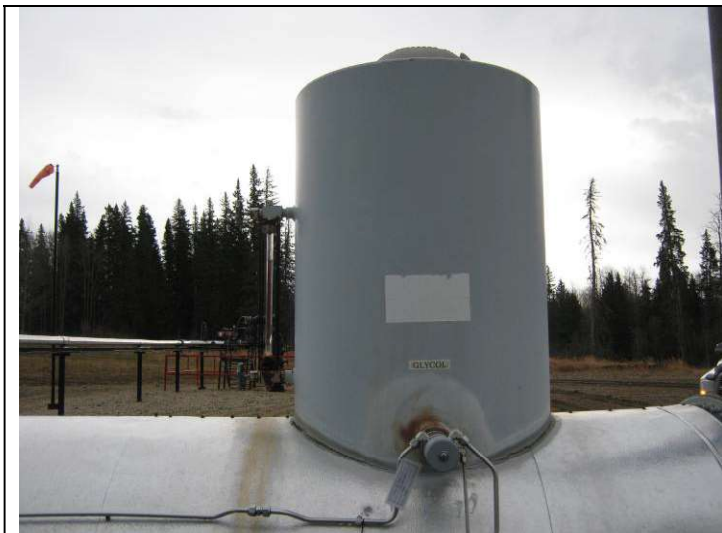
Expansion tank with liquid level

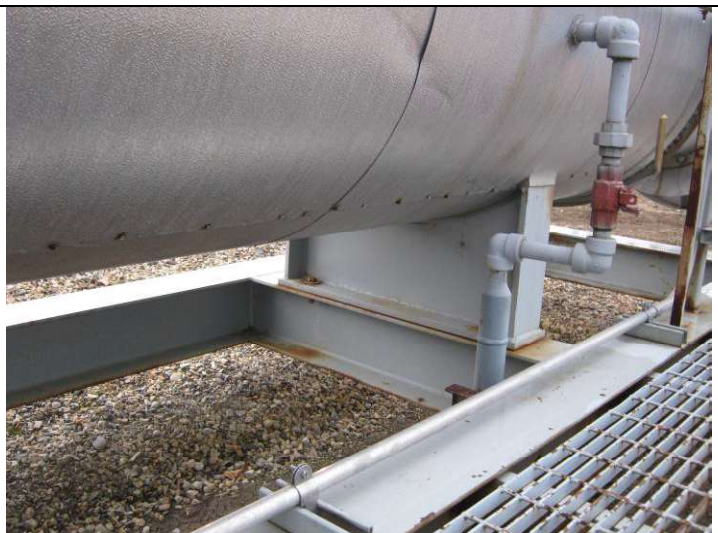
Saddle

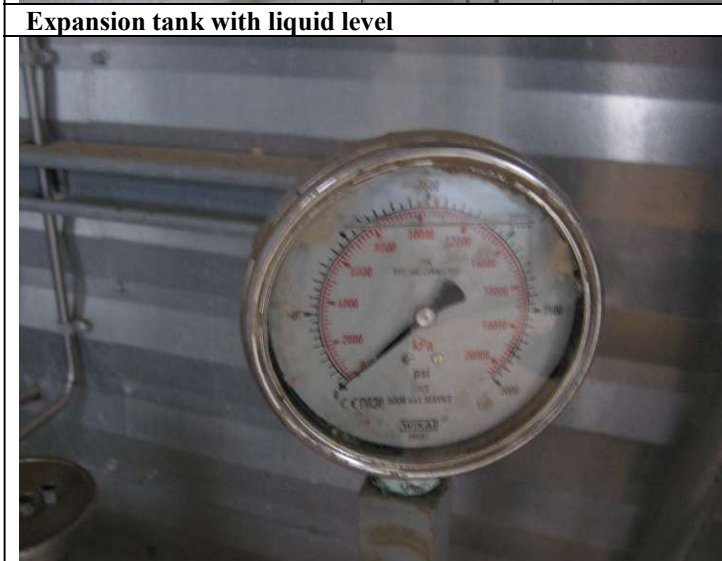
Inlet pressure gauge

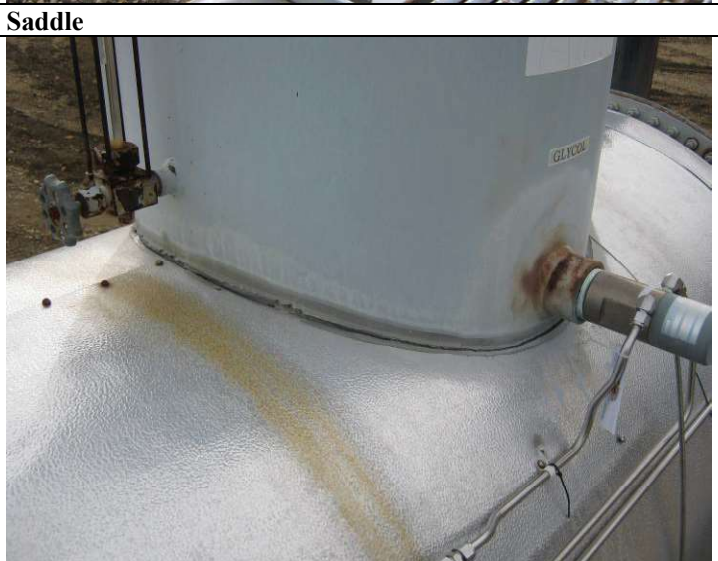
External Inspection Items	G	F	P	N/A	Comments
Insulation Verify sealed around manways, nozzles, no damage present, and there is no egress of moisture.		X			Vessel is 80% insulated. Cladding is securely fastened. No open or loose sections Wall closure sealed – no egress of moisture. Cladding not sealed at expansion tank.
External Condition Assess paint condition, areas peeling, record any corrosion, damage, etc (record location, size and depth of corrosion or damage)	X				Paint chipped to 5% exposed metal – no corrosion. No damage. No corrosion.
Leakage Record any leakage at flanges, threaded joints, weep holes on repads, etc.	X				No leaks observed.
Saddle/Skirt Assess condition of paint, fire protection, concrete. Look for corrosion, buckling, dents, etc. Look at vessel surface area near supports. Verify no signs of leakage at attachment to vessel and attachment welds are acceptable. Ground wire attached?	X				Vessel saddle is bolted to skid. No evidence of corrosion at shell to saddle weld – no leaks. Paint in good condition – no exposed metal. No distortion. No buckles. Skid package is mounted to pilings above ground level. Skid package has ground wire attached.

Closure not sealed around expansion tank

Other					
Recommendations or corrective actions : Vessel is Fit for Service or describe corrective actions required) (MIC to review corrective actions with Operations, discuss with Chief Inspector where necessary, and get remedial action implemented) Recommendations: 1. Reseal cladding at expansion tank. Summary: Vessel is in overall good condition, visual external inspection and ultrasonic corrosion survey performed – pipe metal thickness detected below nominal minus corrosion allowance. Thickness calculations carried out to ensure sufficient metal exists for safe operation. Vessel is fit for service.
