Canadian Natural Resources Limited
GENERAL PRESSURE VESSEL INFORMATION **Job # 05.003071**

District: Grande Prairie AB	Skid No.
Facility: Gold Creek East Gas Field	Location (LSD): 06-33-67-04W6M
Vessel Name Equipment Number: Flare Knockout Drum	
Orientation: Horizontal	
Status: In Service	Regulatory Inspection

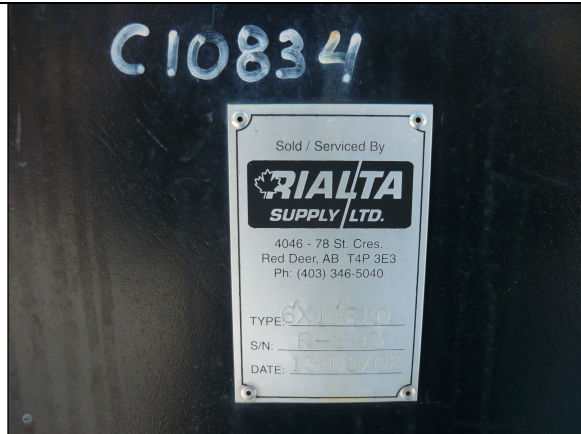
vessel data plate

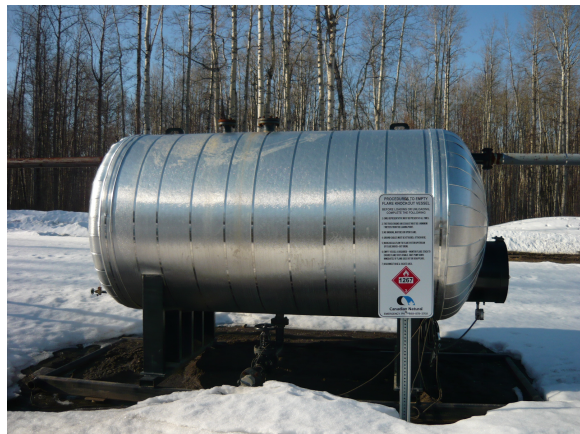
vessel overview

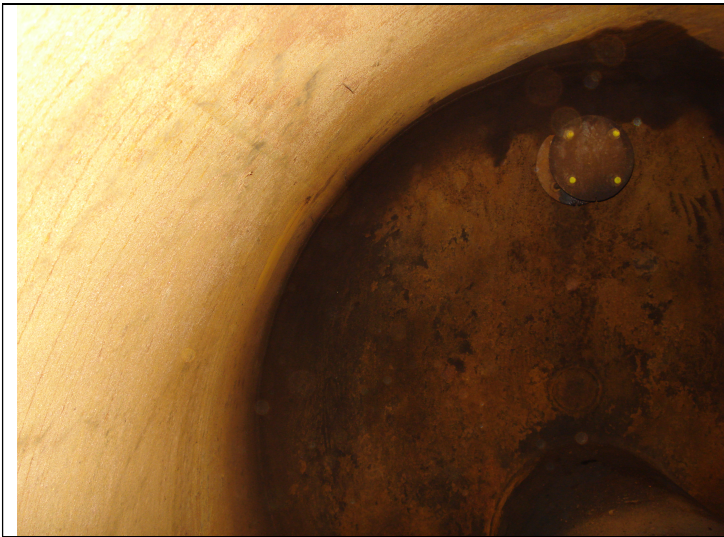
View of the shell

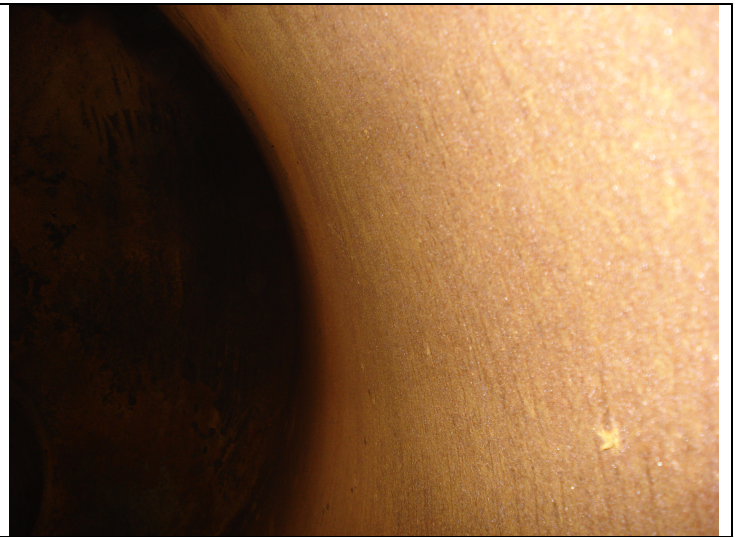
View of the shell

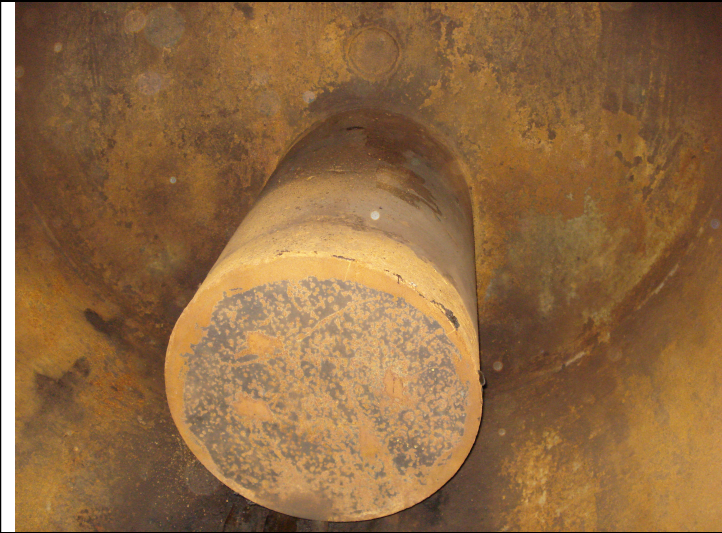
View of attachment.

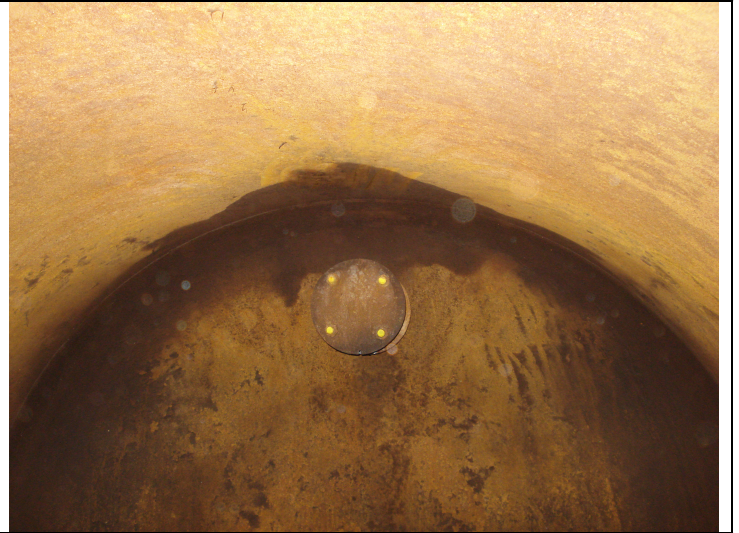
View of attachment.

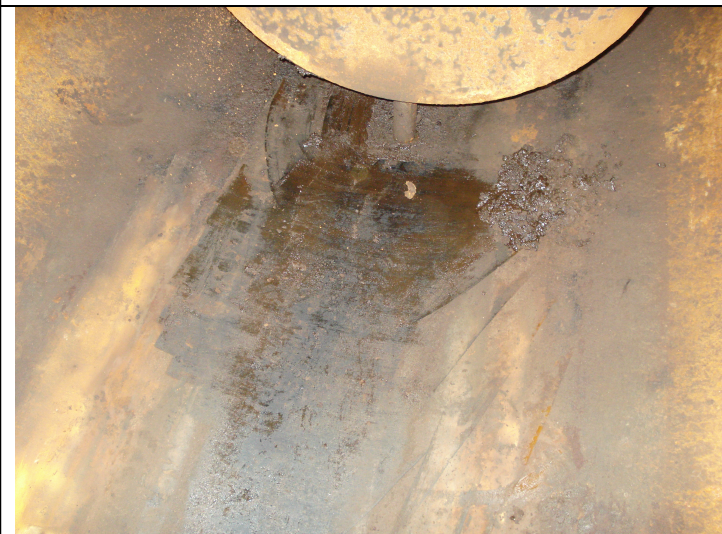
View of the deposits left behind post cleaning

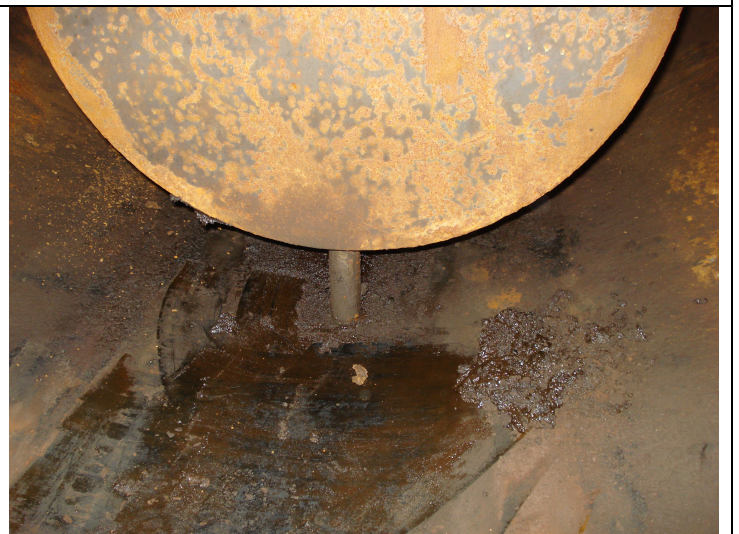
View of the deposits left behind post cleaning
