**Canadian Natural Resources Limited
GENERAL PRESSURE VESSEL INFORMATION**

Job # 105.00774

District: Ft St John B.C.						
Facility: Halfway Battery		Location (LSD): 05-12-87-25-W6M.				
Vessel Name & Equipment Number: Low Pressure Flare Knock Out Drum						
Orientation: Horizontal						
Status: Operating		Regulatory Inspection				
PRESSURE VESSEL NAMEPLATE DATA						
"A" or "G" or "S" (Sask.) or BC Registration Number. C36020		CRN Number Non Code				
Vessel serial number: 3856-A		Size : 60 in. x 20 ft.				
Shell thickness: 9.5 mm		Shell material: SA 36				
Head thickness: 9.5 mm		Head material: SA 36				
Tube wall thickness:		Tube material:				
Tube diameter:		Tube length:				
Channel thickness:		Channel material:				
Design pressure	Shell: Atmos.	Operating pressure	Shell:			
	Tubes:		Tubes:			
Design Temp.	Shell:	Operating temperature	Shell:			
	Tubes:		Tubes:			
X-ray: Nil		Heat treatment: Nil				
Code parameters: Non Code		Coated: No				
Manufacturer: Argo sales		Year built: 2006				
Corrosion allowance: 1.6 mm		Manway: Yes

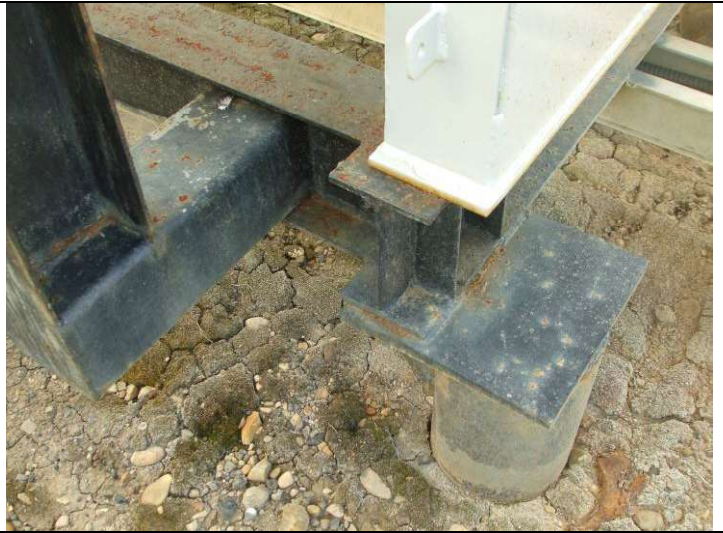
Base anchored securely
