Canadian Natural Resources Limited
GENERAL PRESSURE VESSEL INFORMATION **Job # 105.00774 / 10.110433**

District: Ft St John B.C.						
Facility: Halfway Battery		Location (LSD): 05-12-87-25-W6M				
Vessel Name & Equipment Number: Low Pressure Flare Knock Out Drum						
Orientation: Horizontal						
Status: Operating		Regulatory Inspection				
PRESSURE VESSEL NAMEPLATE DATA						
"A" or "G" or "S" (Sask.) or BC Registration Number. C36020		CRN Number Non Code				
Vessel serial number: 3856-A		Size : 60 in. x 20 ft.				
Shell thickness: 9.5 mm		Shell material: SA 36				
Head thickness: 9.5 mm		Head material: SA 36				
Tube wall thickness:		Tube material:				
Tube diameter:		Tube length:				
Channel thickness:		Channel material:				
Design pressure	Shell: Atmos.	Operating pressure	Shell:			
	Tubes:		Tubes:			
Design Temp.	Shell:	Operating temperature	Shell:			
	Tubes:		Tubes:			
X-ray: Nil		Heat treatment: Nil				
Code parameters: Non Code		Coated: No				
Manufacturer: Argo sales		Year built: 2006				
Corrosion allowance: 1.6 mm		Manway: Yes

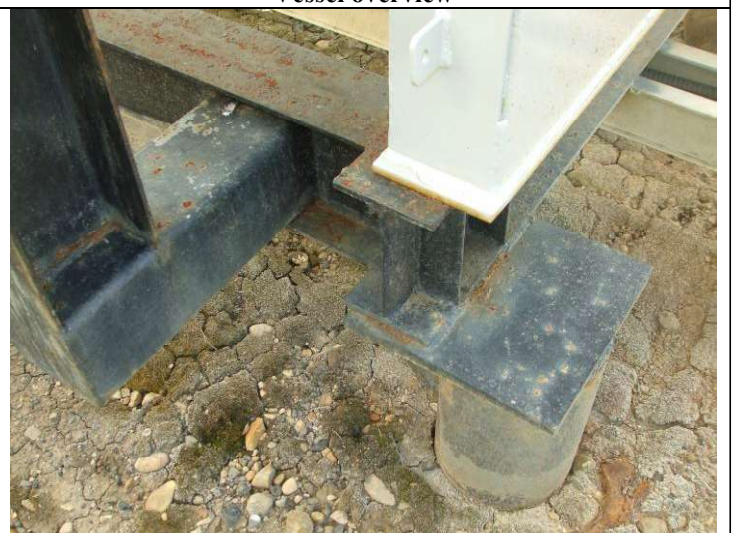
Base anchored securely
