Canadian Natural Resources Limited GENERAL PRESSURE VESSEL INFORMATION Job: 10.113674										
District: Grande	Prairie AB.		Skid No.							
Facility: North	Sturgeon	Location (LSD): 10-29-71-23-W6M								
	ipment Number: Free Wat	er Knockout								
Orientation: Hor	•									
	t of Service			R	egulatory Insp	ection				
		PRESSURE VES	SEL NA							
"A" or "G	" or "S" (Sask.) or BC Regis	CRN Number:								
	A0102369	A8372.2								
Vessel serial num				Siz	Size: 10ft. X 30 ft.					
Shell thickness:					ell material: SA		2

Summary: This vessel is in good condition, visual external and ultrasonic thickness inspection carried out – no metal thickness detected below nominal minus corrosion allowance. Vessel is fit for service.

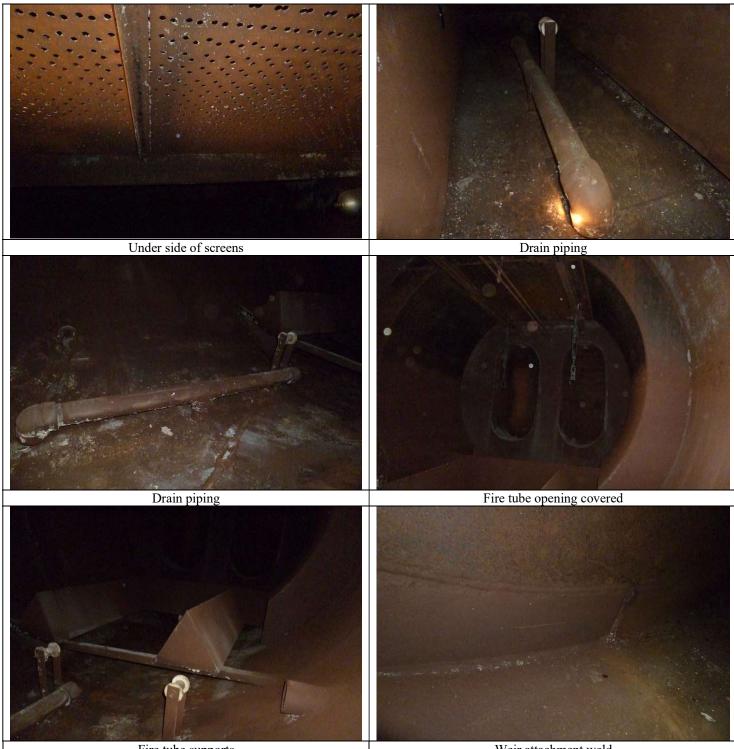
Fire tube supports

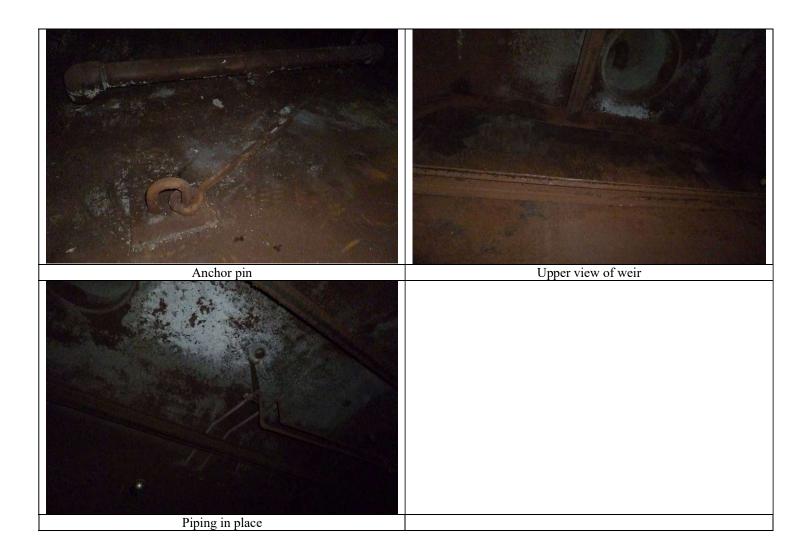
Weir attachment weld
