**Canadian Natural Resources Limited  
GENERAL PRESSURE VESSEL INFORMATION**

District: <b>Grande Prairie.</b>	Skid No.
Facility: <b>Knopcik North Gas Gathering.</b>	Location (LSD): <b>07-11-75-11-W6M.</b>
Vessel Name Equipment Number: <b>3 Phase Separator.</b>	
Orientation: <b>Vertical</b>	
Status: <b>In service.</b>	<b>Regulatory Inspection</b>

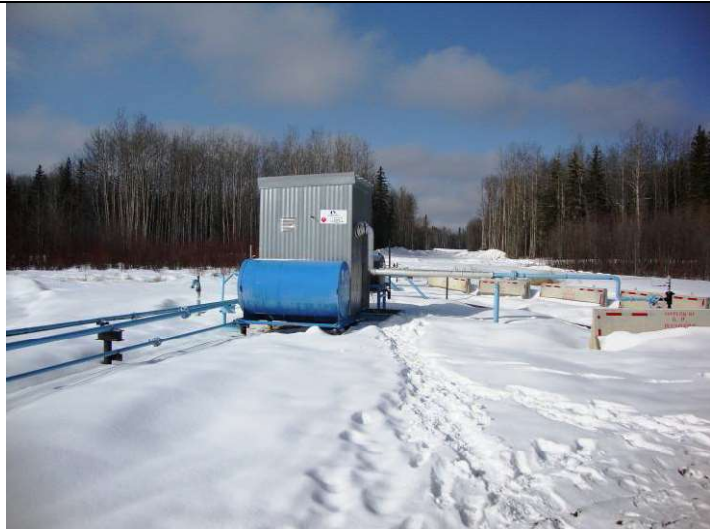
Site overview.

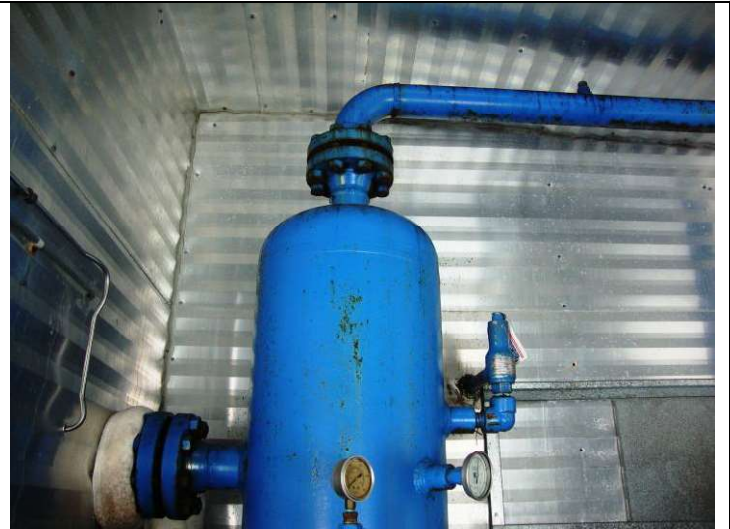
Upper shell.

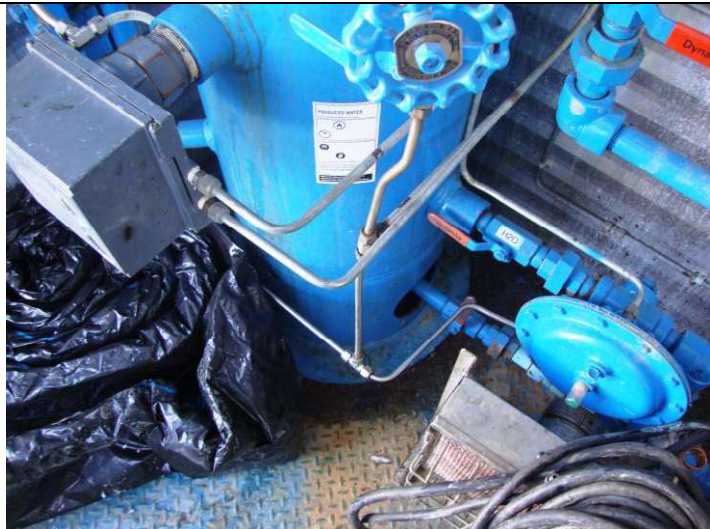
Lower shell/skirt.

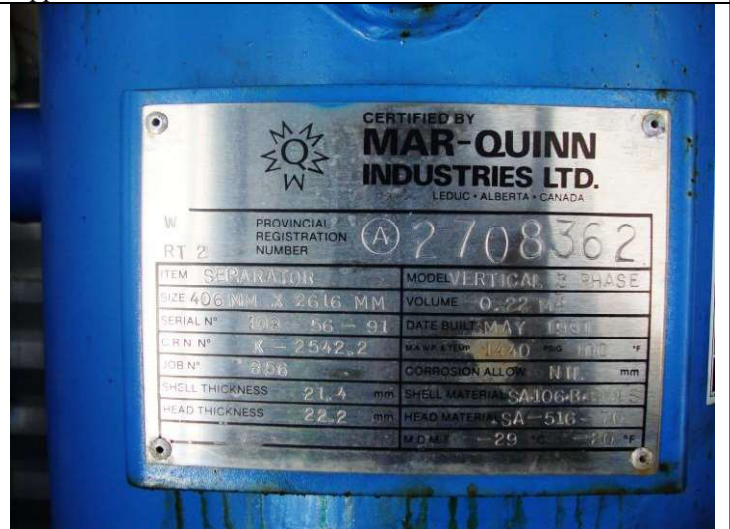
Vessel data plate.

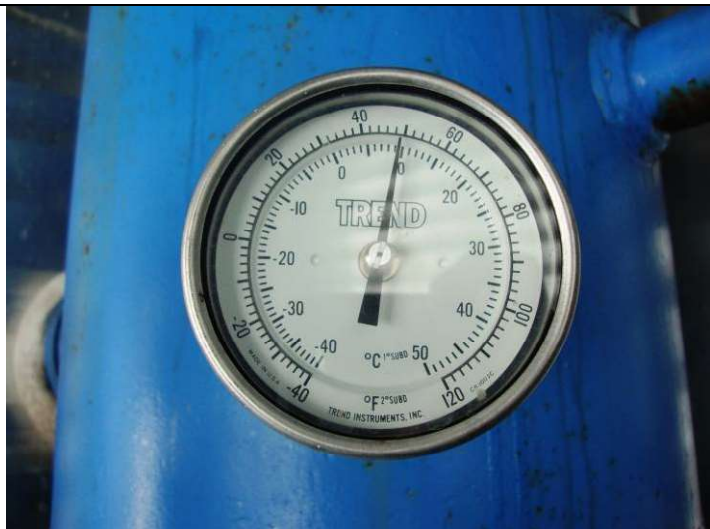
Temp gauge.

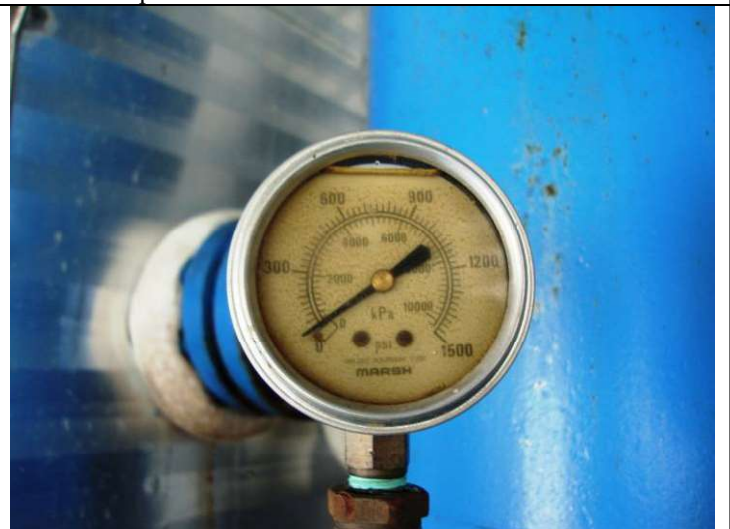
Pressure gauge.
