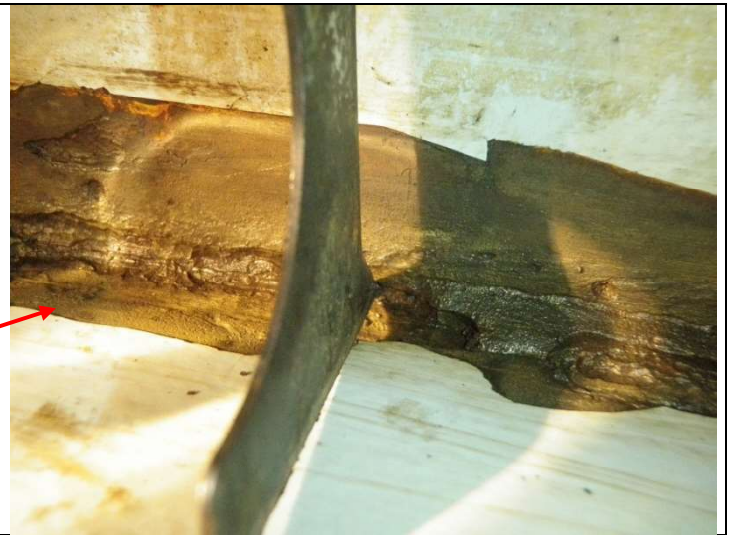
Corrosion/pitting at shell to floor weld

Approximately 0.200 inches loss
