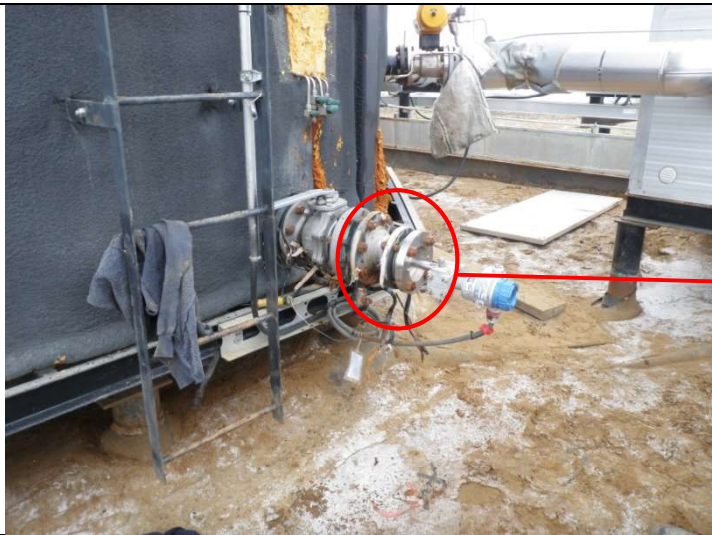
Transmitter valving – signs of leaking

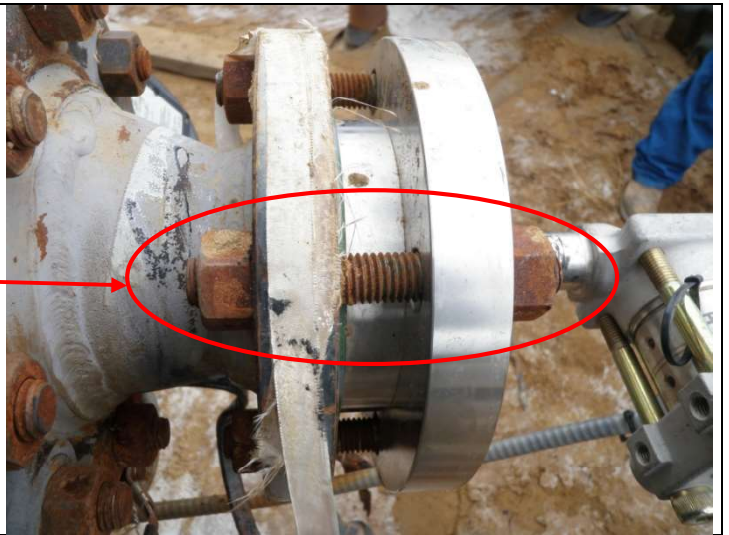
Stainless to carbon flanges – no CP isolation kit installed

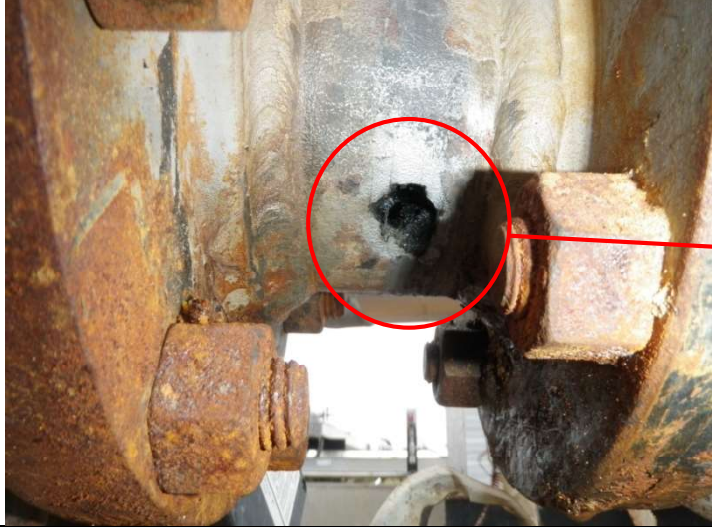
1 inch hole through corrosion
