**Canadian Natural Resources Limited  
GENERAL PRESSURE VESSEL INFORMATION**

<b>District: GP South</b>		<b>Skid No.</b>				
<b>Facility: Hamburg Water Injection</b>		<b>Location (LSD): 13-20-96-09 W6M</b>				
<b>Vessel Name &amp; Equipment Number: 1000 bbl Produced Water Tank</b>						
<b>Orientation: Vertical</b>						
<b>Status: In Service</b>		<b>Regulatory Inspection</b>				
<b>PRESSURE VESSEL NAMEPLATE DATA</b>						
"A" or "G" or "S" (Sask.) or BC Registration Number. <b>C51989</b>		CRN Number  Not Required				
Tank serial number: 16805		Size: 17 ft. 3 in. X 24 ft.				
Shell thickness: 4.8mm		Shell material: SA 36				
Bottom thickness: 6.4mm		Bottom material: SA 36				
Deck thickness: 4.8mm		Deck material: SA 36				
Tube diameter:		Tube length:				
Channel thickness:		Channel material:				
Design pressure	Shell: 4 oz	Operating pressure	Shell:			
	Tubes:		Tubes:			
Design Temp.	Shell:	Operating temperature	Shell:			
	Tubes:		Tubes:			
X-ray: Nil		Heat treatment: Nil				
Code parameters: API 12 F		Coated: Yes

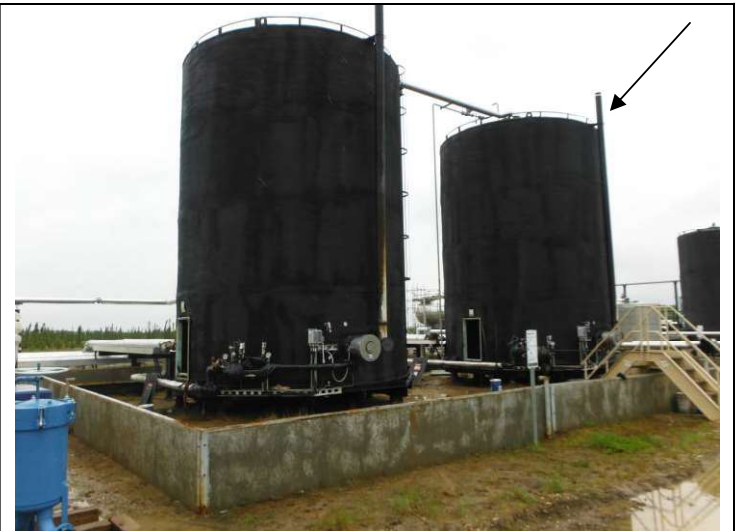
Overview - Tank farm

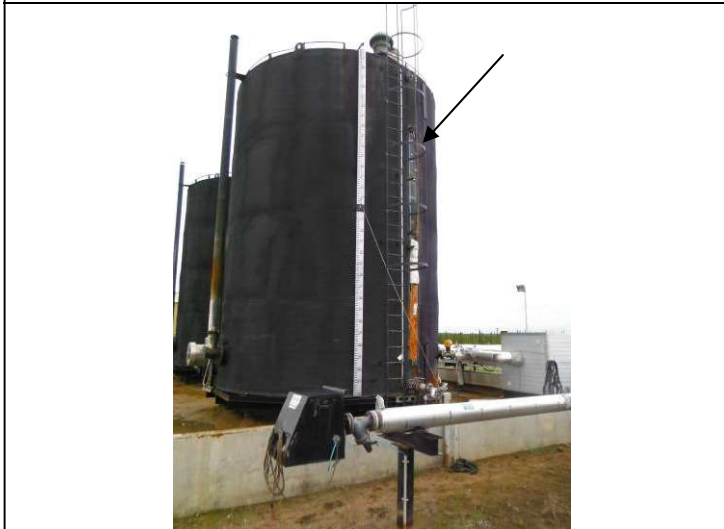
Overview - Tank with large areas of insulation removed

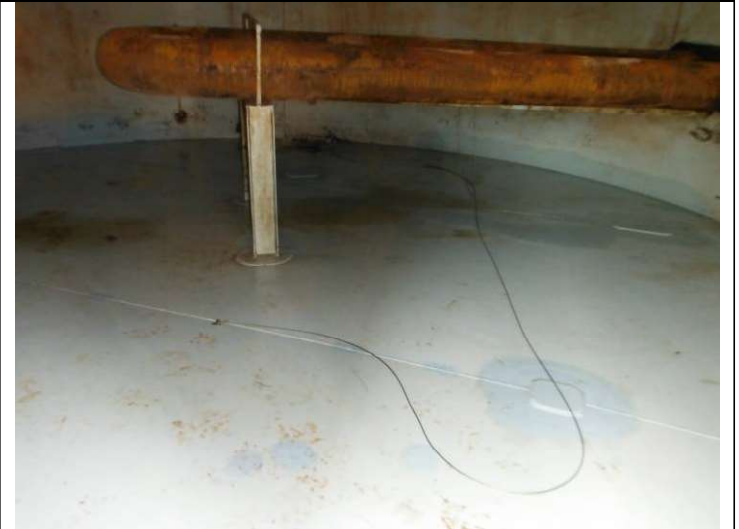
Overview - floor with loose float cable detached.

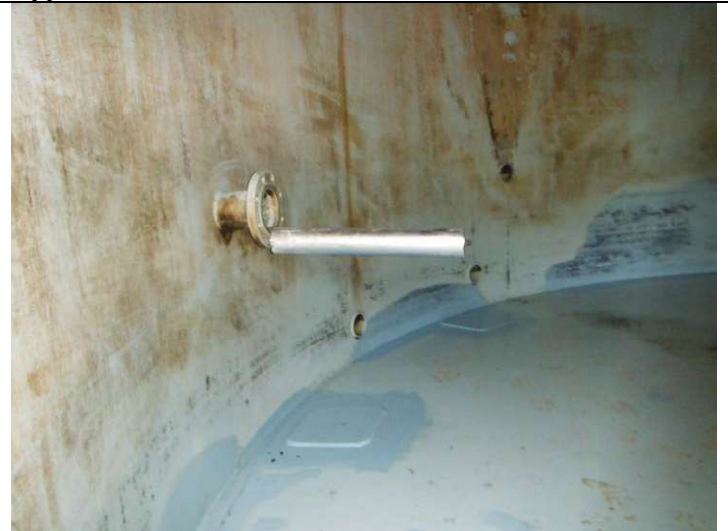
**Anode installed**

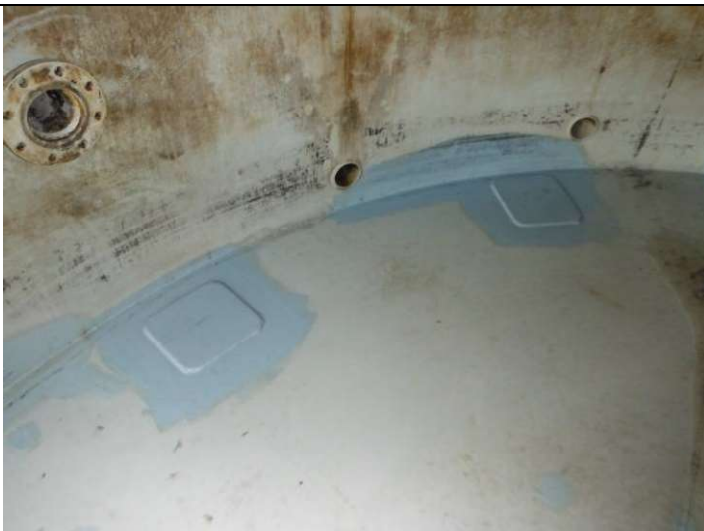
Internal Inspection Items	G	F	P	N/A	Comments
<b>Coating</b> Assess coating. Describe area coated, general condition of coating.	X				<b>Internal surface - 100% coated with epoxy – Several previous coating repairs on floor and lower shell. All are in good condition – no areas of failed coating.</b>
<b>Anodes.</b> How many, type, condition. % consumed. Are they being replaced?				X	<b>None. To be installed during June TAR.</b>
<b>Internal Piping</b> Is there any? If so, carbon or stainless steel. Describe condition, dents, corrosion, erosion, etc. Ensure supports are secure and any bolts are suitable for future use.				X	<b>None</b>
<b>Bottom</b> Record location, size and depth of all erosion, corrosion or mechanical damage. Describe General condition.	X				<b>Good condition. Bottom is 100% coated – Several patch plates previously installed and in good condition. No areas of failed coating.</b>

**Previously installed patch plates**

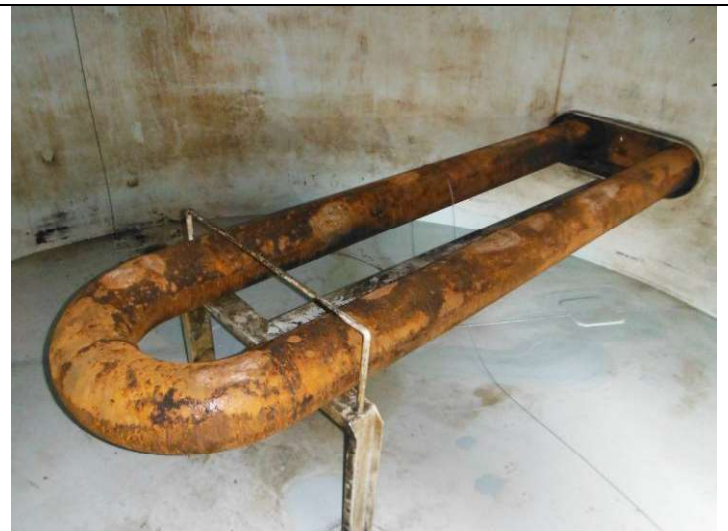
<b>Fire Tube / Heat Medium Coil:</b>	X				<b>Fire tube is externally corroded range 0.050 to 0.150 inch depth. Several previous fill weld repairs.</b>
<b>NDE Inspections</b>				X	<b>No NDE inspections at this time.</b>
<b>Recommendations or corrective actions (indicate if fit for service)</b> <b>Recommendations: 1. Install float and reattach cable. 2. Repair open sections of open insulation. 3. Install separate ground wire.</b> <b>Summary: This tank is in good overall condition, visual internal and external inspection carried out.</b> <b>Tank is fit for service.</b>

**Overview – fire tube**
