**Canadian Natural Resources Limited
GENERAL PRESSURE VESSEL INFORMATION**

Job # 10.112250

District: BC and North	Skid No.
Facility: Chinchaga Battery	Location (LSD): 13-20-96-09 W6M

Tank Name / Equipment Number: **1000 bbl Produced Water Tank**

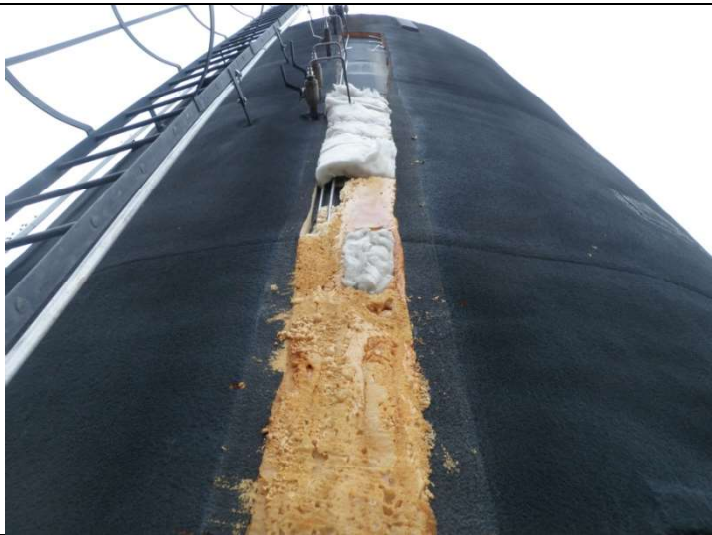
External Inspection Items	G	F	P	N/A	Comments
Insulation Verify sealed around man way, nozzles, no damage present, and there is no egress of moisture.			X		Foam insulated – Two large open sections on shell. No signs of water ingress.
External Condition Assess paint condition, areas peeling, record any corrosion, damage, etc (record location, size and depth of corrosion or damage)		X			Mechanical damage to lower shell (evident internally).
Leakage Record any leakage at flanges, threaded joints, weep holes on repads, etc.	X				No leaks observed.
Base Assess condition of paint, fire protection, concrete. Look for corrosion, buckling, dents, etc. Is tank mounted above ground water level – on pilings? Ground wire attached?	X				Set above ground on pilings -tank is welded to skid frame and frame is welded to piling plates. No buckling or dents. No sign of leakage at attachment welds to tank. Grounded trough pilings.

Foam insulation - Open sections

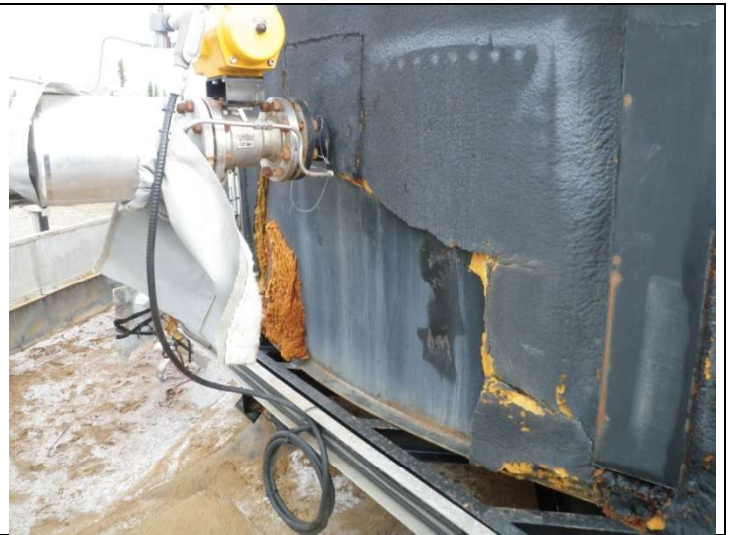
Foam insulation - Open sections

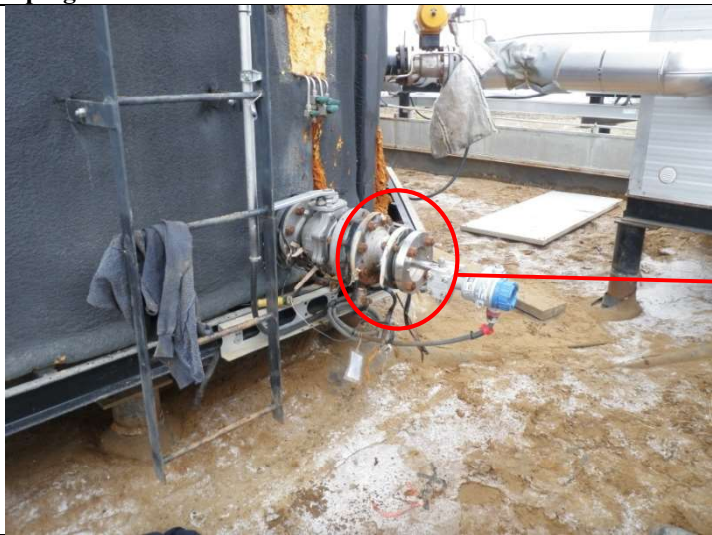
Transmitter valving - signs of leaking

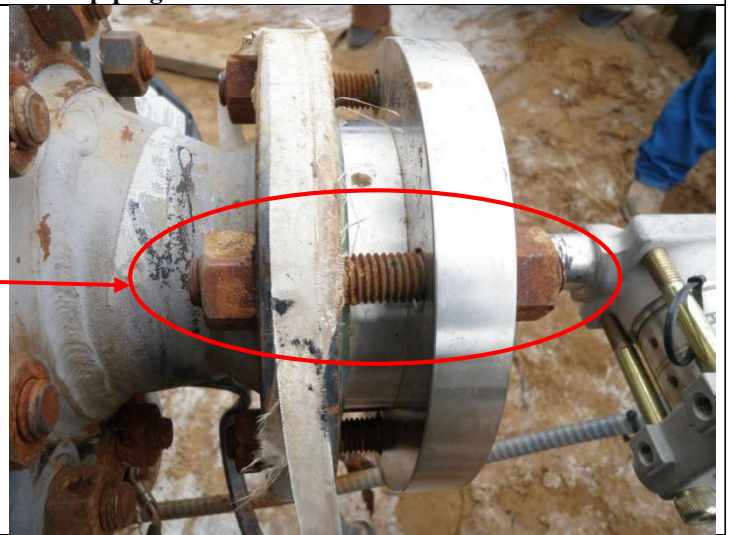
Stainless to carbon flanges - no CP isolation kit installed

<p>Recommendations or corrective actions : Vessel is Fit for Service or describe corrective actions required) (MIC to review corrective actions with Operations, discuss with Chief Inspector where necessary, and get remedial action implemented) Recommendations: 1.Replace corroded nozzle and install CP isolation kit. 2. Repair open sections of open insulation. 3. Install ground wire. Summary: Vessel is in overall good condition. Visual external inspection carried out.</p>

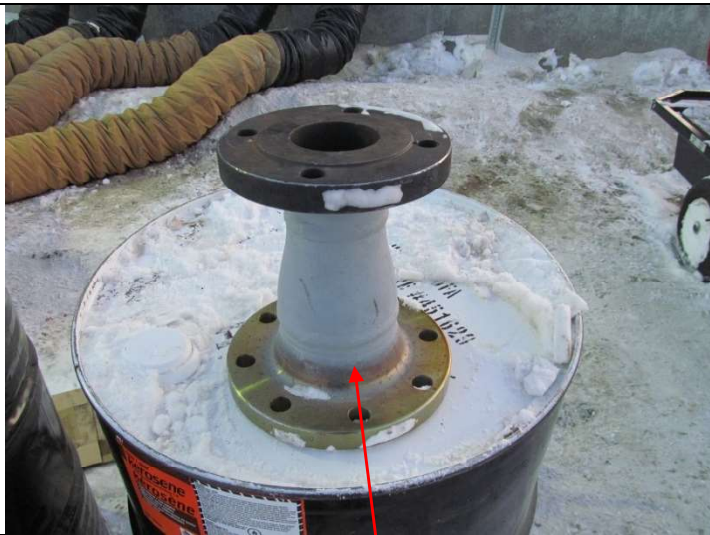
New carbon steel piping spool – coated with Devco 142 C grout to replace leaking spool identified below.

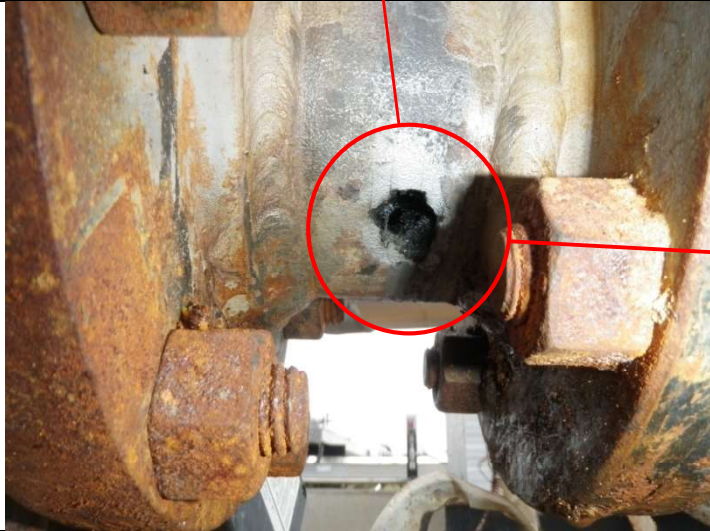
1 inch hole through corrosion

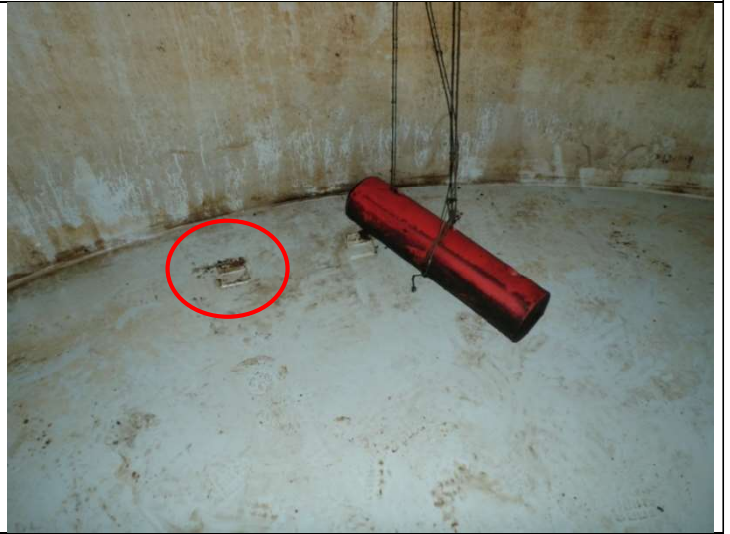
Float guide wire broken

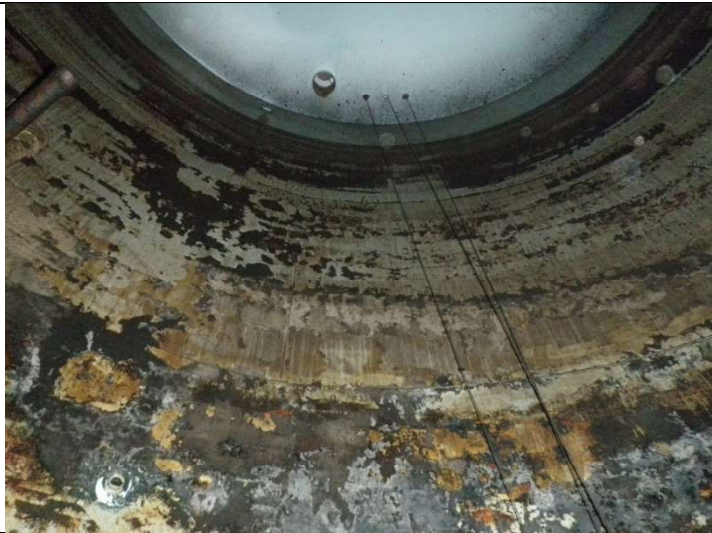
Shell – tightly adhered product scale

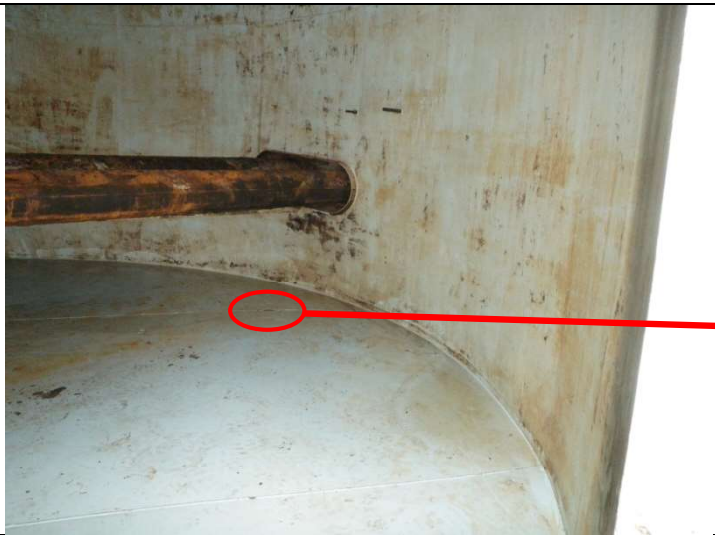
Internal Inspection Items	G	F	P	N/A	Comments
Coating Assess coating. Describe area coated, general condition of coating.			X		Coating failures resulting in hole through pitting/corrosion to floor. Coating is cracked in several locations along floor to shell weld location.
Anodes. How many, type, condition. % consumed. Are they being replaced?				X	A anode should be installed inside this tank during the re work in March / April 2012.
Internal Piping Is there any? If so, carbon or stainless steel. Describe condition, dents, corrosion, erosion, etc. Ensure supports are secure and any bolts are suitable for future use.	X				Oil skimmer piping is firmly attached. No signs of leaking. No deflection noted.
Baffles, deflector plates, etc. If present, describe condition. Look closely at welds attached to vessel wall.				X	No baffles or deflectors.
Bottom Note all corrosion, erosion or mechanical damage. (If vessel is horizontal identify direction of this head) Exchanger may have 2 pancake covers instead.			X		3 coating failures resulting in hole through pitting/corrosion to floor. Pitting/corrosion exists at floor to shell weld.

Through hole at weld

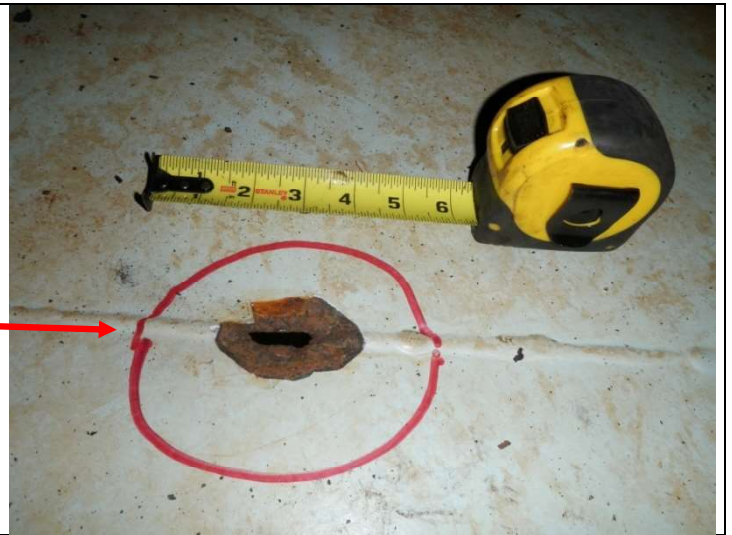
Through hole at weld 2.0 inches

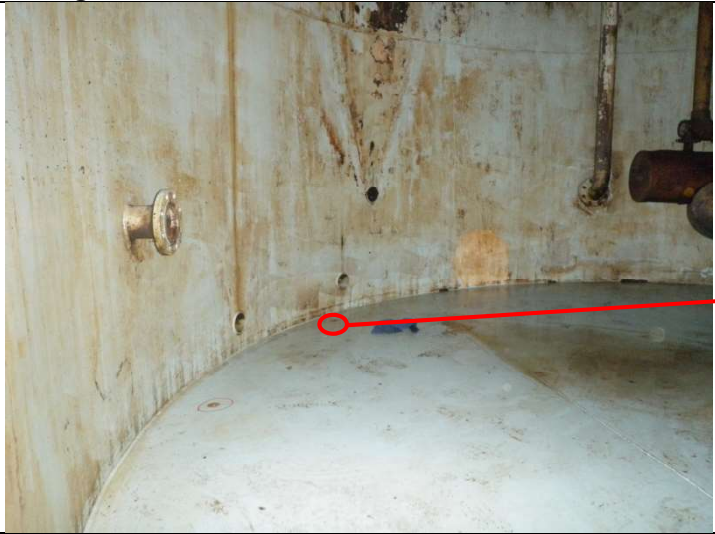
Through hole on bottom

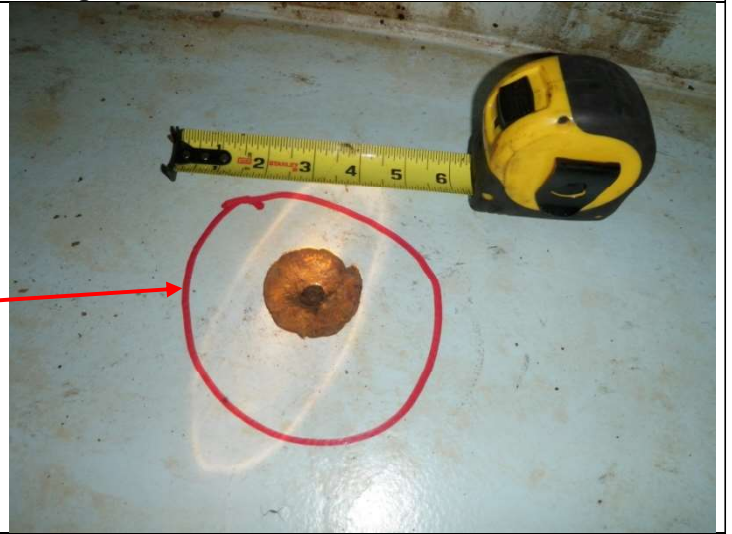
Through hole 2.5 inches dia.

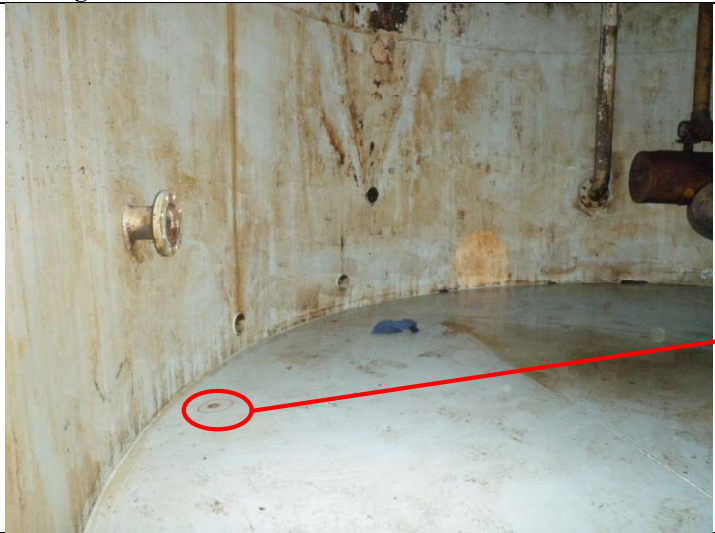
Through hole on bottom of tank.

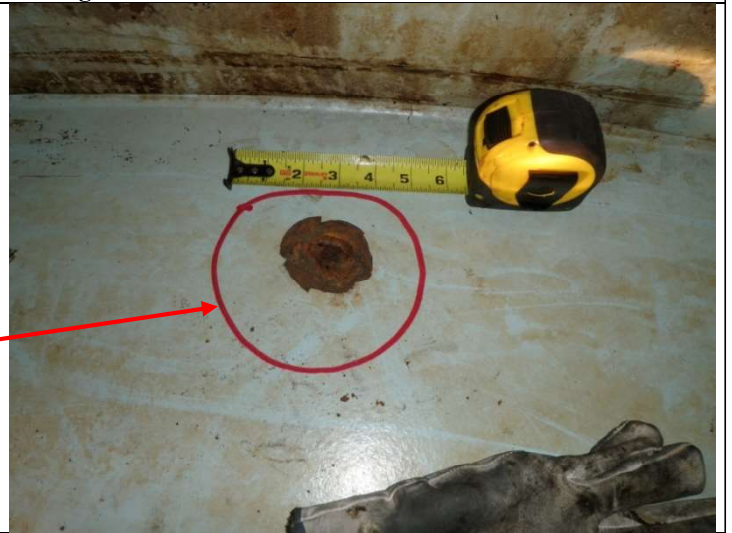
Through hole - 3.0 inches dia.

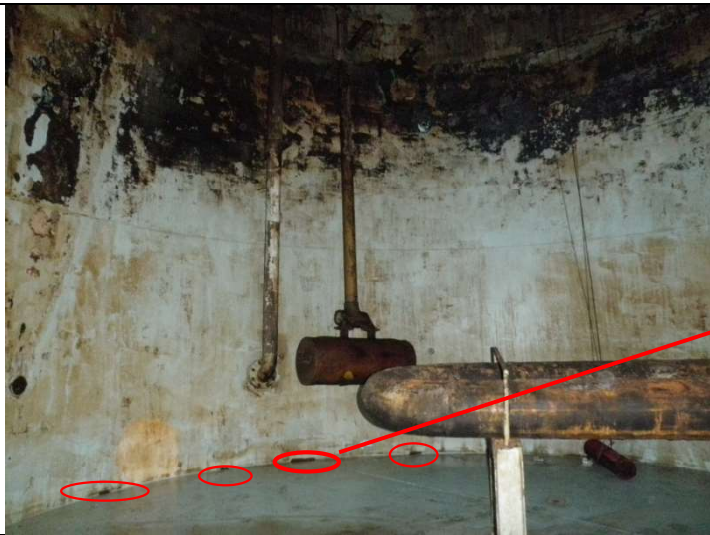
Welds Inspect all welds, including attachment welds. Record all service-related damages and if there is any discuss with Chief Inspector before closing.			X		Pitting/corrosion exists at floor to shell weld. Coating is cracked in several locations along floor to shell weld location.
Repairs Required. If yes, ensure procedure and copy of AB 40 is on file, and one sent to local ABSA, and Chief Inspector	X				<ol style="list-style-type: none"> 1. Blast coating and complete thorough visual inspection. 2. Install patch plates at identified hole through locations. 3. Remove and clean fire tube to complete thorough visual inspection. Perform Magnetic Particle (MPI) inspection to check for cracking at corroded/pitted locations and welds. Perform weld fill repair where required. 4. Perform MPI at deflected areas to confirm no cracking exists.
NDE Was any NDE done. (MI coordinator to review results) Include tubular inspections in document and results.	X				Ultrasonic thickness surveys were carried out at hole through locations to establish repair patch locations and dimensions.

Corrosion/pitting at shell to floor weld

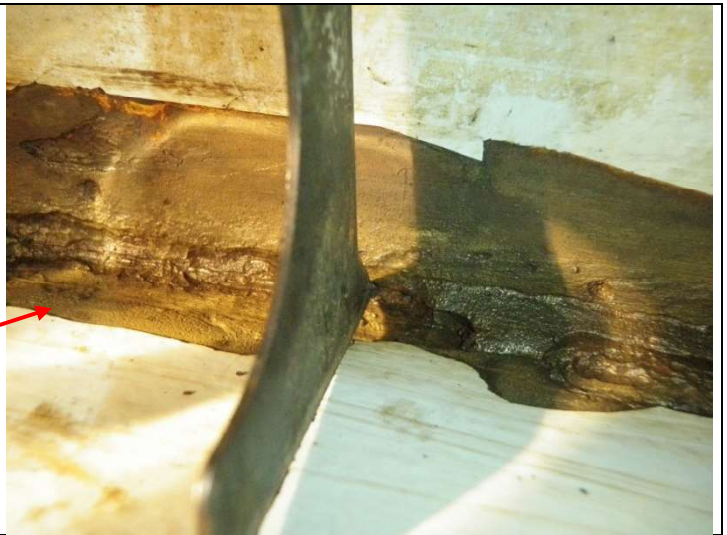
Bottom to shell weld - Approximately 0.200 inches loss

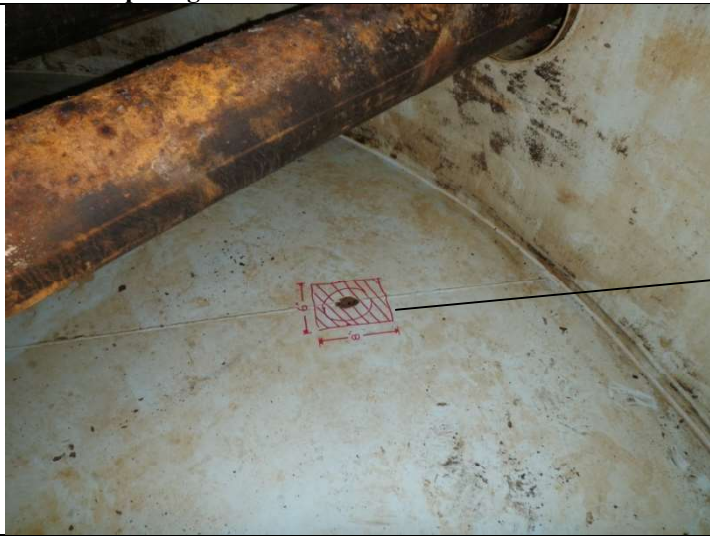
Repair patch required on bottom

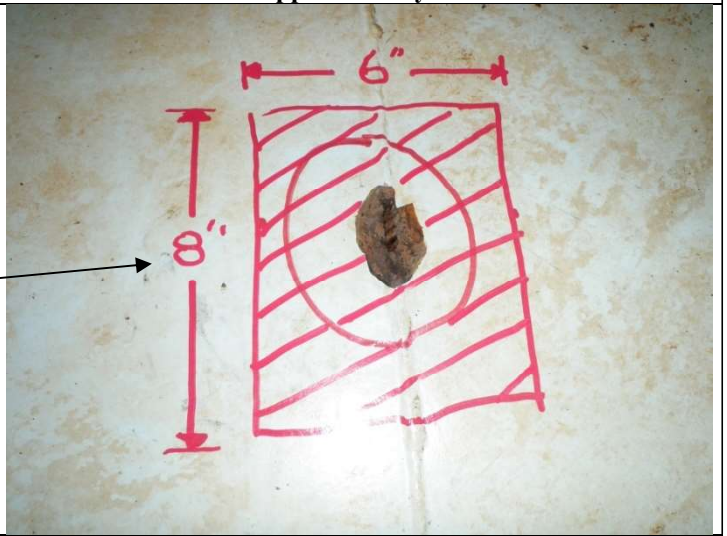
Pitting on bottom 8.0 x 6.0 inches

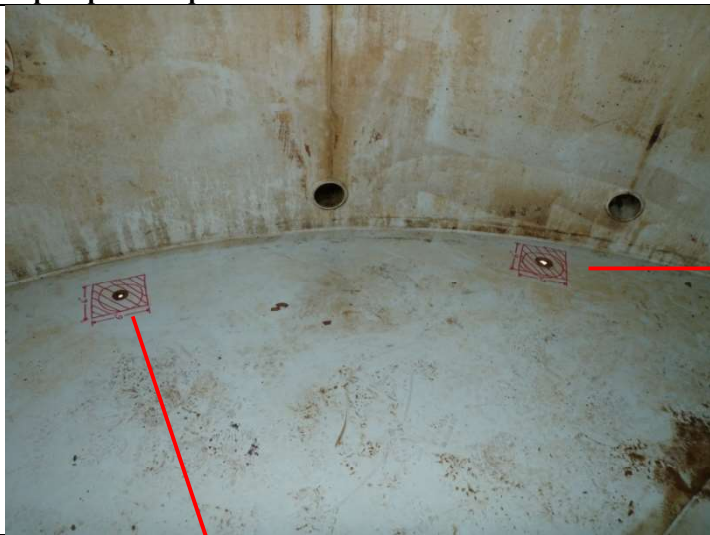
Repair patches required on bottom

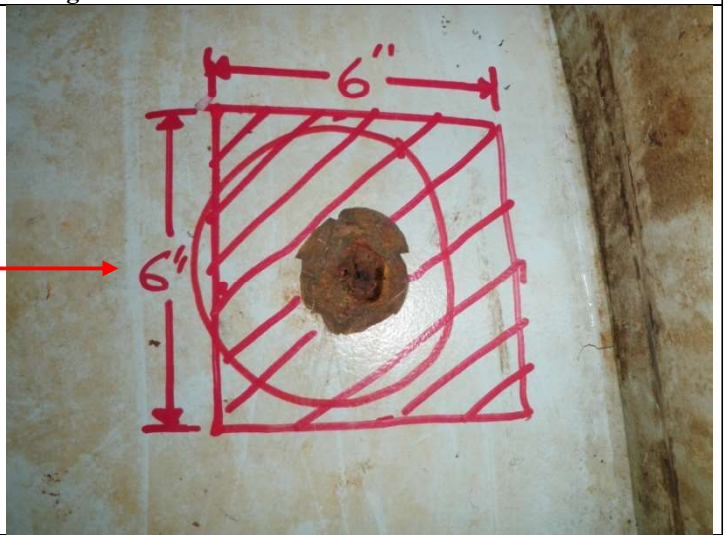
Pitting on bottom 6.0 x 6.0 inches

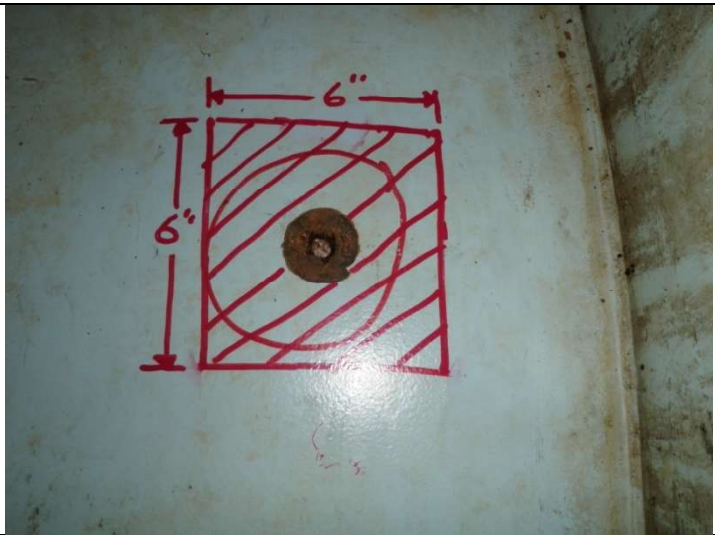
Pitting on bottom 6.0 x 6.0 inches

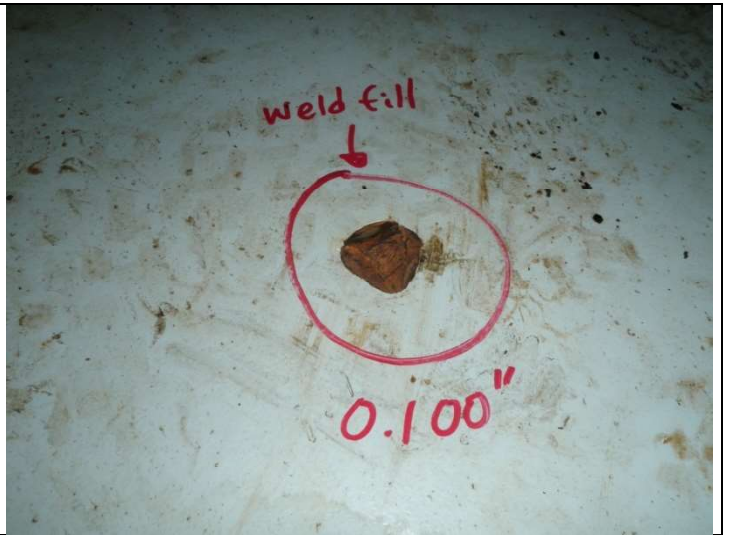
Pitting on bottom 0.100 inch depth and 3.0 inch dia.

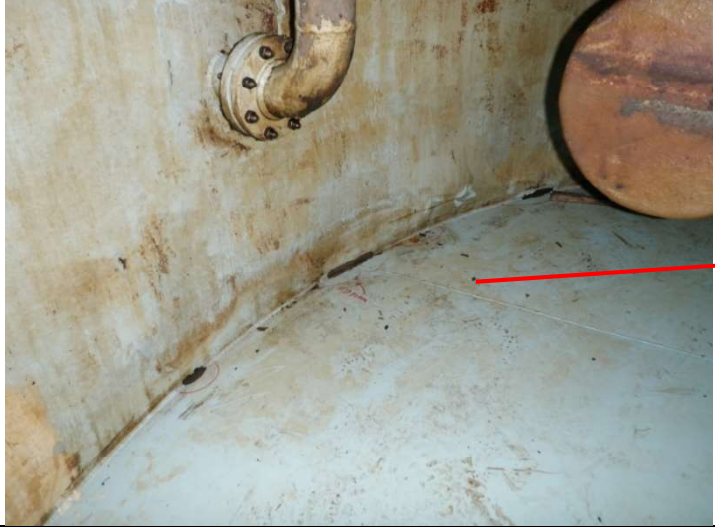
Areas of noted weld corrosion/pitting

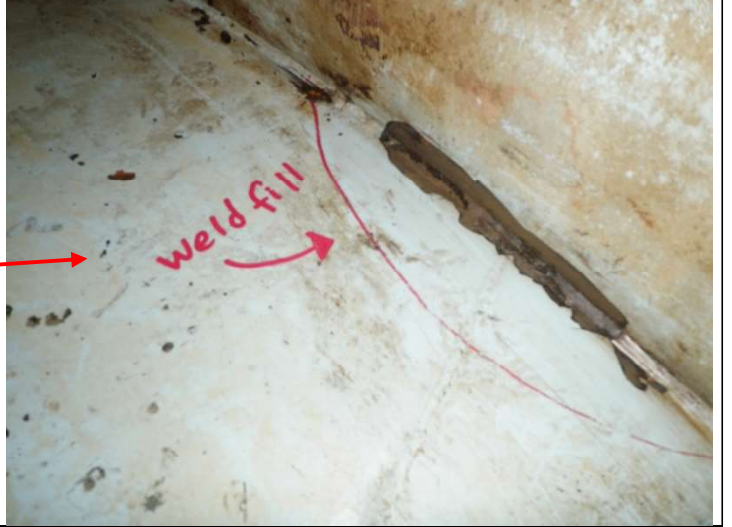
Weld fill

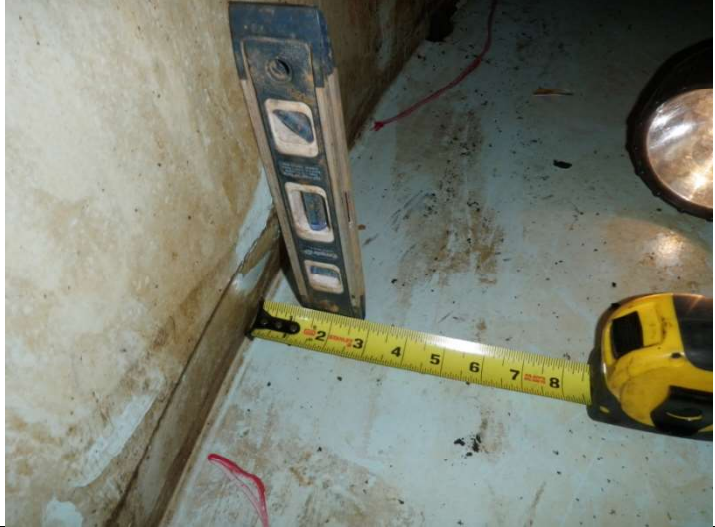
Inward deflection – 1.5 inches

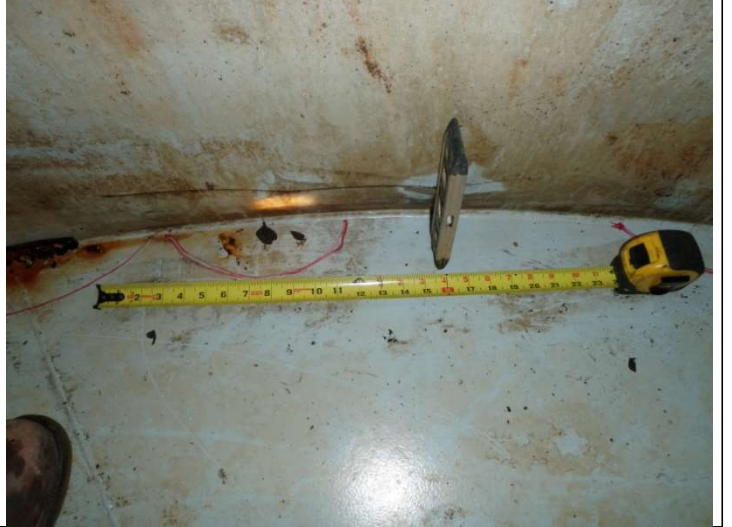
24.0 inches length

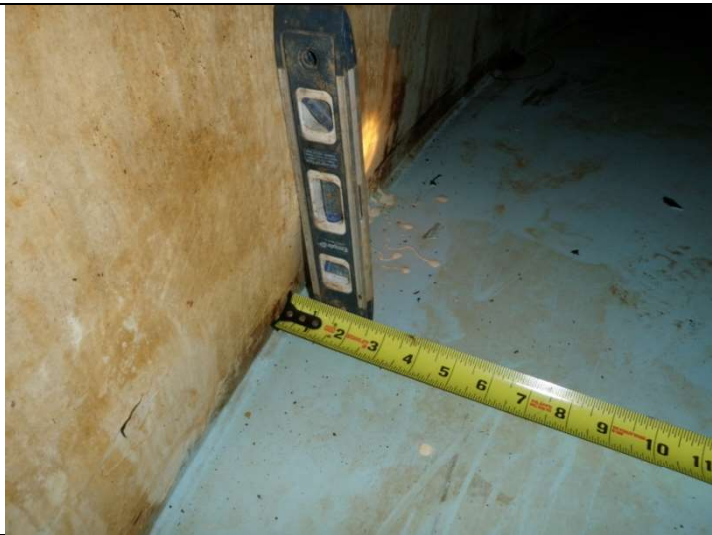
Inward deflection – 0.5 inches

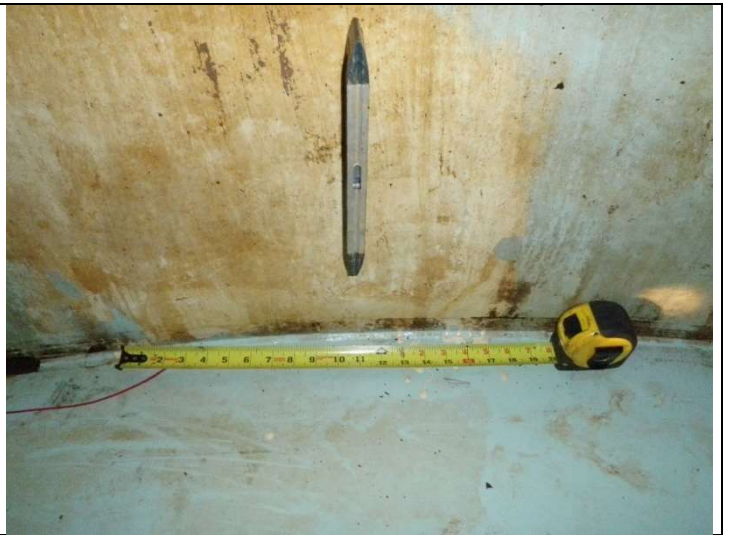
Inward deflection at shell to bottom – 20.0 inches length

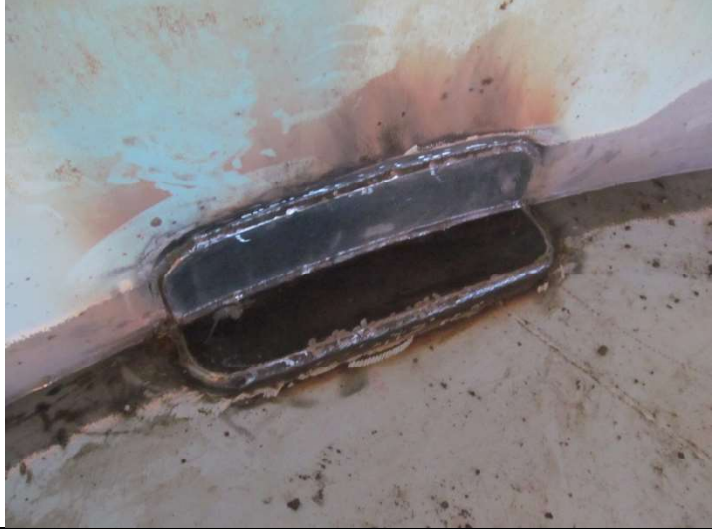
Welded patches – Nov 22 – a patch was required on the shell area where the weld from the shell to bottom was corroded through,

Nov 22: Weld repairs to shell to bottom weld in 3 areas and 7 patches were installed by REED Energy.

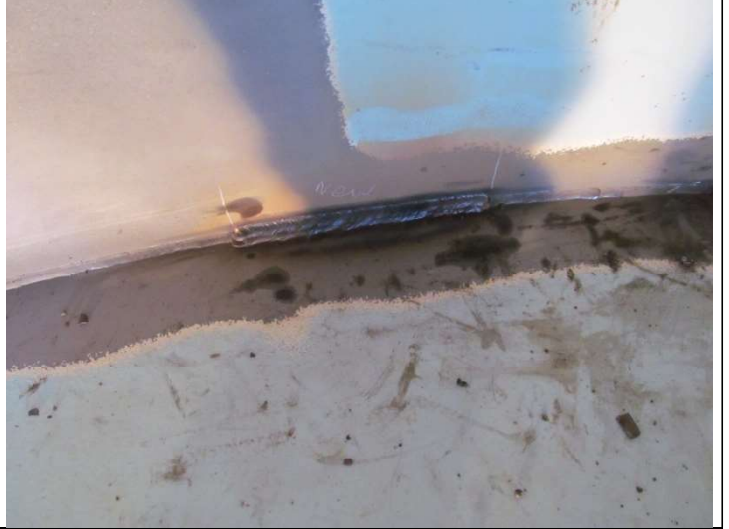
Shell to bottom weld repair.

Nov 22: Weld repairs inspected with Magnetic Particle Inspection method – no cracking detected.

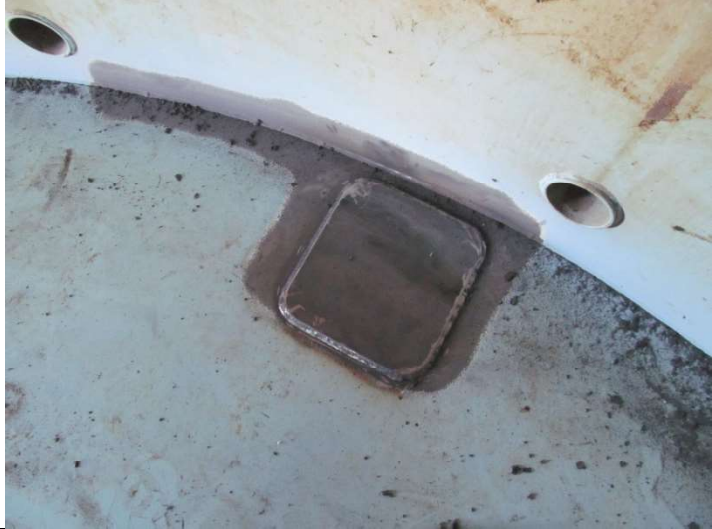
Welded Patch Nov 22

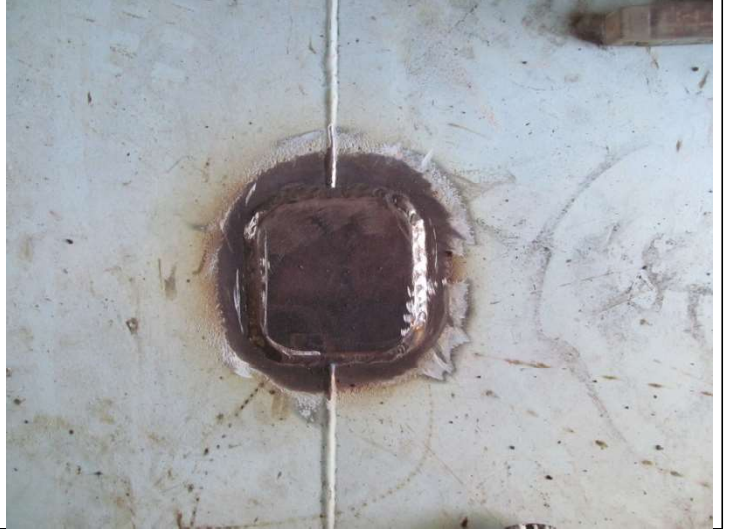
Welded patch – Nov 22

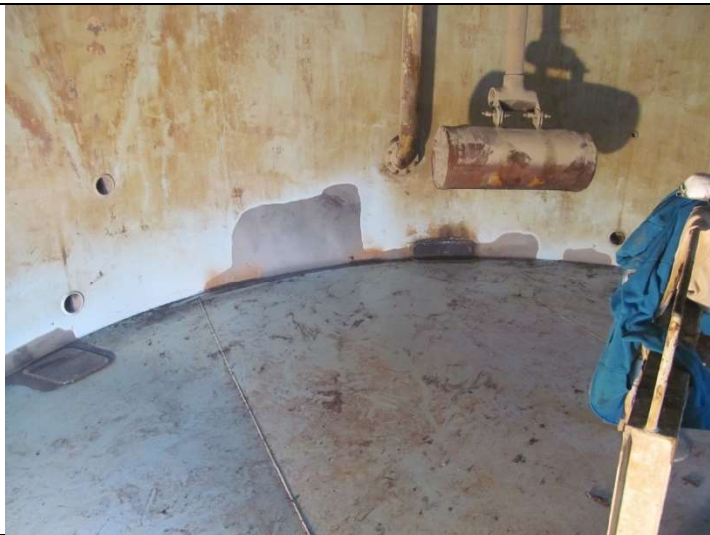
Over view of patched area – Nov 22

Nov 23: Premier coatings coat the patched areas with Devco 142 C grout (Hand laid up).

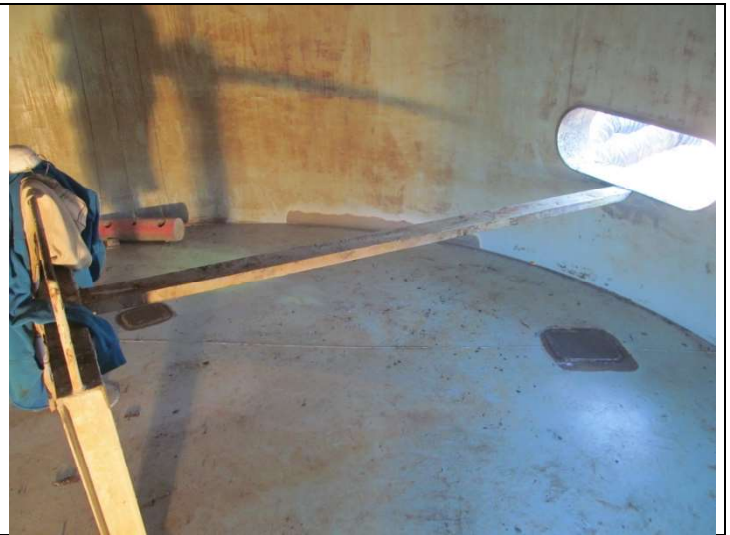
Over view of patched areas – Nov 22.

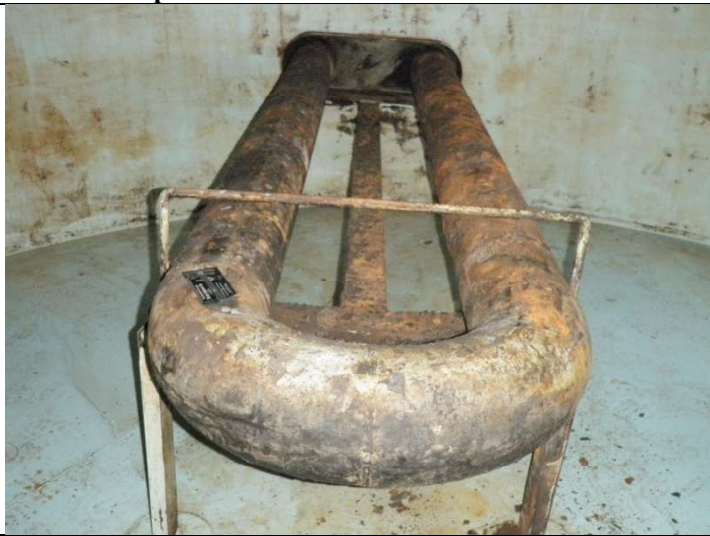
Nov 22: The 8 inch fire tube was inspected for pitting – pitting detected to near through holes along the upper section of the tube – large diameter pits – deepest to 8.0 mm / tube was built at 9.3 mm.

Fire Tube – corrosion/pitting

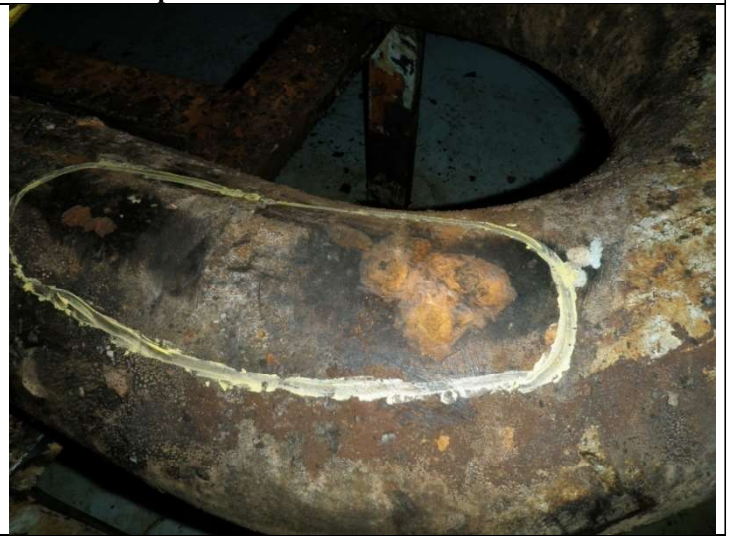
Pitting

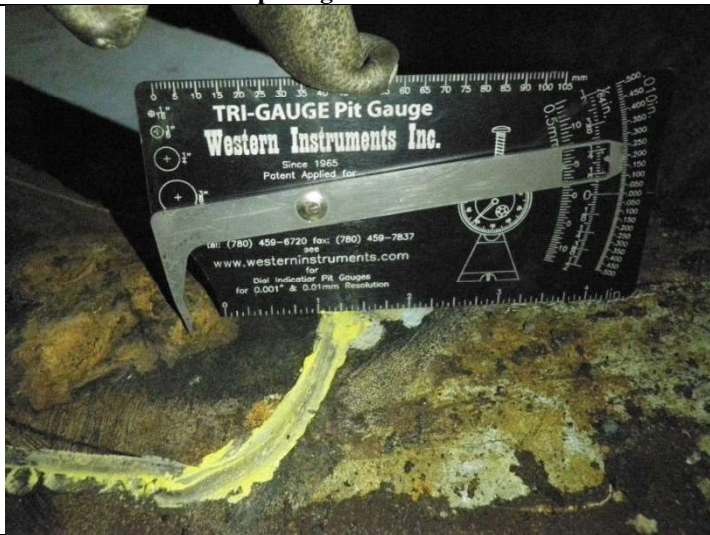
Pit depth 0.200 inches

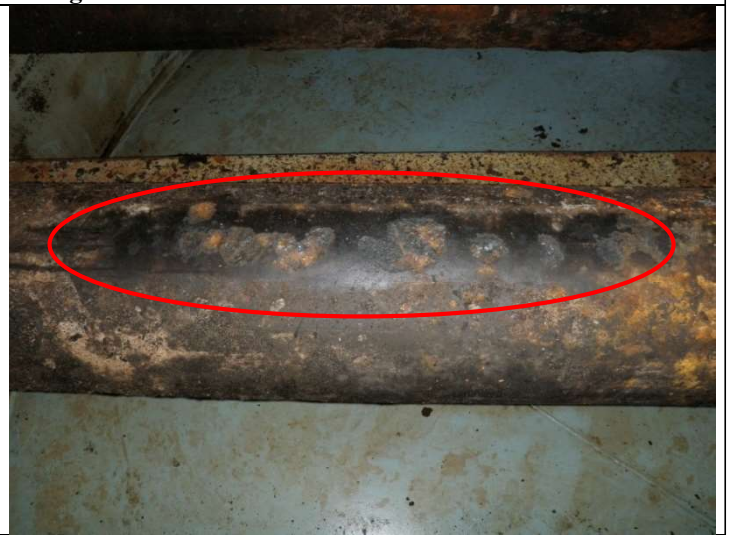
Pitting/ corrosion

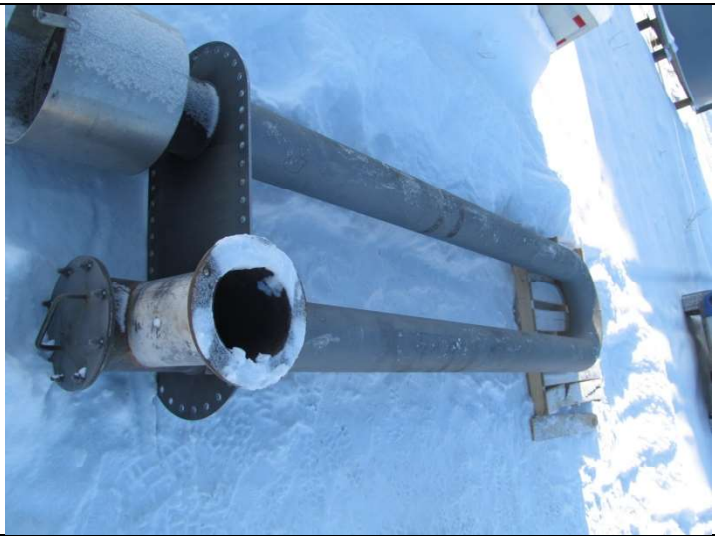
Fire tube after sand blasting

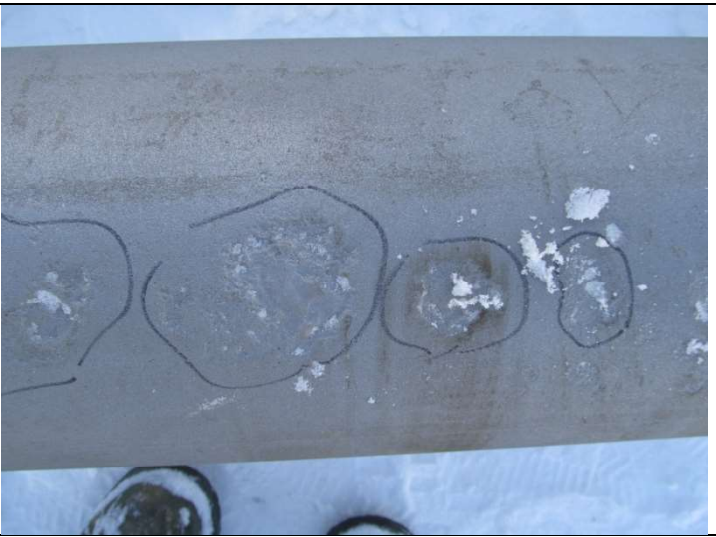
Clusters of pitting

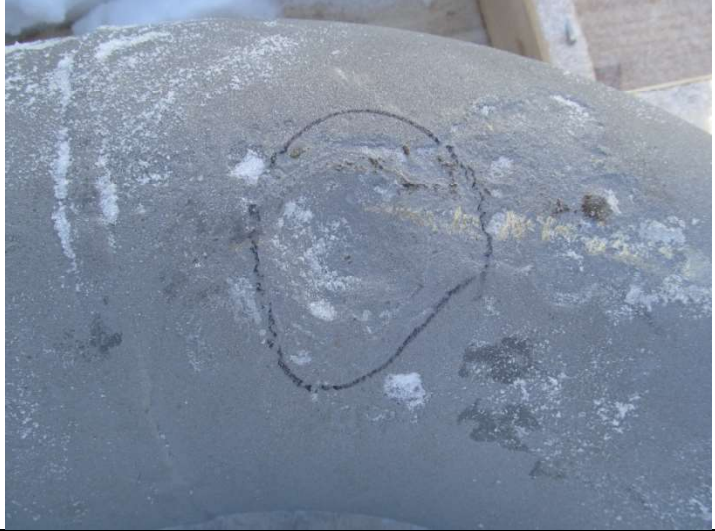
Nov 22: Deepest pits were weld built up using E 7018-1 by REED Energy. (This was a stop gap only as the tank had to be put back into production – operations stated that the tank would again be opened in March / April time frame and a new tube could be built) Ultrasonic thickness on unpitted areas showed some corrosion – min thickness was 8.3 mm – so tube has some internal problems as well as external problems.

General corrosion with deep pits

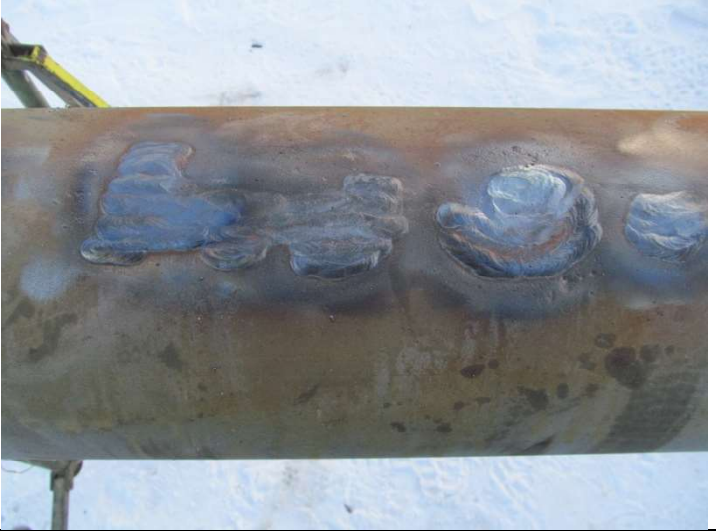
Weld build up on fire tube

Nov 22: Welded areas inspected with Magnetic Particle Inspection method – no cracking detected.
