**Canadian Natural Resources Limited
GENERAL PRESSURE VESSEL INFORMATION**

District: Hamburg Oil – GP South		Skid No.				
Facility: Hamburg Water Injection		Location (LSD): 13-20-96-09 W6M				
Vessel Name & Equipment Number: 1000 Produced Water Tank						
Orientation: Vertical						
Status: In Service		Regulatory Inspection				
PRESSURE VESSEL NAMEPLATE DATA						
"A" or "G" or "S" (Sask.) or BC Registration Number. C51990		CRN Number Not Required				
Vessel serial number: 16804		Size: 17ft 3in x 24 ft				
Shell thickness: 4.8mm		Shell material: SA 36				
Bottom thickness: 6.4mm		Bottom material: SA 36				
Deck thickness: 4.8 mm		Deck material: SA 36				
Tube diameter:		Tube length:				
Channel thickness:		Channel material:				
Design pressure	Shell: Atmos.	Operating pressure	Shell:			
	Tubes:		Tubes:			
Design Temp.	Shell:	Operating temperature	Shell:			
	Tubes:		Tubes:			
X-ray: Nil		Heat treatment: Nil				
Code parameters: API 650		Joint efficiency (if on nameplate):				
Manufacturer: Platinum Energy Services Corp.		Year built: 2006

Date: June 26, 2013

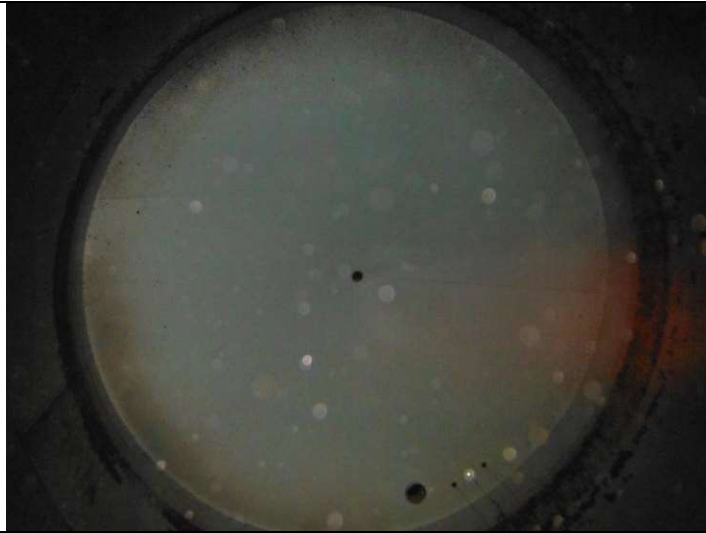
Deck internal

Roof / Deck Record location, size and depth of all erosion, corrosion or mechanical damage. Describe General condition.	X				Good condition, 100% coated with epoxy – no areas of failed coating.
Float	X				Good condition, intact and attached.
Man Way Access	X				Man way coating. No areas of failed coating.
Nozzles	X				All nozzles un obstructed. Nozzles 100% coated with epoxy.
Thermal Probe	X				Thermal probe in good condition.

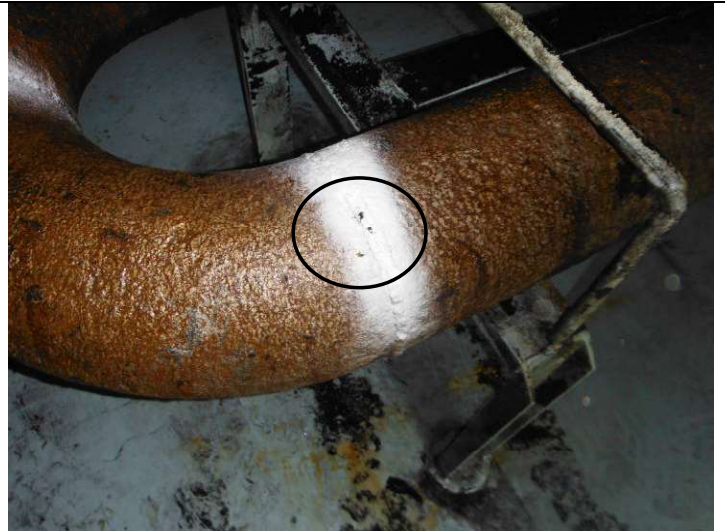
Welds Inspect all welds, including attachment welds. Record all service-related damages and if there is any discuss with Chief Inspector before closing.	X			Welds are 100% coated with epoxy. Approx 15 feet of coating on floor to shell weld is cracked and disbonded.
Fire Tube / Heat Medium Coil:			X	Fire tube is in poor condition with 1 through wall location and severe corrosion on upper area of tubes. Firetube will be removed from service but will be used as a temporary seal at fire tube access.
Repairs Required			X	1. Repair through hole on floor using an 8 inch x 40 inch SA 36 0.25 inch thick plate material. Fillet weld to shell using E 7018-1 Welding rod – max .125 inch diameter. 2. Grit blast areas of failed coating at shell to bottom weld as well as patch plate / attachment weld and recoat areas of repair with epoxy. 3. Fill weld identified locations on fire tube.
Recommendations or corrective actions (indicate if fit for service) Recommendations: 1. See above Repairs Required. 2. Next TAR: Grit blast and recoat floor and lower 3 ft of shell with epoxy. Summary: This tank is in generally good overall condition, internal and external inspection carried out. Coating failure at shell to bottom weld for a length of approx 15 ft. Scattered underlying pitting to 0.020 inch. Two isolated areas of bottom coating failure resulted with 1 through hole location approx 0.375 inch dia. Patch plate repair carried out by REED Energy. Magnetic particle inspection carried – no cracking detected. No coating company was available at time of repair. Areas of coating repair were prepped and applied by RTD. Fire tube is in poor condition with 1 through hole location and severe corrosion 10:00 to 2:00 position. Fire tube will be fill-welded and temporarily remain in place, but will be removed from service.

Fire tube – through hole identified with major corrosion to 0.220 inch depth

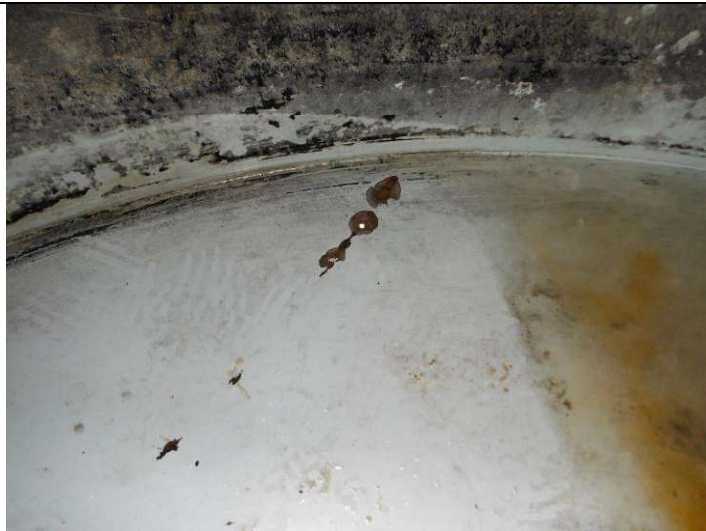
Internal Inspection Items	G	F	P	N/A	Comments
Coating Assess coating. Describe area coated, general condition of coating.			X		Tank is 100% coated with epoxy – several areas coating failure on floor and shell to floor weld causing corrosion and 1 floor hole location.
Anodes. How many, type, condition. % consumed. Are they being replaced?				X	No anodes.
Internal Piping Is there any? If so, carbon or stainless steel. Describe condition, dents, corrosion, erosion, etc. Ensure supports are secure and any bolts are suitable for future use.				X	No internal piping
Bottom Record location, size and depth of all erosion, corrosion or mechanical damage. Describe General condition.			X		100 % coated with epoxy – several areas of failed coating. 1 through hole location
Shell Sections Record number of shell sections. Record location, size and depth of all erosion, corrosion or mechanical damage. Describe General condition.	X				4 shell sections generally in good condition, 100% coated with epoxy. No areas of failed coating. Heavy deposits on 2nd course.

Bottom – Failed coating and one through hole identified.

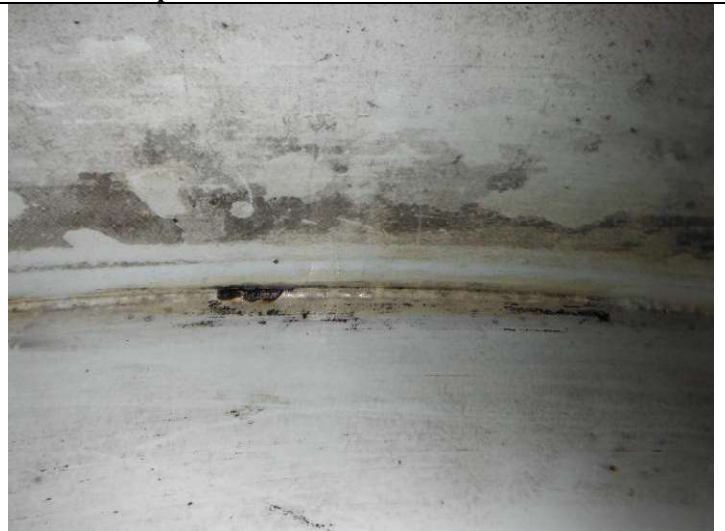
Coating failure at shell to bottom weld to approx 15 ft.
