Canadian Natural Resources Ltd. GENERAL PRESSURE TANK INFORMATION							Job#-10.111847
District: Grande Prairie AB.			Area: Spirit River				
Facility: South Spirit River Battery			Location (LSD): 08-09-77-07W6M				
Tank Name / Equipment Number: Production Storage Tank							
Orientation: Vertical							
Status: Out of Service			Regulatory Inspection				
ABOVE GROUND STORAGE TANK NAMEPLATE DATA							
"A" or "G" or "S" (Sask.) or BC Registration Number. C 47901			CRN Number Not required				
Vessel serial number: G-01-218-3			Diameter: 17.25 FT				
Shell thickness Course 1: 1/4"			Shell material: A-36				
Course 2: 3/16"			Floor material:				
Course 3: 3/16"			Height: 24.00 FT				
Capacity: 1000 BBL			Roof thickness: 5/16"				
MAWP	Shell:		Design Metal Temp				
	Tubes:						
Design Temp.	-11degrees F minimum		Operating temperature	Shell:			
Specific Gravity: 1.0			Heat treatment: N/A				
Code parameters: API 650 Modified			Joint efficiency (if on nameplate): N/A

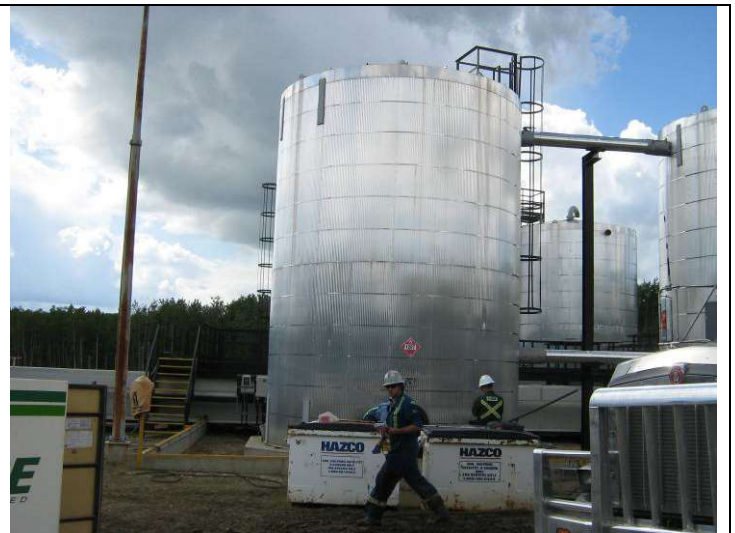
Tank Lot Overview

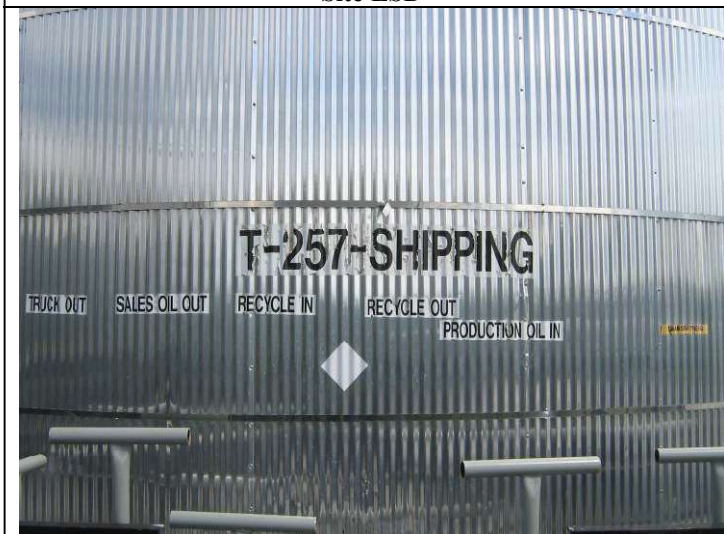
Tank identification

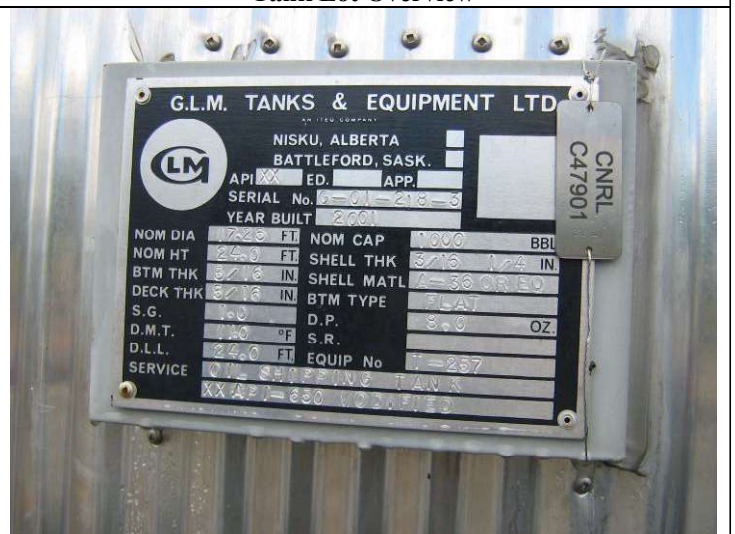
Data Plate

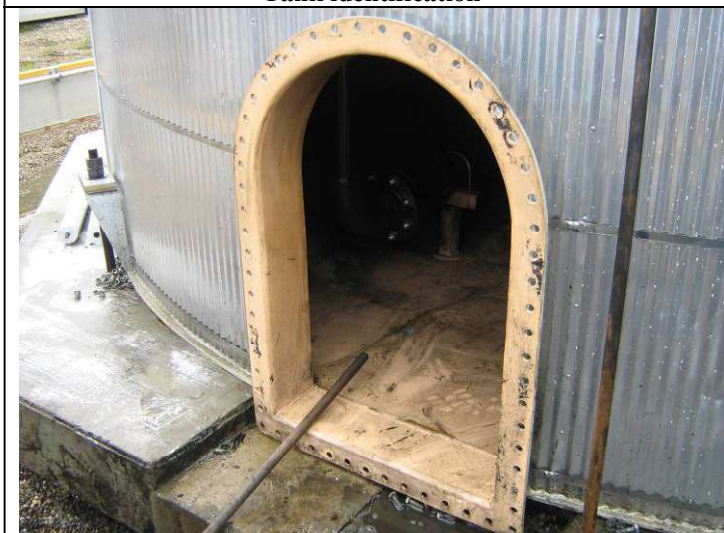
Manway Access door

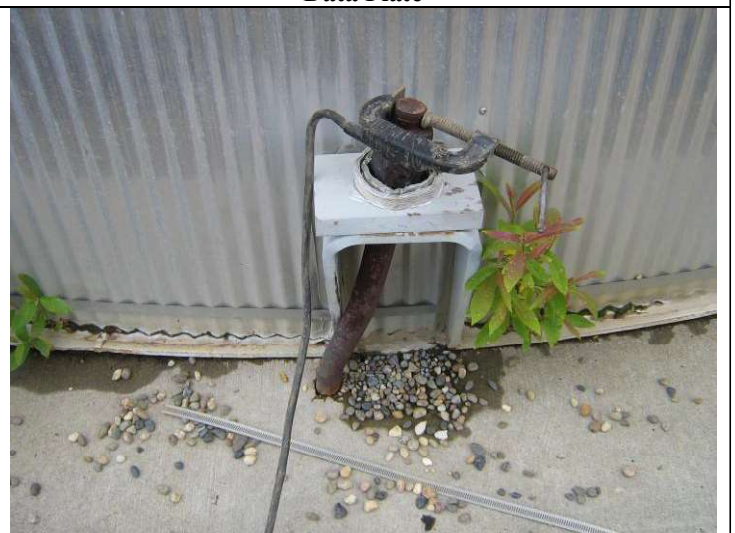
External Inspection Items	G	F	P	N/A	Comments
Insulation Verify sealed around manways, nozzles, no damage present, and there is no egress of moisture. Are straps secured?	X				Shell is insulated. No damage to the cladding or moisture egression noticed. All insulation appears sealed and straps are secure.
External Condition Assess paint condition, areas peeling, record any corrosion, damage, distortion etc (record location, size and depth of corrosion or damage)				X	Tank is not painted externally
Leakage Record any leakage at flanges, threaded joints, weep holes on repads, etc.	X				No areas of leaking observed where available.
Base: Assess condition of paint, fire protection, and concrete. Look for corrosion, buckling, dents, etc. Look at vessel surface area near supports. Is tank mounted above ground water level-on pilings? Is ground wire attached?		X			Tank is in a burm with secondary containment. Tank has no signs of settlement on the elevated concrete pad. One anchor bolt has severe deformation. Ground wire firmly attached.

Anchor bolt deformed

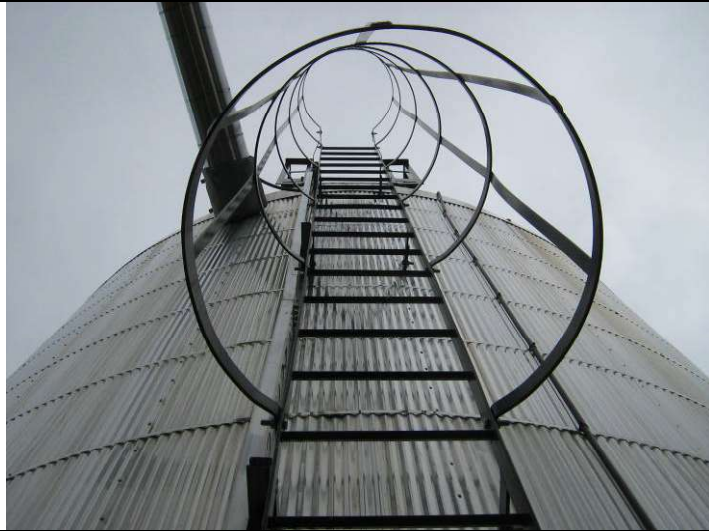
Ladder Assembly

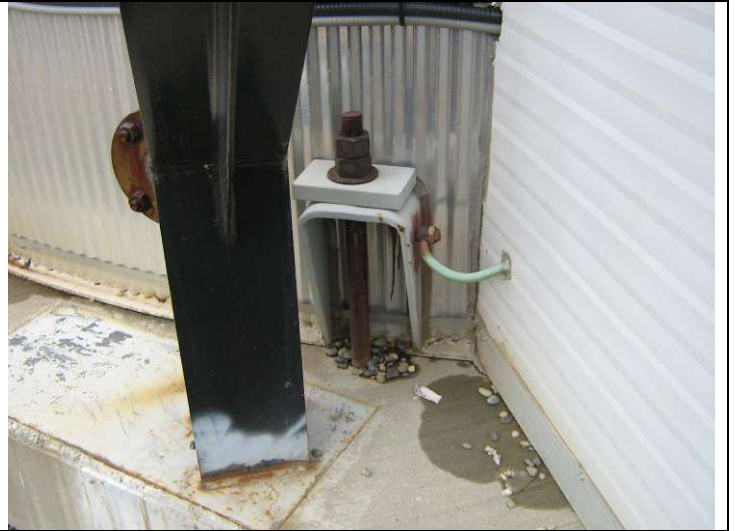
Tank is grounded

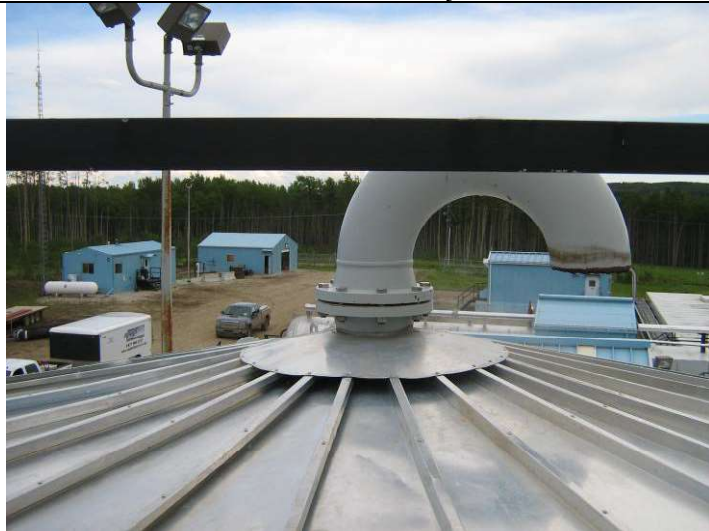
Roof Overview

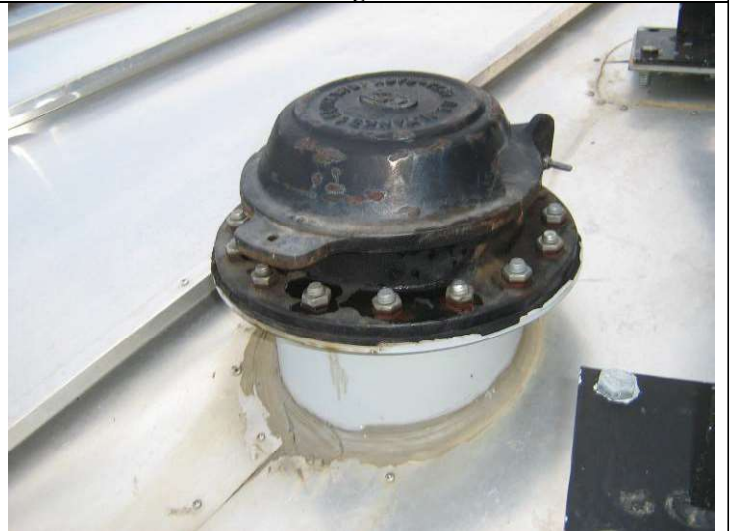
Gauge Hatch

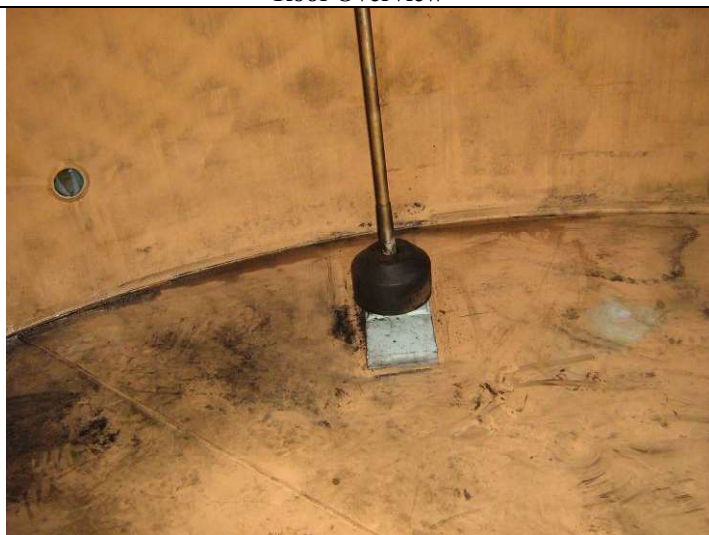
Floor and shell Overview

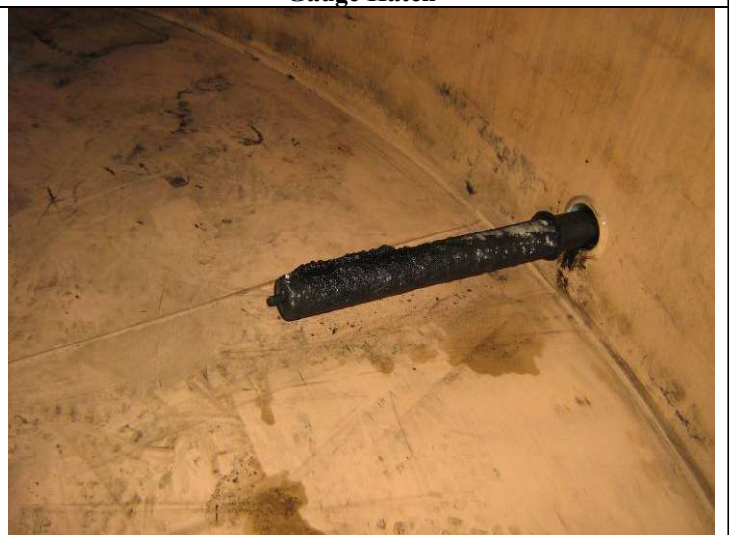
Typical Anode

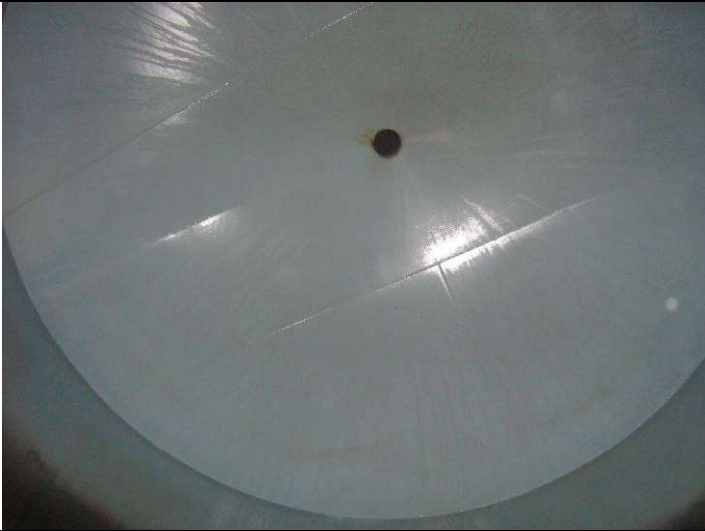
Internal Roof and upper shell

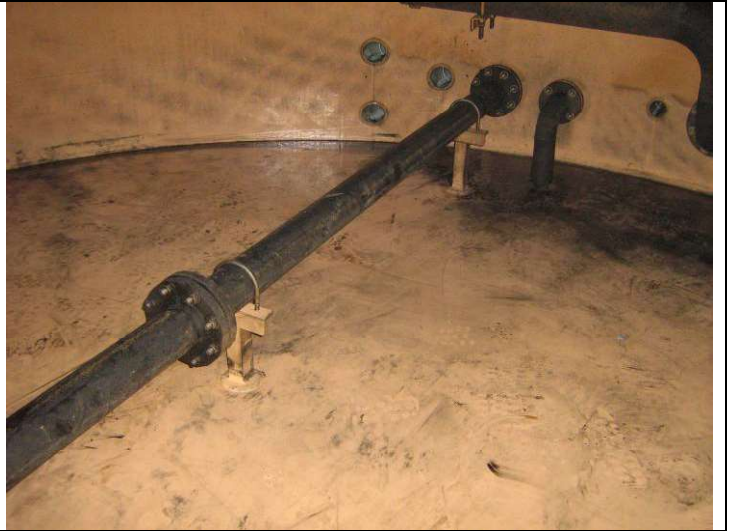
Internal Piping
