**Canadian Natural Resources Ltd.
GENERAL PRESSURE TANK INFORMATION**

Job#-10.111847

District: Grande Prairie AB.		Area: Spirit River				
Facility: South Spirit River Battery		Location (LSD): 08-09-77-07W6M				
Tank Name / Equipment Number: Production Storage Tank						
Orientation: Vertical						
Status: Out of Service		Regulatory Inspection				
ABOVE GROUND STORAGE TANK NAMEPLATE DATA						
"A" or "G" or "S" (Sask.) or BC Registration Number. C 47903		CRN Number Not required				
Vessel serial number: G-01-218-4		Diameter: 17.25 FT				
Shell thickness Course 1: 1/4"		Shell material: A-36				
Course 2: 3/16"		Floor material:				
Course 3: 3/16"		Height: 24.00 FT				
Capacity: 1000 BBL		Roof thickness: 5/16"				
Floor thickness: 5/16"		MAWP				
Shell:		Design Metal Temp				
Tubes:						
Design Temp. -11degrees F minimum		Operating temperature				
Shell:		Heat treatment: N/A				
Specific Gravity: 1.0		Joint efficiency (if on nameplate): N/A				
Code parameters: API 650 Modified		Year built: 2001

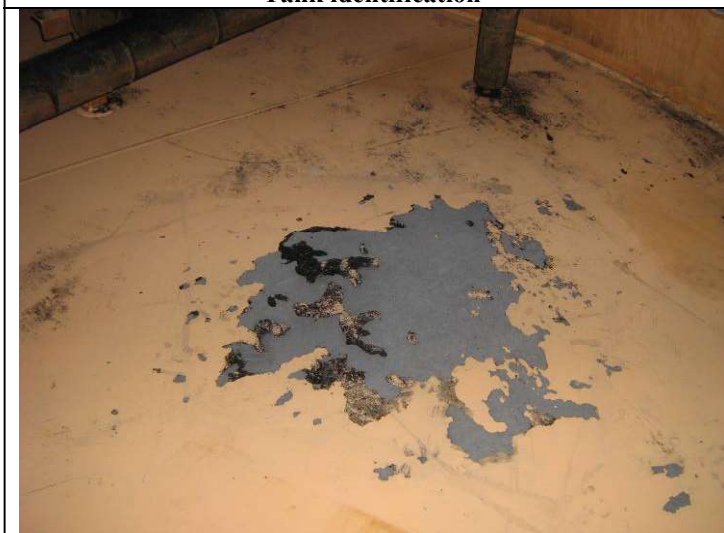
Patch of paint that could not be removed

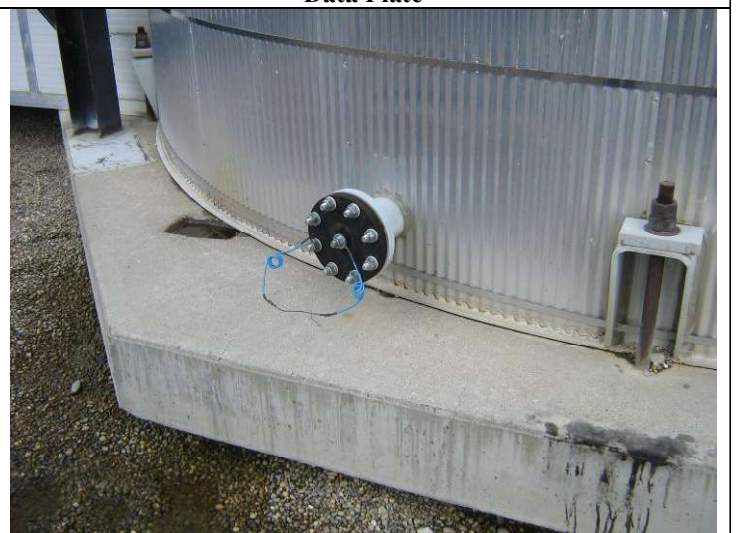
External Inspection Items	G	F	P	N/A	Comments
Insulation Verify sealed around manways, nozzles, no damage present, and there is no egress of moisture. Are straps secured?	X				Shell is insulated. No damage to the cladding or moisture egression noticed. All insulation appears sealed and straps are secure.
External Condition Assess paint condition, areas peeling, record any corrosion, damage, distortion etc (record location, size and depth of corrosion or damage)				X	Tank is not painted externally
Leakage Record any leakage at flanges, threaded joints, weep holes on repads, etc.	X				No areas of leaking observed where available.
Base: Assess condition of paint, fire protection, and concrete. Look for corrosion, buckling, dents, etc. Look at vessel surface area near supports. Is tank mounted above ground water level-on pilings? Is ground wire attached?	X				Tank is in a burm with secondary containment. Tank has no signs of settlement on the elevated concrete pad. Ground wire could not be located.

Tank bolted to concrete pad

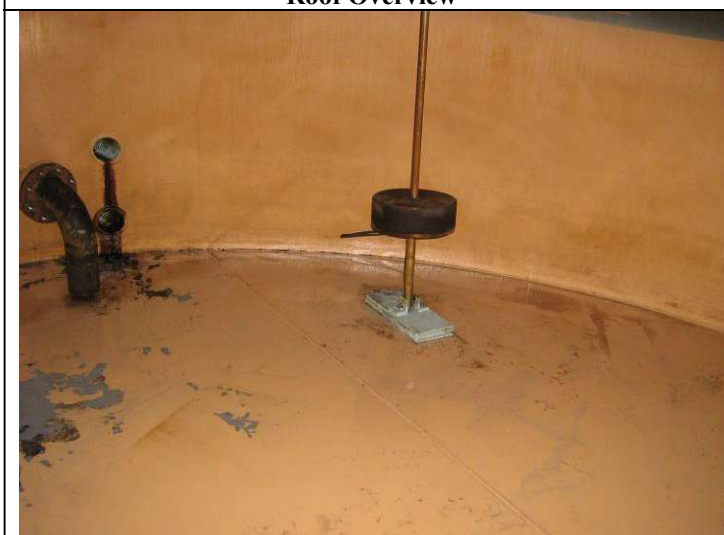
Floor and shell Overview

Bottom Note all corrosion, erosion or mechanical damage. (If vessel is horizontal identify direction of this head)	X				No corrosion found.
Deck Note all corrosion, erosion or mechanical damage. (If vessel is horizontal identify direction of this head)	X				Deck is internally painted and in new like condition
Shell Sections Record number of shell sections. Record location, size and depth of all erosion, corrosion or mechanical damage. Describe general condition. If any corrosion greater than corrosion allowance is observed in either shell or head, discuss with Chief Inspector before closing vessel.	X				Tank consists of 4 courses at 6 feet tall. There was no corrosion noticed and all courses had been internally painted. Paint was in good condition.
Fire tube / Heat Medium Coil: Is it in place – anchored? Is it clean?				X	
Welds Inspect all welds, including attachment welds. Document corrosion and pitting.	X				All welds were free of any welding defects or any type of corrosion or erosion.
