Canadian Natural Resources Ltd. GENERAL PRESSURE TANK INFORMATION Job#-10.111847						
District: Grande Prairie AB.			Area: Spirit River			
Facility: South Spirit River Battery			Location (LSD): 08-09-77-07W6M			
Tank Name / Equipment Number: Production Storage Tank						
Orientation: Vertical						
Status: Out of Service			Regulatory Inspection			
ABOVE GROUND STORAGE TANK NAMEPLATE DATA						
"A" or "G" or "S" (Sask.) or BC Registration Number. C 47904			CRN Number Not required			
Vessel serial number: G-01-218-2			Diameter: 17.25 FT			
Shell thickness Course 1: 1/4"			Shell material: A-36			
Course 2: 3/16"			Floor material:			
Course 3: 3/16"			Height: 24.00 FT			
Capacity: 1000 BBL			Roof thickness: 5/16"			
MAWP			Shell:		Design Metal Temp	
			Tubes:			
Design Temp.		-11degrees F minimum		Operating temperature		Shell:
Specific Gravity: 1.0			Heat treatment: N/A			
Code parameters: API 650 Modified			Joint efficiency (if on nameplate): N/A

Inspected By: Matt Wood

Date: June 20, 2012

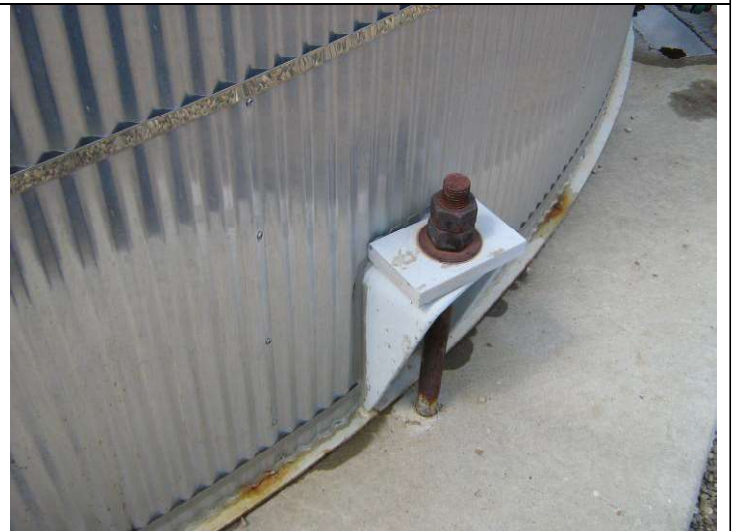
External Inspection Items	G	F	P	N/A	Comments
Insulation Verify sealed around manways, nozzles, no damage present, and there is no egress of moisture. Are straps secured?	X				Shell is insulated. No damage to the cladding or moisture egression noticed. All insulation appears sealed and straps are secure.
External Condition Assess paint condition, areas peeling, record any corrosion, damage, distortion etc (record location, size and depth of corrosion or damage)				X	Tank is not painted externally
Leakage Record any leakage at flanges, threaded joints, weep holes on repads, etc.	X				No areas of leaking observed where available.
Base: Assess condition of paint, fire protection, and concrete. Look for corrosion, buckling, dents, etc. Look at vessel surface area near supports. Is tank mounted above ground water level-on pilings? Is ground wire attached?	X				Tank is in a burm with secondary containment. Tank has no signs of settlment on the elevated concrete pad. Ground wire firmly attached.

Tank bolted to concrete pad

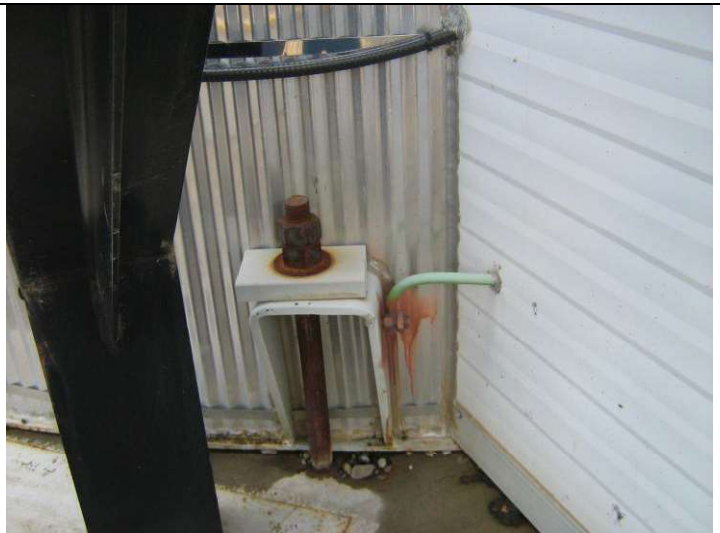
Tank is grounded

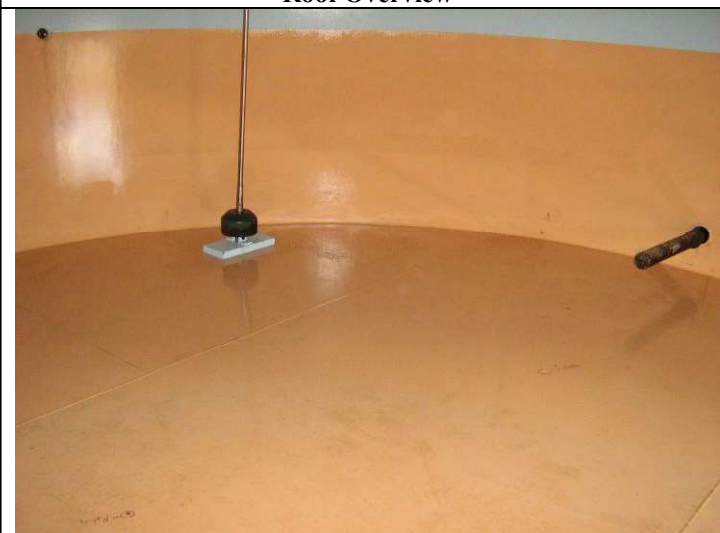
Floor and shell Overview

Baffles, deflector plates, etc. If present, describe condition. Look closely at welds attached to tank wall.				X	
Bottom Note all corrosion, erosion or mechanical damage. (If vessel is horizontal identify direction of this head)	X				No corrosion found. One chip in the coating was identified and repaired.
Deck Note all corrosion, erosion or mechanical damage. (If vessel is horizontal identify direction of this head)	X				Deck is internally painted and in new like condition
Shell Sections Record number of shell sections. Record location, size and depth of all erosion, corrosion or mechanical damage. Describe general condition. If any corrosion greater than corrosion allowance is observed in either shell or head, discuss with Chief Inspector before closing vessel.	X				Tank consists of 4 courses at 6 feet tall. There was no corrosion noticed and all courses had been internally painted. Paint was in good condition.

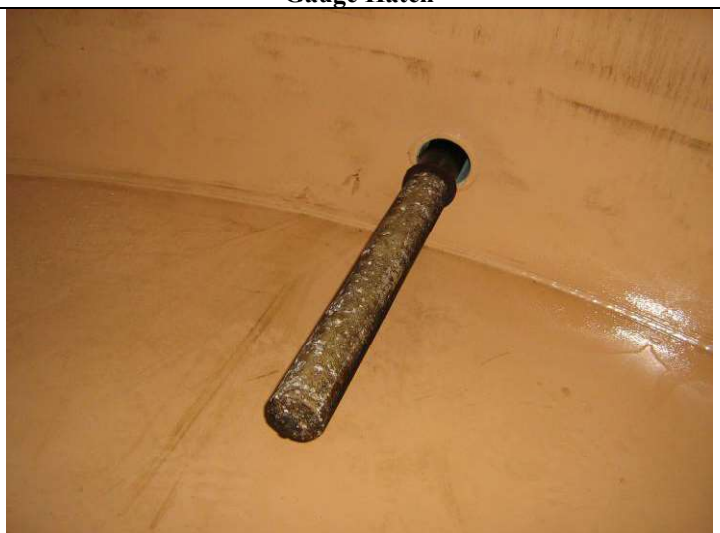
Typical Anode that was removed

Other:					
Recommendations or corrective actions : Vessel is Fit for Service or describe corrective actions required) (MIC to review corrective actions with Operations, discuss with Chief Inspector where necessary, and get remedial action implemented) Recommendations: No recommendations at this time. Coating damage was fixed Summary: Tank is in overall good condition, visual external inspection and ultrasonic corrosion survey performed—no metal thickness detected below nominal. Both anodes were changed out. Tank is fit for service
