Canadian Natural Resources Ltd. GENERAL PRESSURE TANK INFORMATION							Job#-10.111847
District: Grande Prairie AB.			Area: Spirit River				
Facility: South Spirit River Battery			Location (LSD): 08-09-77-07W6M				
Tank Name / Equipment Number: Production Storage Tank							
Orientation: Vertical							
Status: Out of Service			Regulatory Inspection				
ABOVE GROUND STORAGE TANK NAMEPLATE DATA							
"A" or "G" or "S" (Sask.) or BC Registration Number. C 47905			CRN Number Not required				
Vessel serial number: G-01-218-1			Diameter: 17.25 FT				
Shell thickness Course 1: 1/4"			Shell material: A-36				
Course 2: 3/16"			Floor material:				
Course 3: 3/16"			Height: 24.00 FT				
Capacity: 1000 BBL			Roof thickness: 5/16"				
MAWP		Shell:	Design Metal Temp				
		Tubes:					
Design Temp.	-11degrees F minimum		Operating temperature		Shell:		
Specific Gravity: 1.0			Heat treatment: N/A				
Code parameters: API 650 Modified			Joint efficiency (if on nameplate): N/A

Inspected By: Matt Wood
(API Certification# 31284)

Date: June 20, 2012

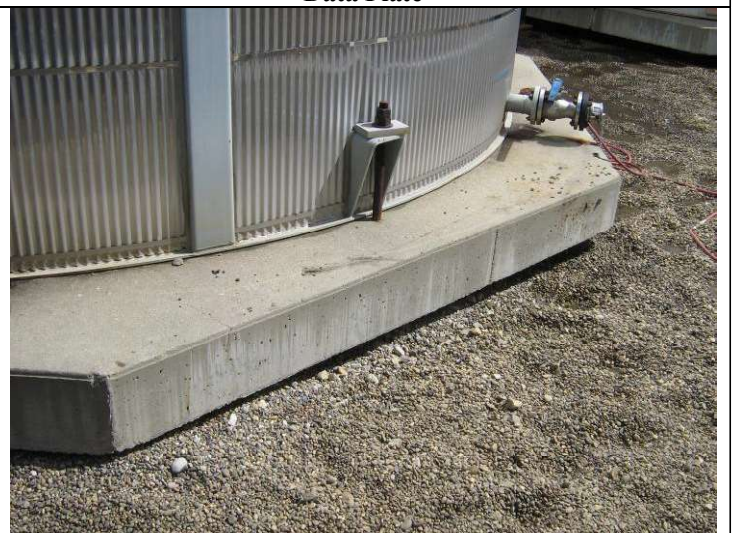
Tank bolted to concrete pad

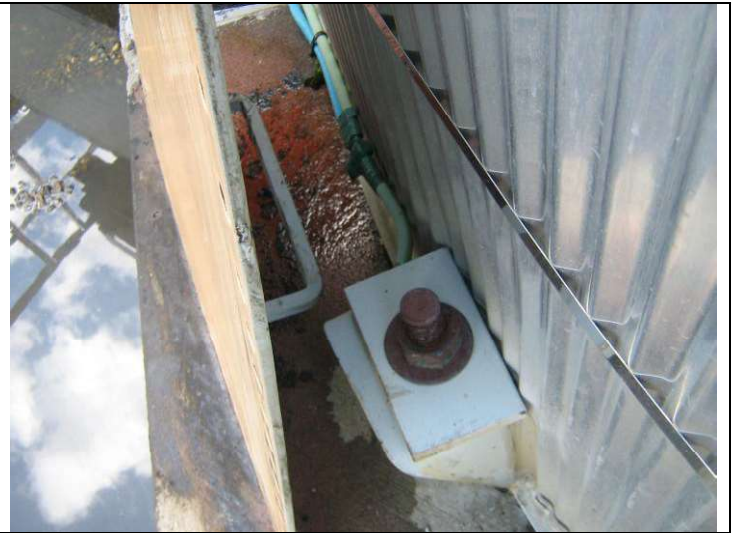
Tank is grounded

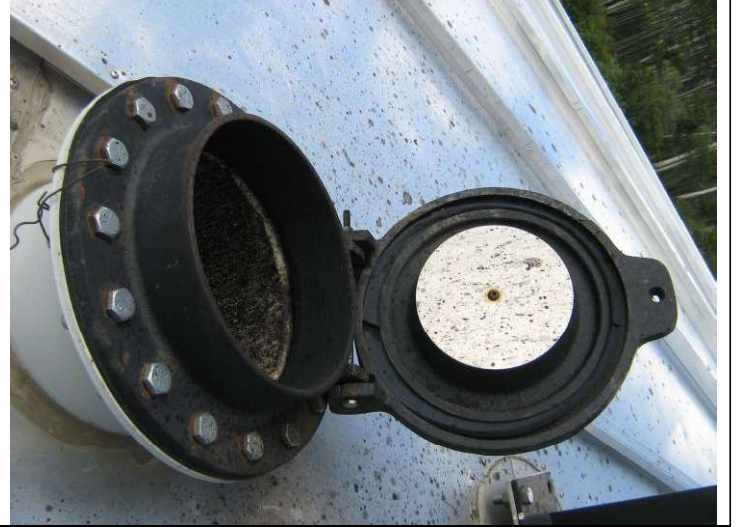
Gauge Hatch

Summary: This tank is in good overall condition, visual external carried out. Thief hatch appeared to be operational and in good condition.

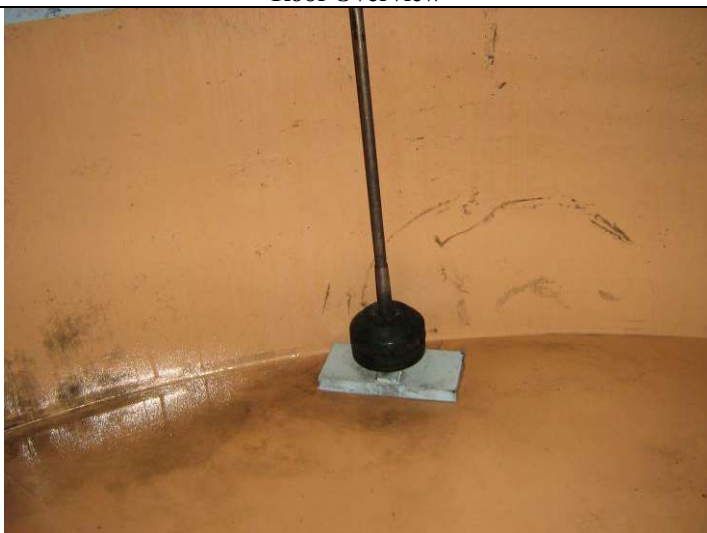
Floor and shell Overview

Bottom Note all corrosion, erosion or mechanical damage. (If vessel is horizontal identify direction of this head)	X				No corrosion found.
Deck Note all corrosion, erosion or mechanical damage. (If vessel is horizontal identify direction of this head)	X				Deck is internally painted and in new like condition
Shell Sections Record number of shell sections. Record location, size and depth of all erosion, corrosion or mechanical damage. Describe general condition. If any corrosion greater than corrosion allowance is observed in either shell or head, discuss with Chief Inspector before closing vessel.	X				Tank consists of 4 courses at 6 feet tall. There was no corrosion noticed and all courses had been internally painted. Paint was in good condition.
Fire tube / Heat Medium Coil: Is it in place – anchored? Is it clean?				X	
Welds Inspect all welds, including attachment welds. Document corrosion and pitting.	X				All welds were free of any welding defects or any type of corrosion or erosion.
