**Canadian Natural Resources Limited
GENERAL PRESSURE VESSEL INFORMATION**

District: Ft St John, B.C.						
Facility: Cypress Gas Gathering		Location (LSD): c-61-L / 93-B-15				
Vessel Name & Equipment Number: 1000 bbl Produced Water Tank						
Orientation: Vertical						
Status: In Service			Regulatory Inspection			
PRESSURE VESSEL NAMEPLATE DATA						
"A" or "G" or "S" (Sask.) or BC Registration Number.			CRN Number Not Applicable			
Vessel serial number: G03-056-S1			Size : 15.25 ft x 32 ft			
Shell thickness: 4.8 mm			Shell material: SA 36			
Bottom thickness: 6.4 mm			Head material: SA 36			
Deck thickness: 4.8 mm			Deck Material: SA 36			
Design pressure	Shell: 4 oz		Operating pressure	Shell:		
	Tubes:			Tubes:		
Design Temp.	Shell:		Operating temperature	Shell:		
	Tubes:			Tubes:		
X-ray: Nil			Heat treatment: Nil			
Code parameters: API 650			Coated: 100 % Devco 253			
Manufacturer: GLM Tanks and Equipment			Year built: 2003			
Corrosion allowance: Not Stated			Manway? Yes

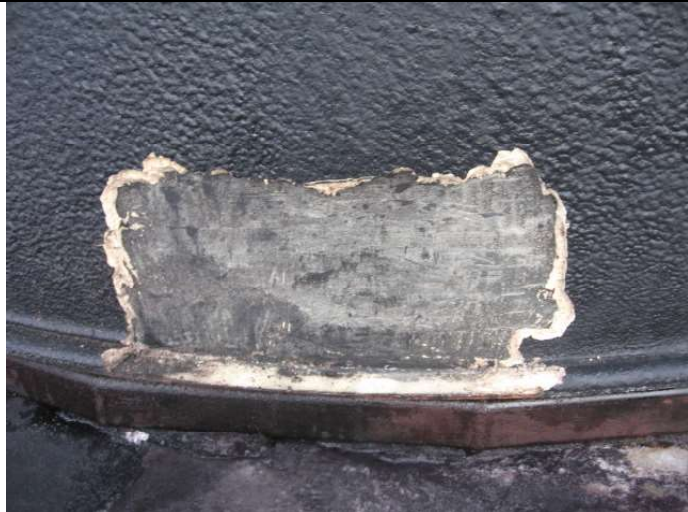
External Inspection Items	G	F	P	N/A	Comments
Insulation Verify sealed around manways, nozzles, no damage present, and there is no egress of moisture.	X				External is covered with tar over foam insulation – one small area exposed on shell where suspected failure.
External Condition Assess paint condition, areas peeling, record any corrosion, damage, etc (record location, size and depth of corrosion or damage)				X	No painted areas to assess.
Leakage Record any leakage at flanges, threaded joints, weep holes on repads, etc.			X		Tank was taken out of service due to leak in bottom – visual internal revealed a 2 inch by 4 inch hole in bottom of tank near shell to bottom area.
Base Assess condition of paint, fire protection, concrete. Look for corrosion, buckling, dents, etc. Look at vessel surface area near supports. Verify no signs of leakage at attachment to vessel and attachment welds are acceptable. Ground wire attached?	X				This tank sits above ground on concrete platform – platform sits above ground on pilings. No distortion to base. Tank is grounded.

Some of the insulation was removed to determine where the failure was located.

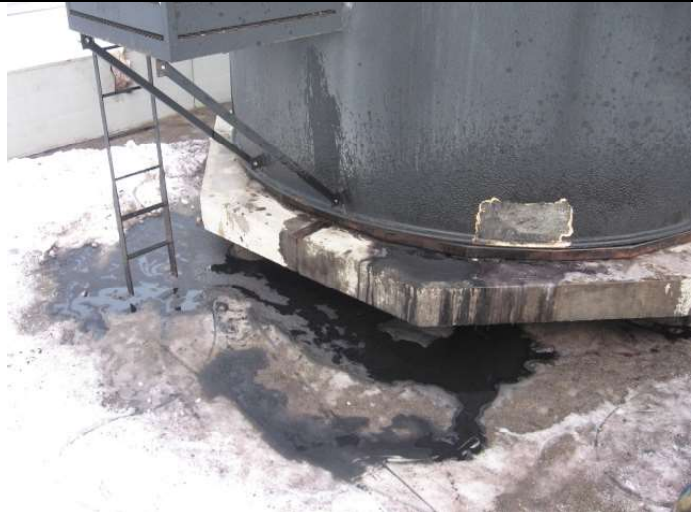
Area of leak

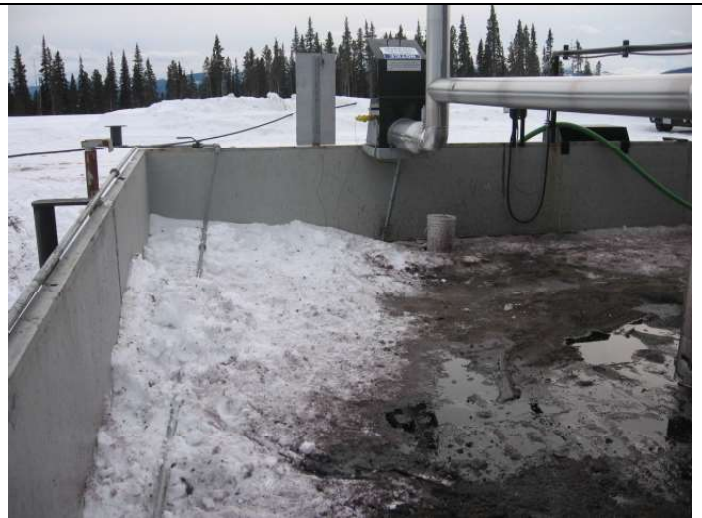
Berm and environment box.

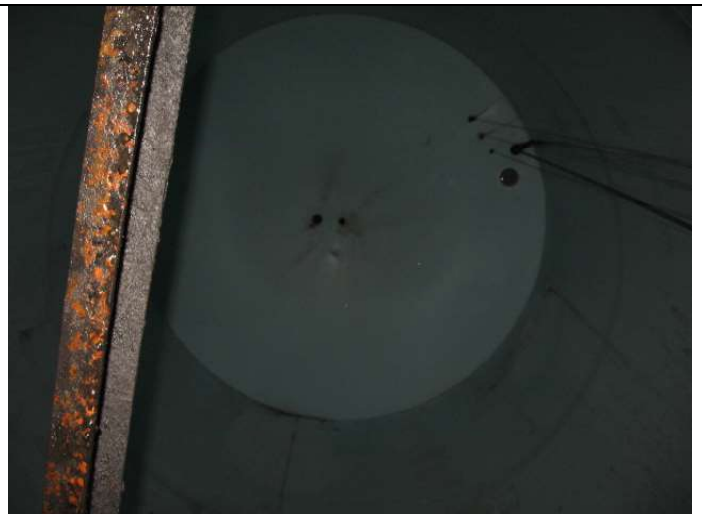
Roof / Deck: Record location, size and depth of all erosion, corrosion or mechanical damage. Describe General condition.	X				Good condition, 100% coated with epoxy – no exposed metal.
Deck supports:	X				No deck supports – deck is self supporting.
Float:	X				Intact and in place – free movement.
Nozzles:	X				All nozzles are unobstructed – coated internally, no failed areas of coating.
Welds Inspect all welds, including attachment welds.	X				Welds are coated with epoxy – no exposed metal.
Fire Tube / Heat Medium Coil:	X				Fire tube in place – no corrosion or erosion.
NDE Inspections				X	No NDE inspections at this time.
Recommendations or corrective actions (indicate if fit for service)					
Recommendations: 1. Weld repair hole in bottom of tank – this will simply require a 10 inch by 10 inch piece of A 36 material - .250 inches thick with 1 inch radius corners. 2. Fillet weld with E 7018-1 welding rod – weld from internal surface. 3. Recoat weld repair area with epoxy grout Devoc 142 C.

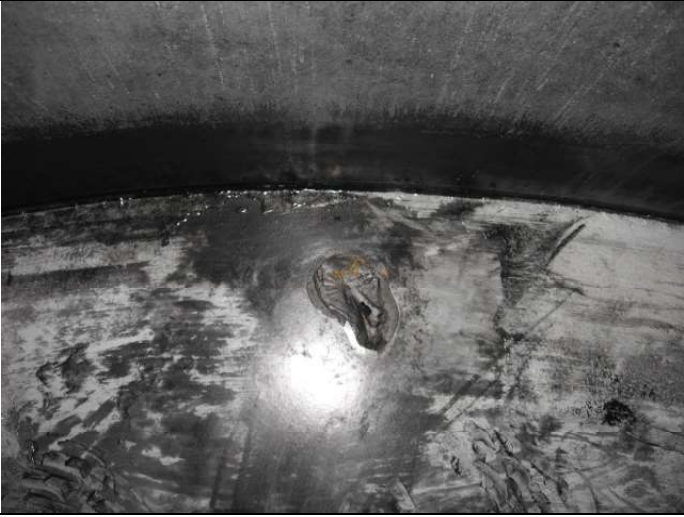
Internal Inspection Items	G	F	P	N/A	Comments
Coating Assess coating. Describe area coated, general condition of coating.	X				Internal surface is 100% coated – exposed metal where 2 inch x 4 inch through hole is on bottom. Remainder of coating is in good condition – no exposed metal.
Anodes. How many, type, condition. % consumed. Are they being replaced?	X				No anodes.
Internal Piping Is there any?	X				Outlet suction piping stem intact and firmly attached.
Internal supports: Fire tube / float / skimmer etc...	X				Fire tube supports are in place – no loose or missing sections. Float is intact and in place – very minimal water level is kept in this tank.
Bottom Record location, size and depth of all erosion, corrosion or mechanical damage.	X				100 % coated with epoxy – 1 area of exposed metal at through hole.
Shell Sections Record number of shell sections. Record location, size and depth of all erosion, corrosion or mechanical damage. Describe General condition.	X				3 courses – Good condition – 100% coated with epoxy, no exposed metal.

Summary: This tank is in good overall condition, visual external and internal carried out – 100% coated with epoxy internally, no loose or lifted coating – 1 area on bottom has a through hole 2 inches by 4 inches. Bring it welding completed repair.					
Tank is fit for service

Through hole in bottom of tank – to be scab patched.
