Client:  
**CNRL**

## PRESSURE EQUIPMENT DATA REPORT

<b>District:</b>	Medicine Hat		
<b>Facility:</b>	Grand Forks Central		
<b>Location /LSD:</b>	07-32-012-13W4	<b>Operating Province:</b>	Alberta
<b>Equipment Name:</b>	GROUP TREATER		
<b>Equipment Status:</b>	Operating	<b>Orientation:</b>	Horizontal
<b>Skid No.:</b>	GROUP TREATER	<b>Unit:</b>

**VISUAL INSPECTION REPORT**

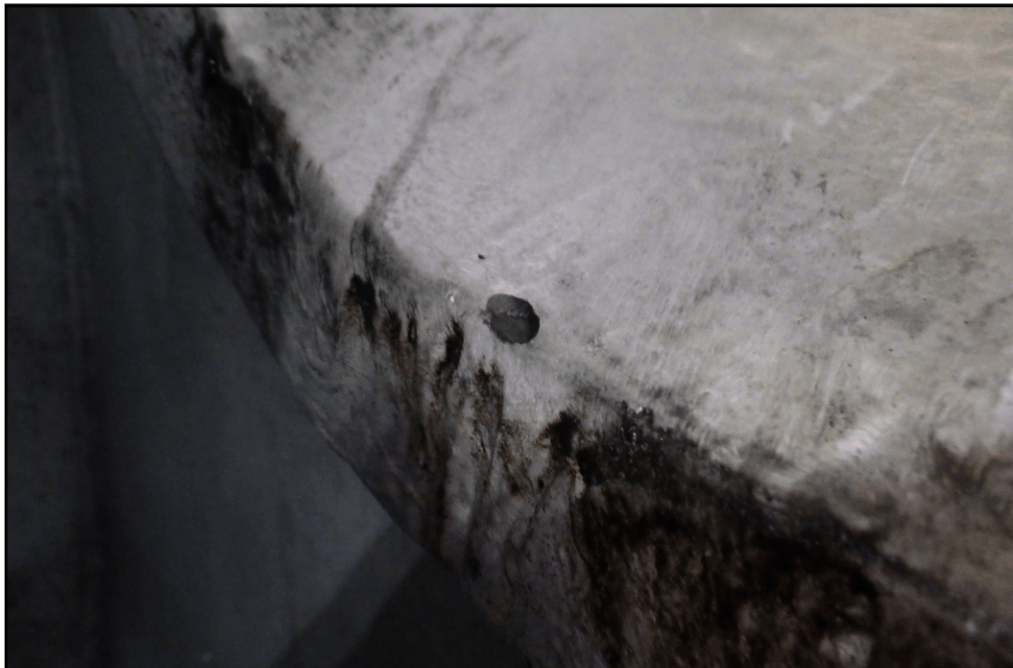
COATING CHIP

VESSEL FIT FOR SERVICE.  
COATING CHIPS REPAIRED BY INSPECTOR.  
FIRETUBE SENT FOR REPAIR.

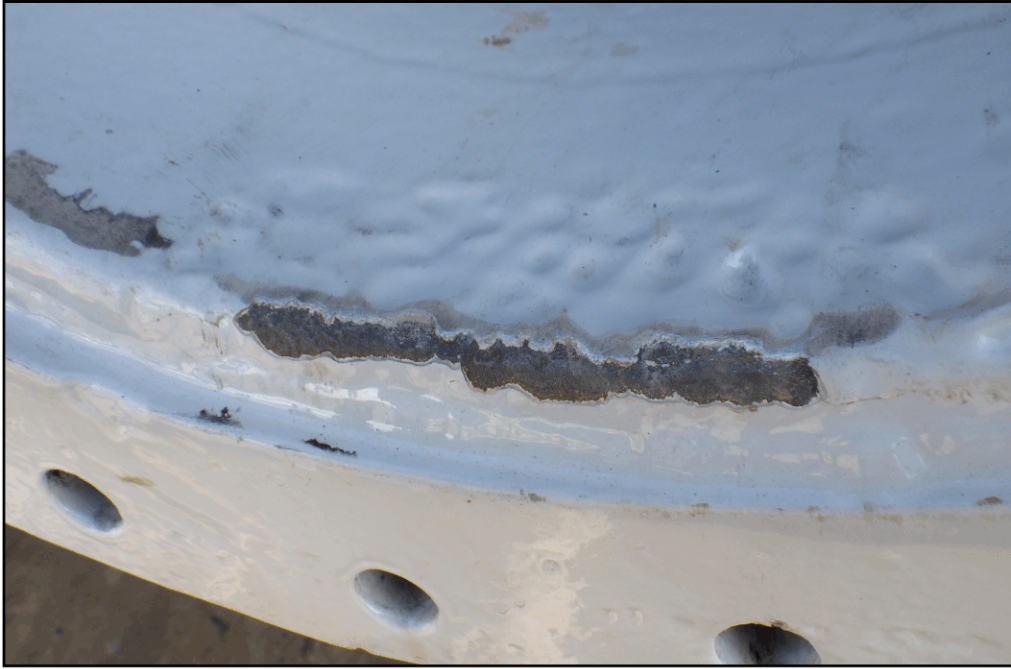
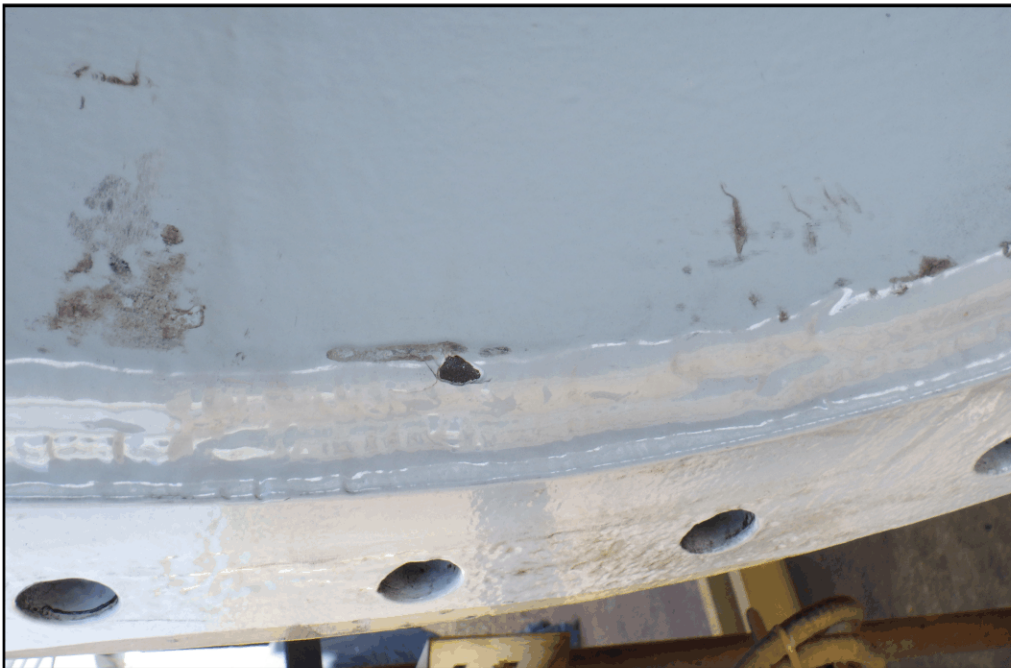
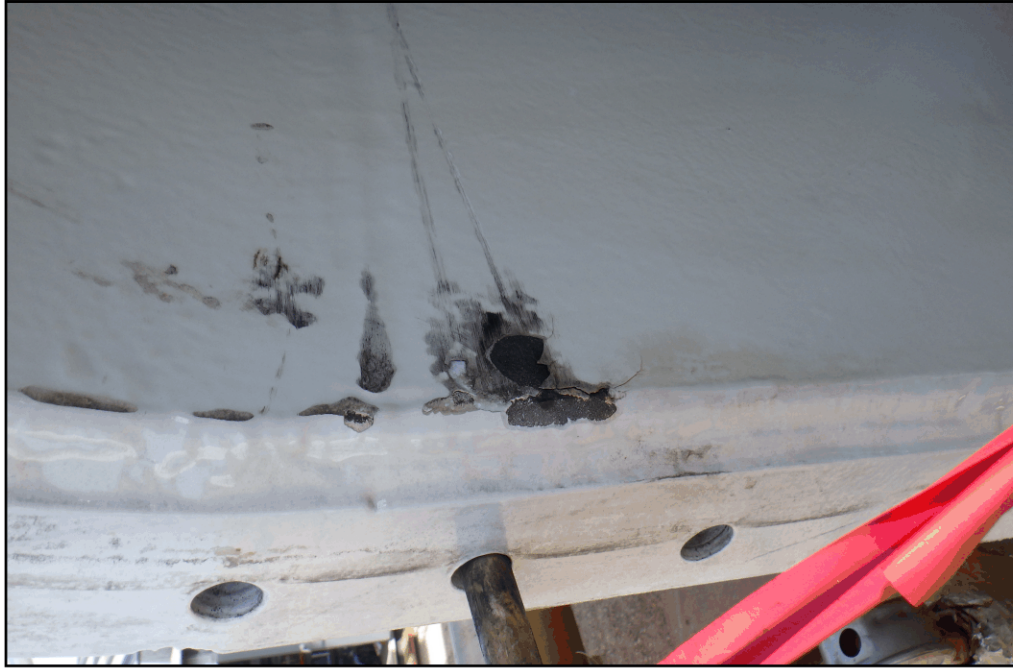
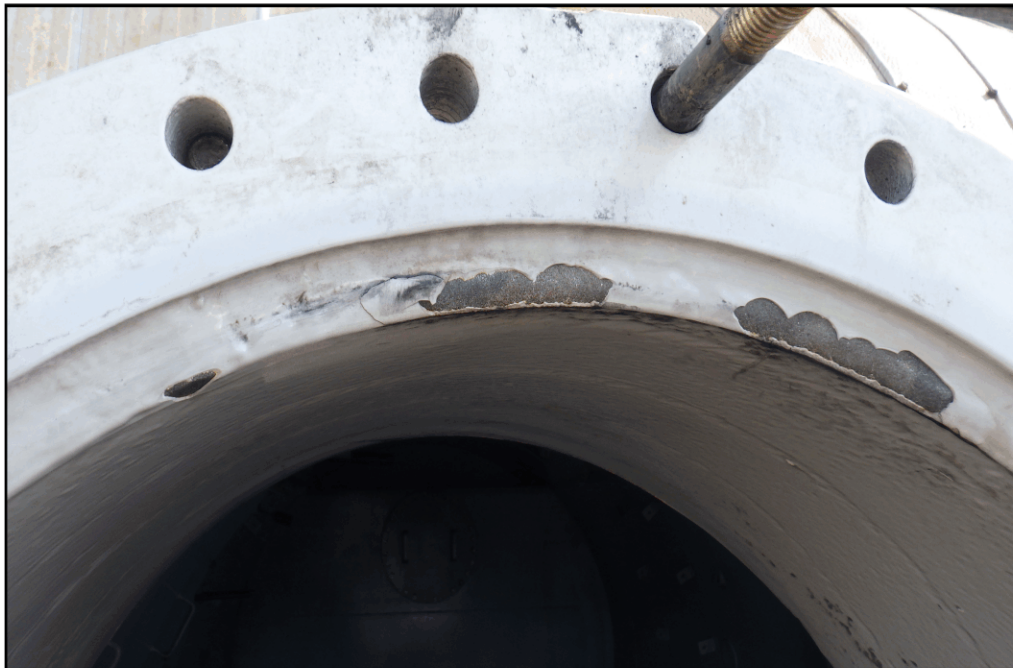
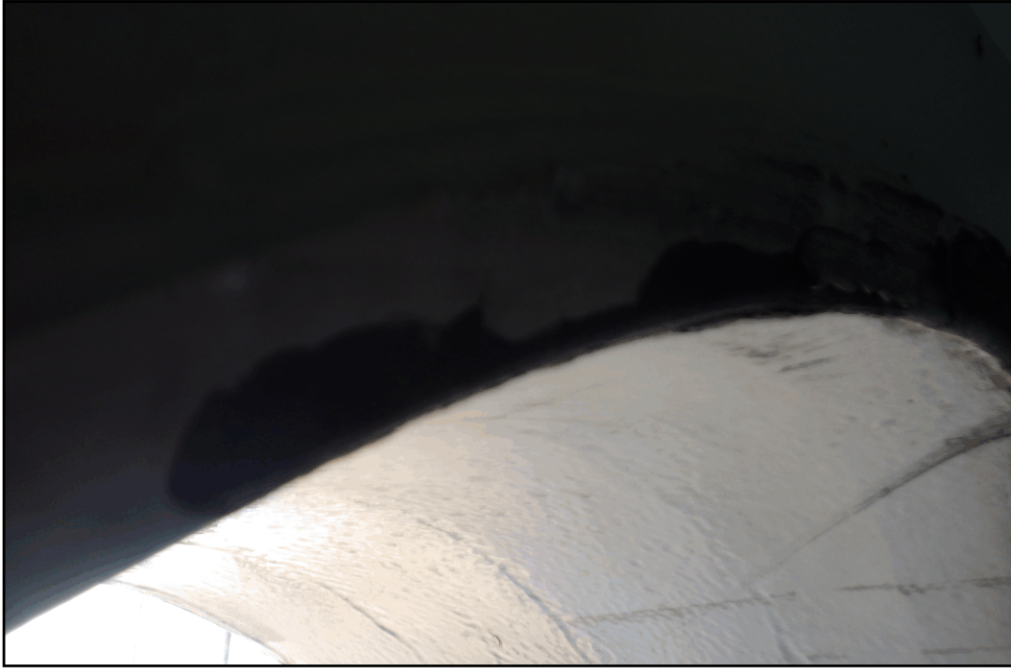
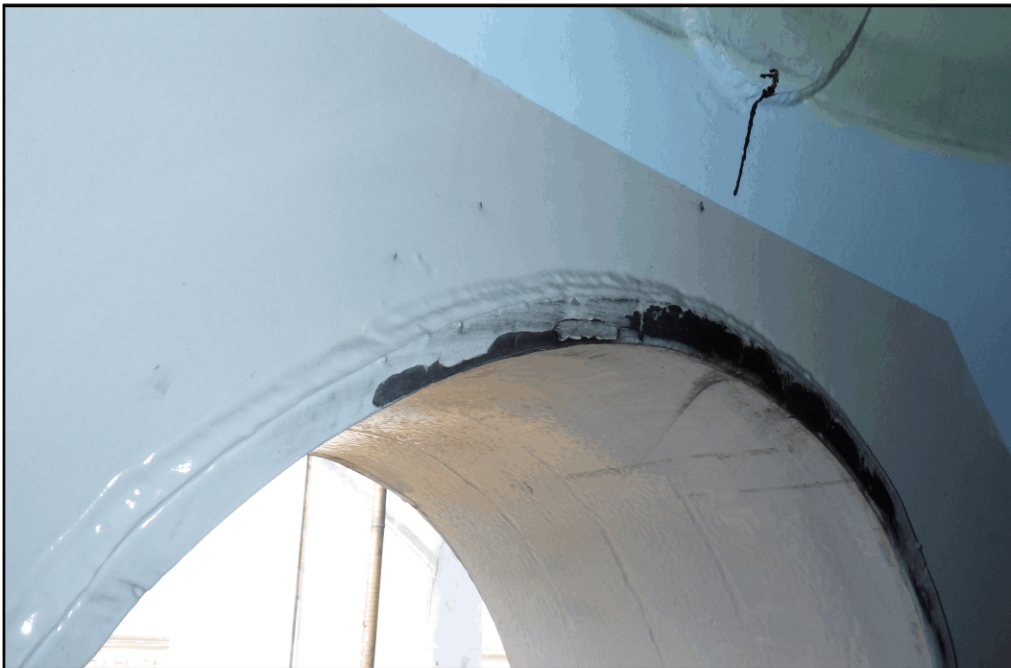
COATING CHIPS

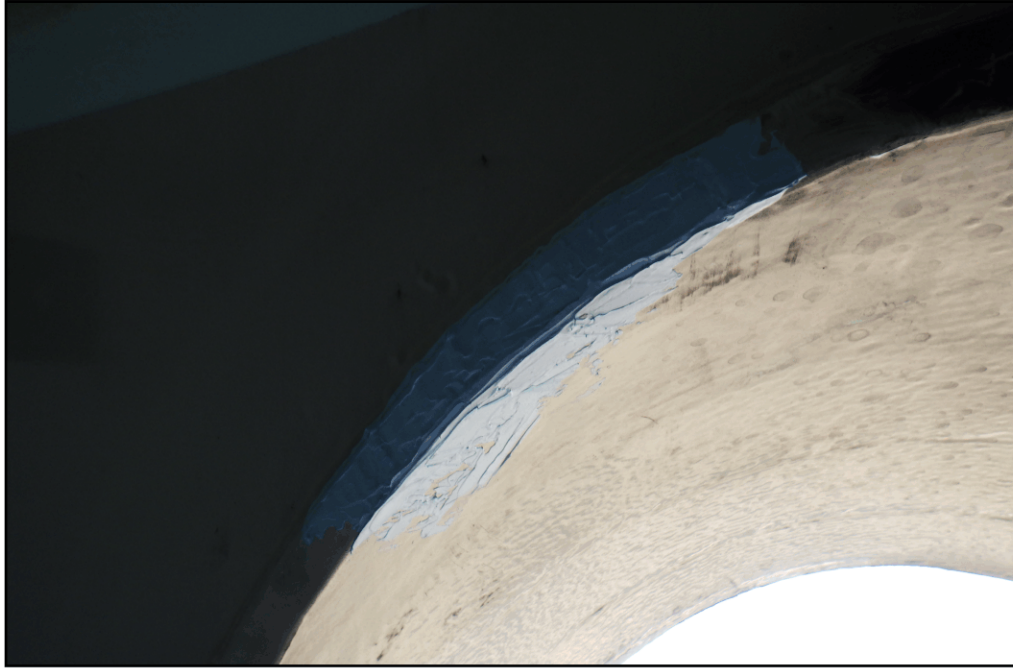
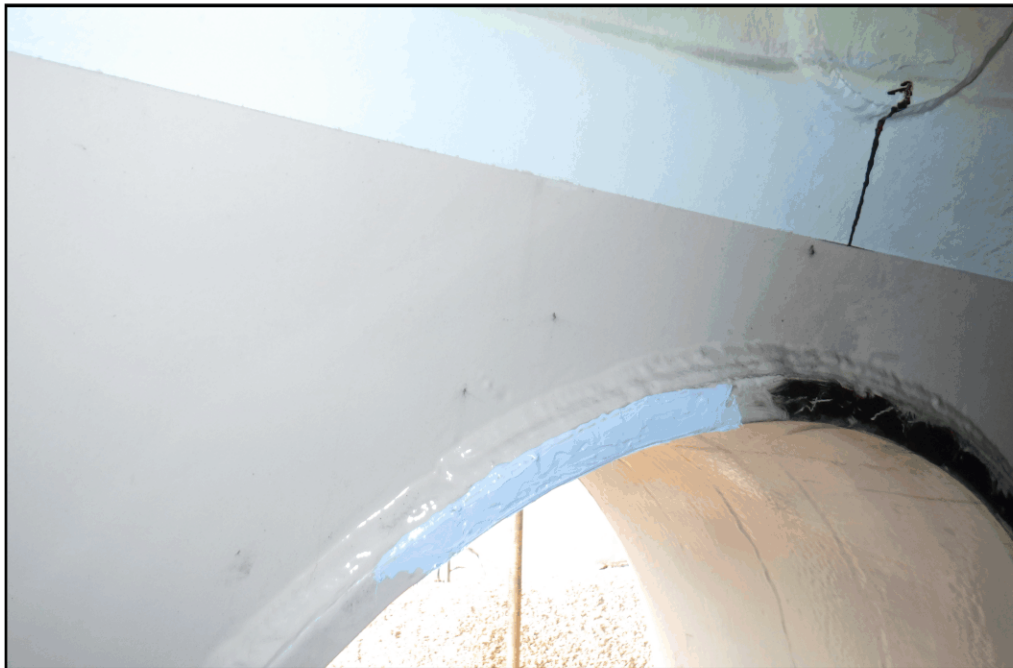
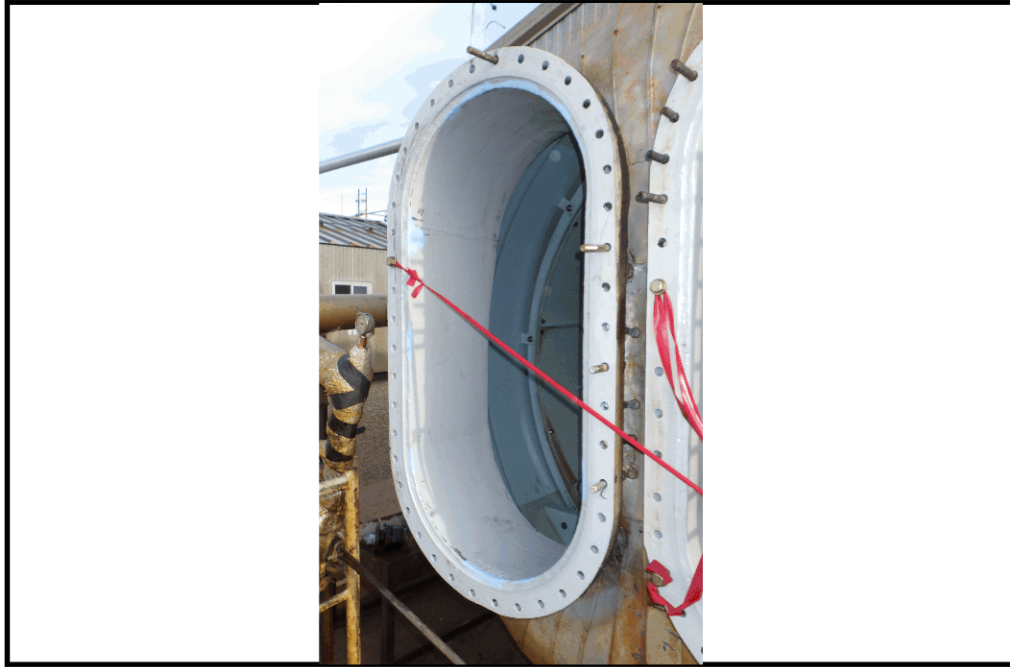
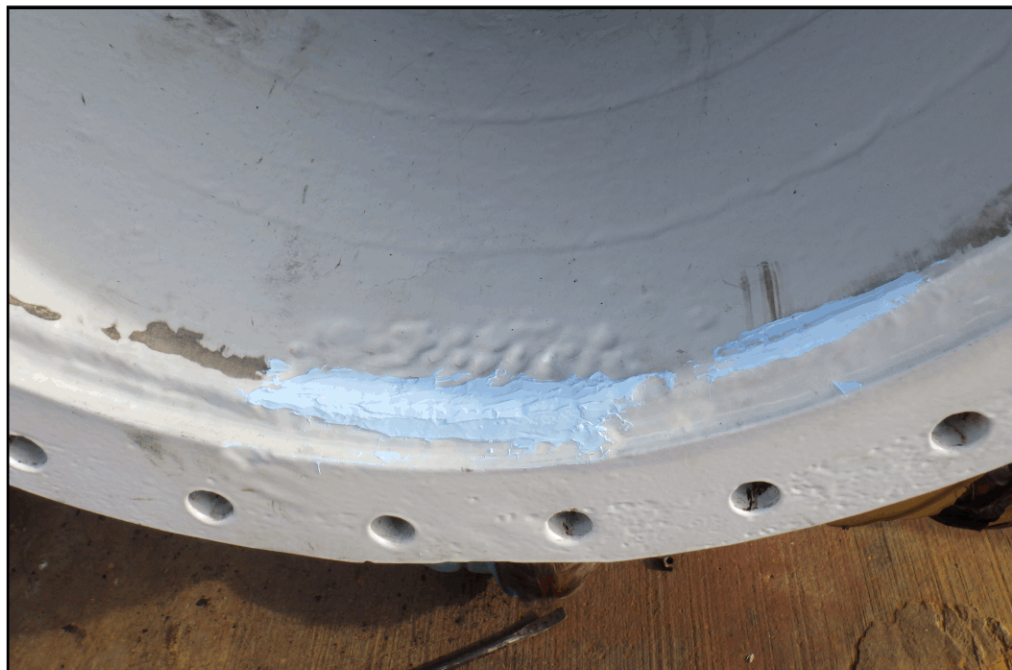
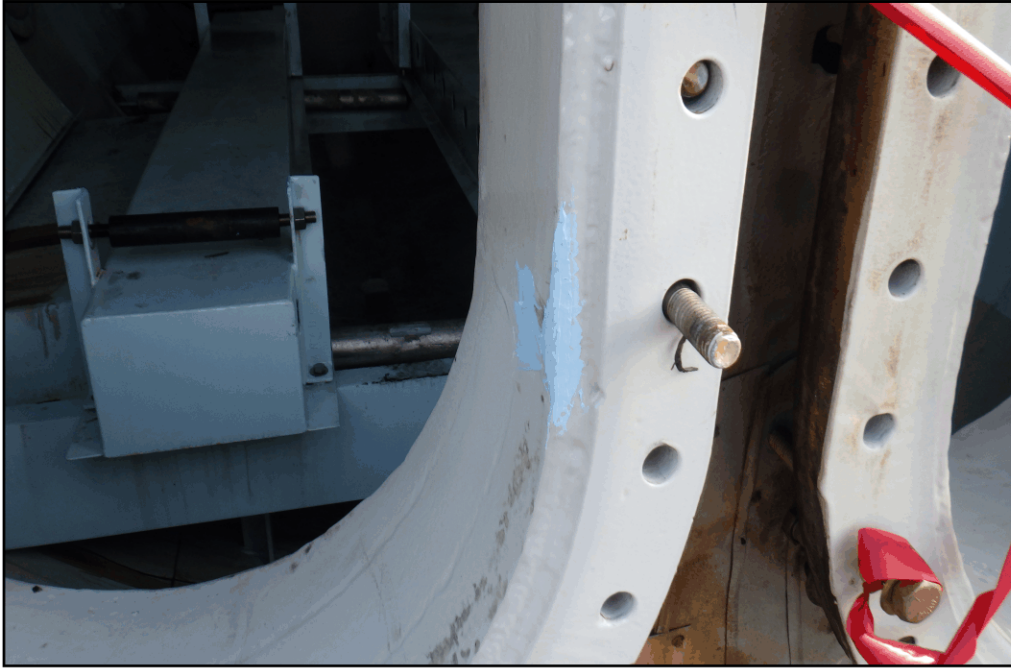
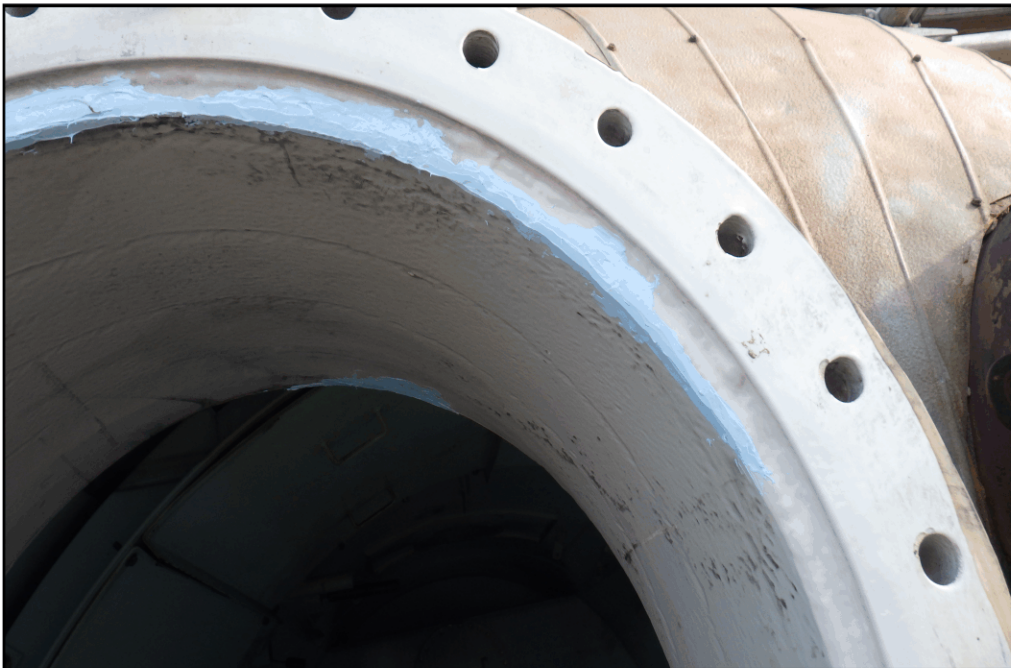
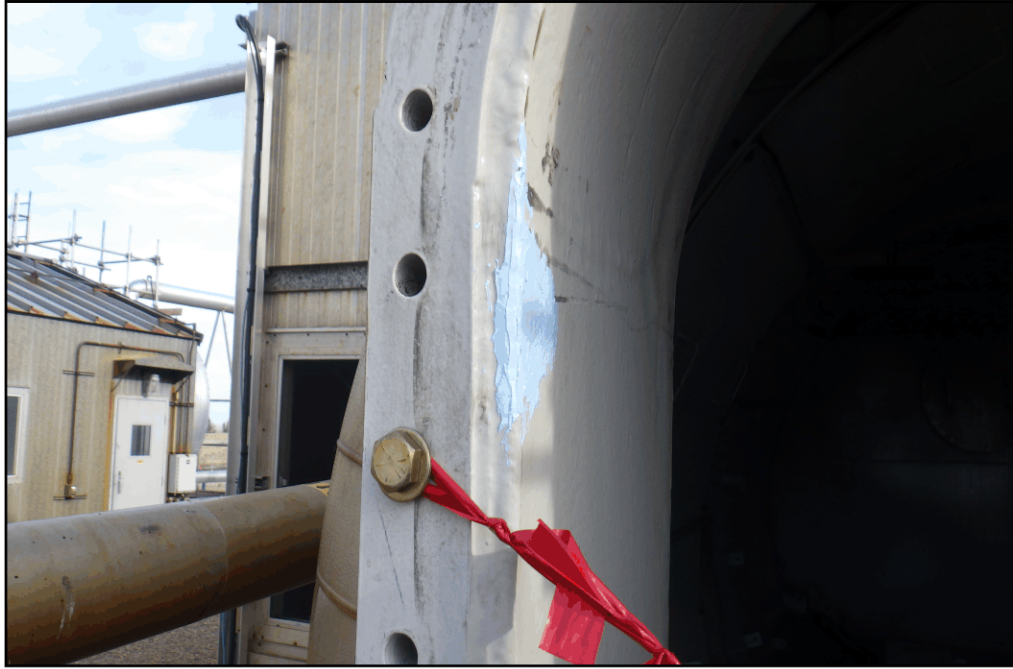
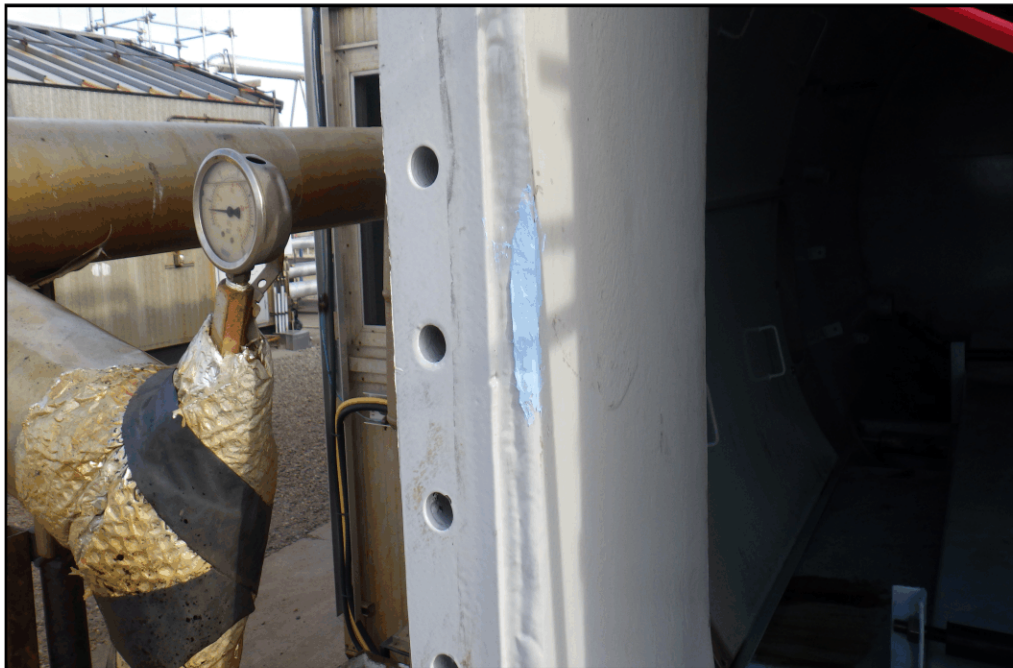
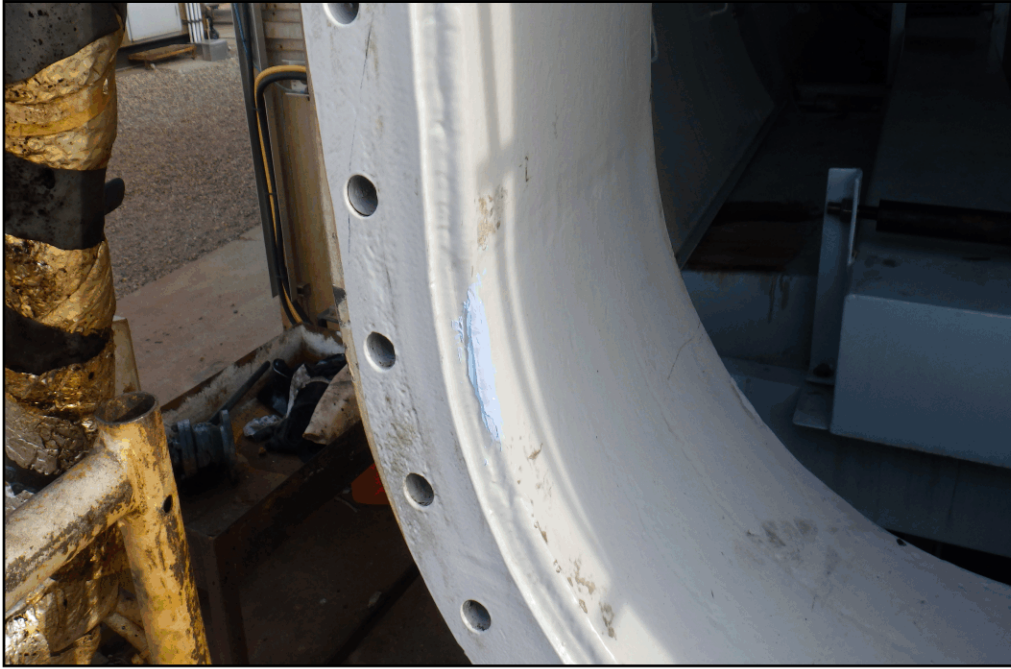
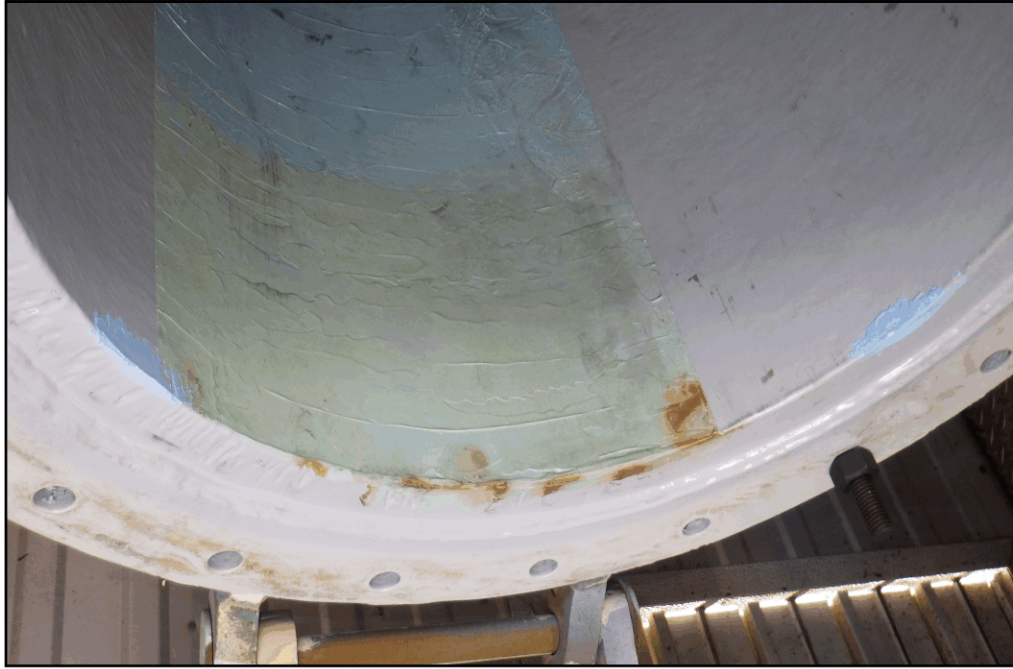
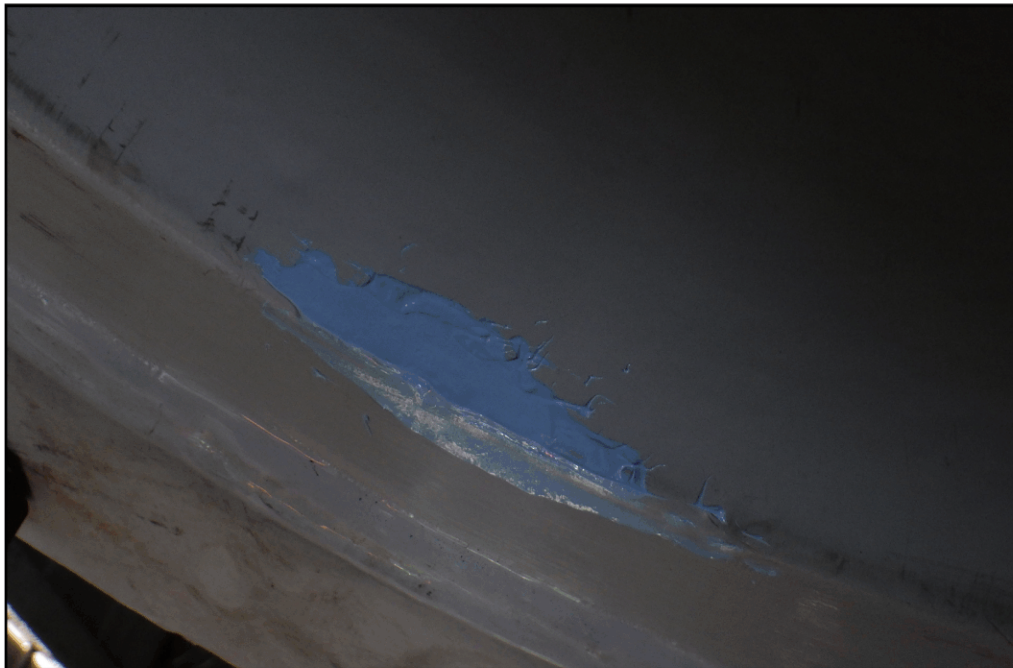
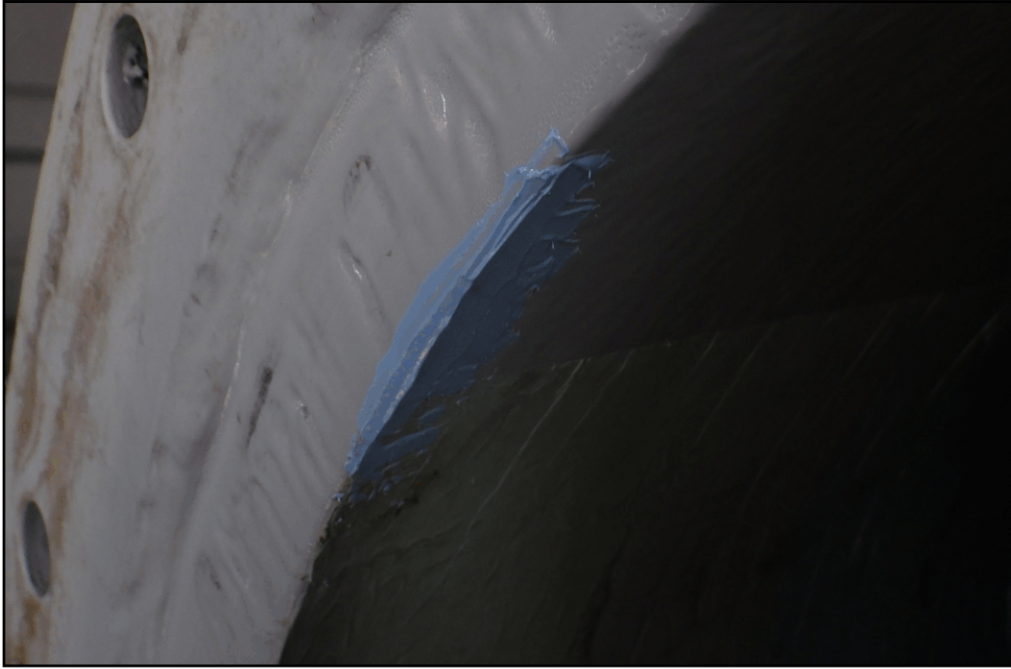
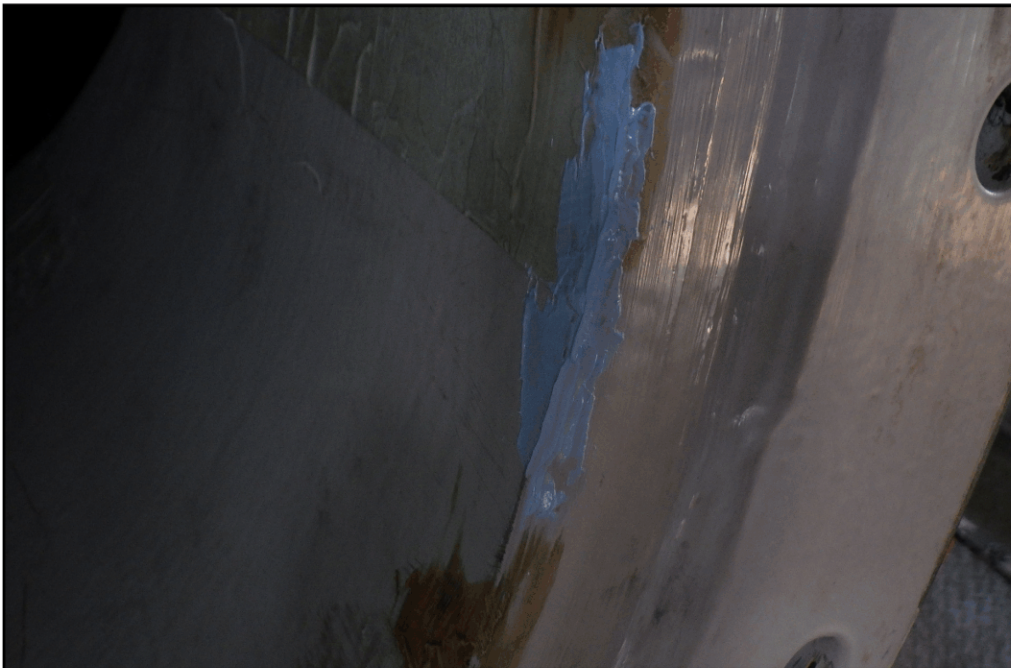
REPAIRED CHIPS

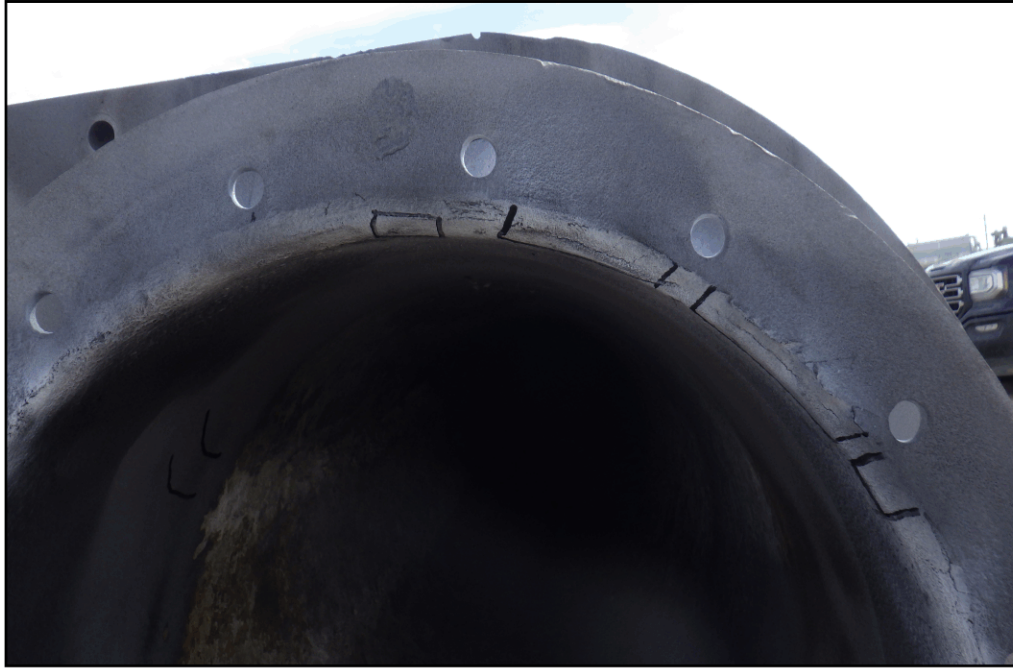
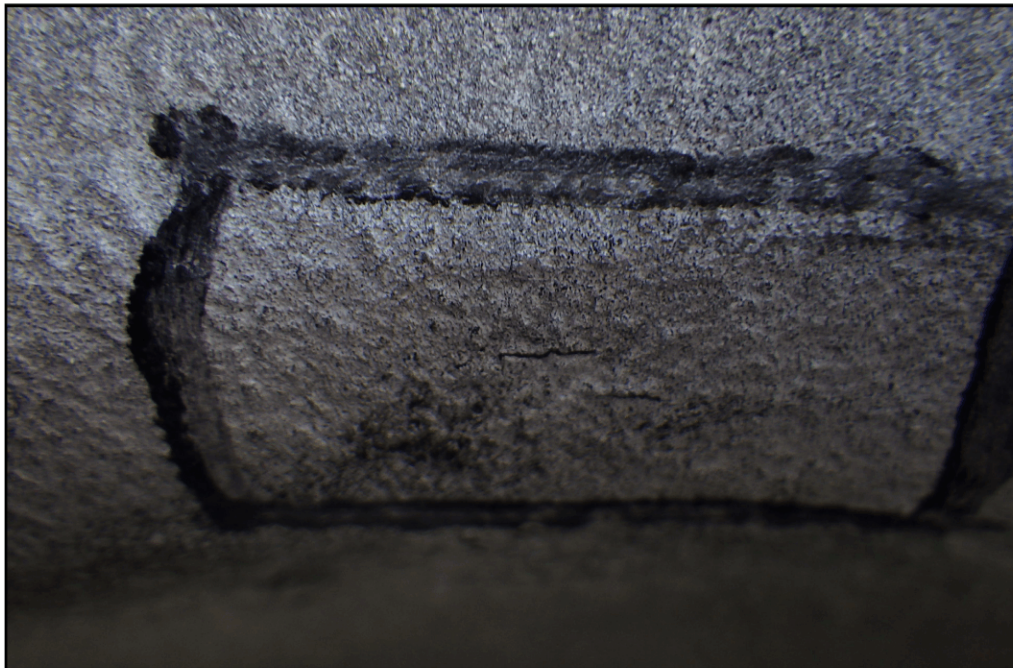
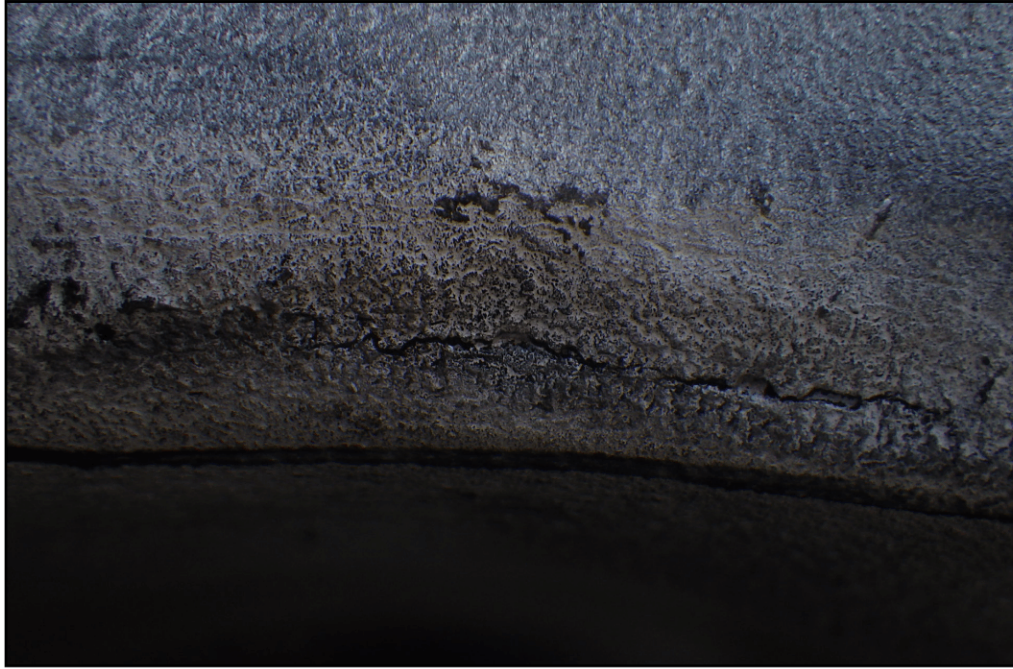
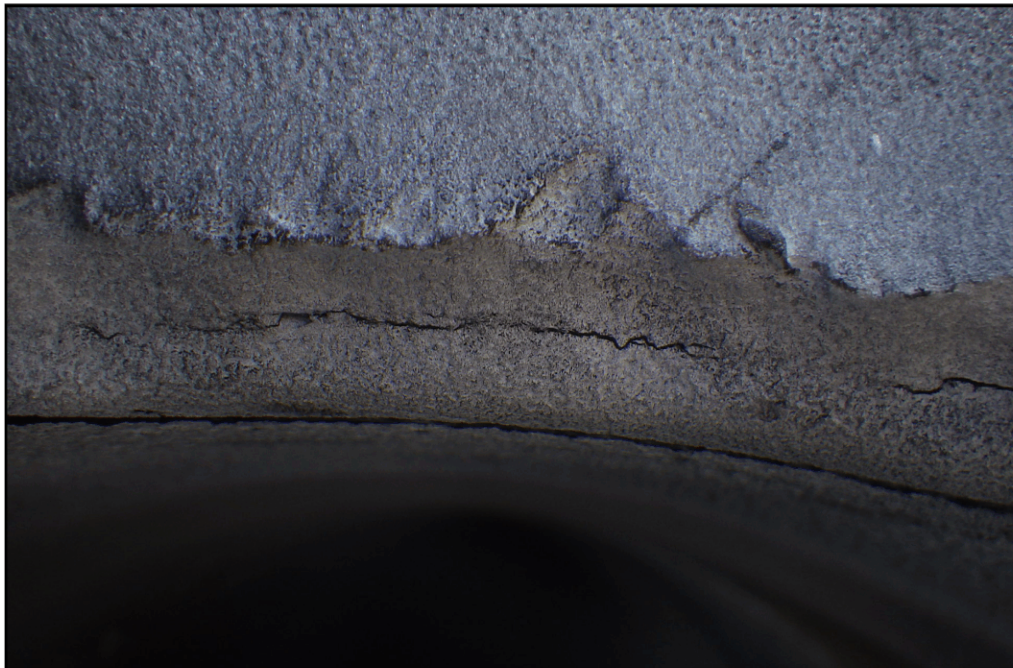
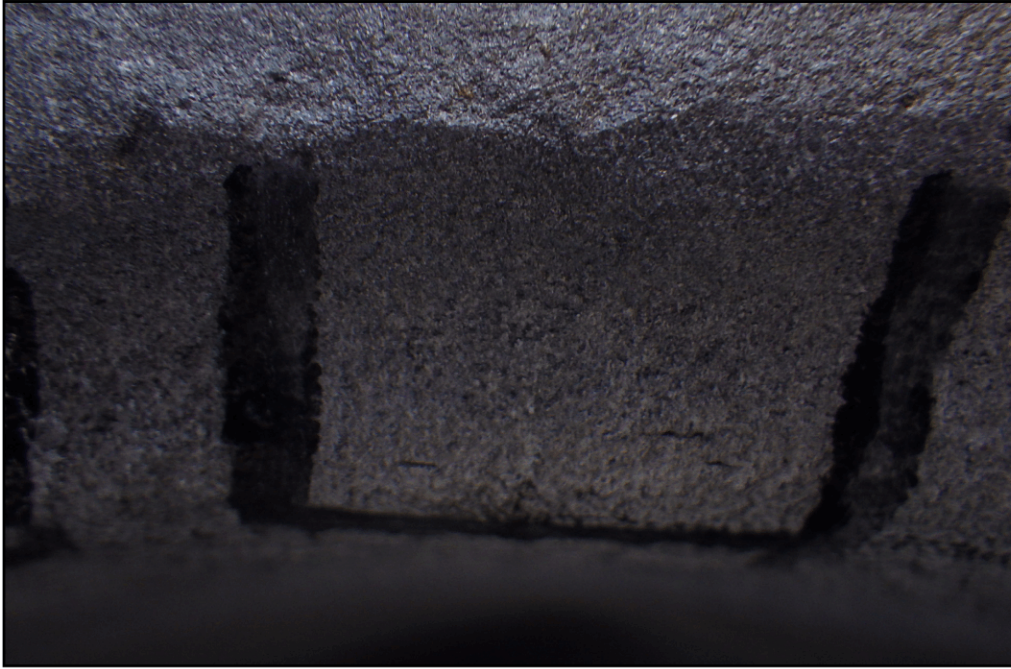
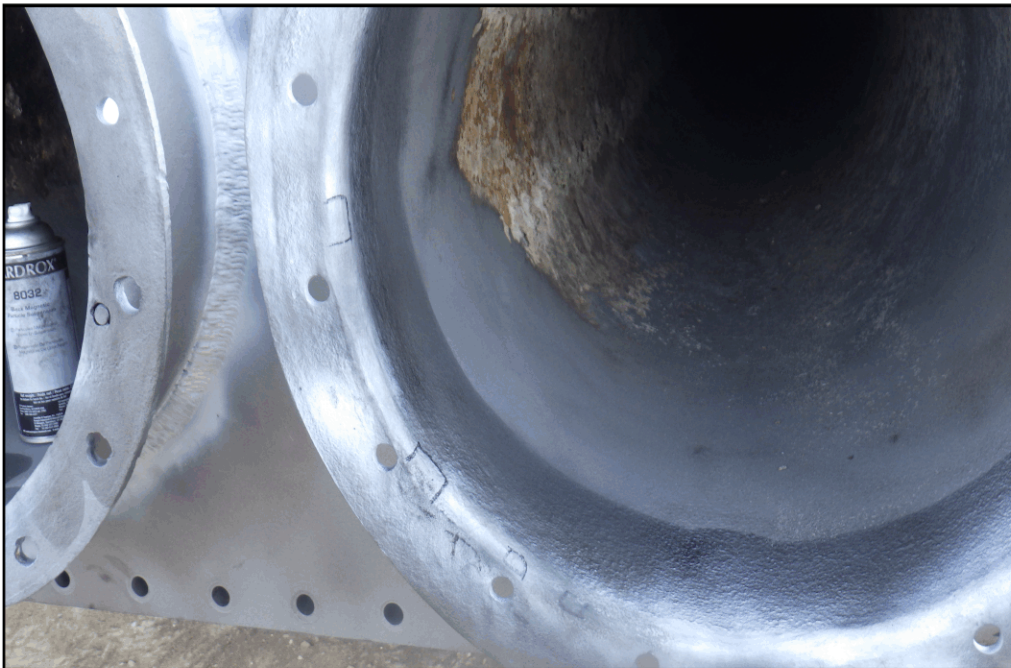
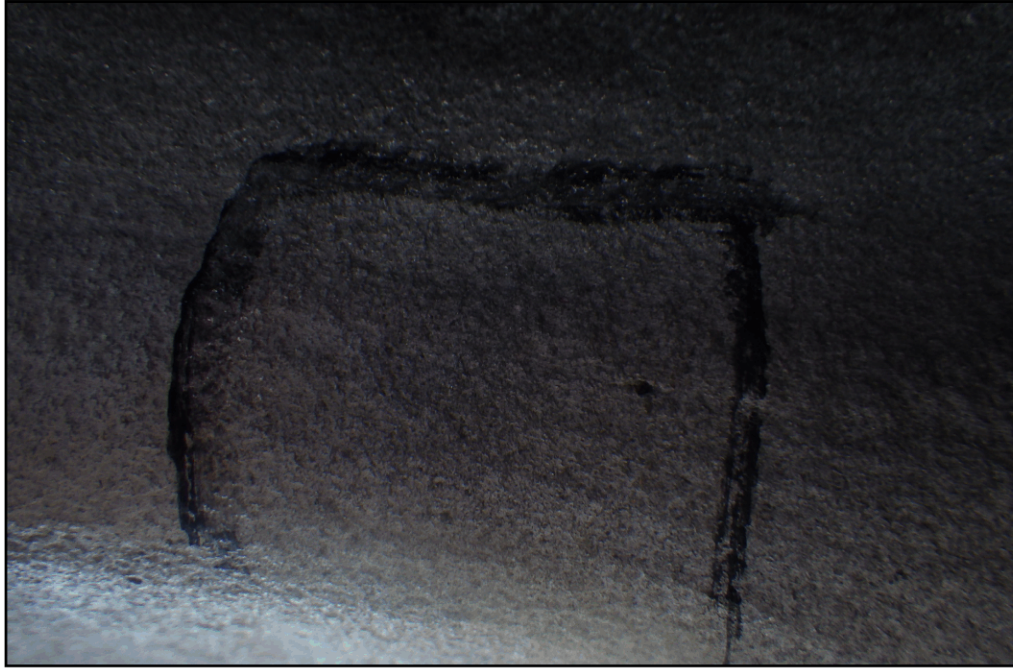
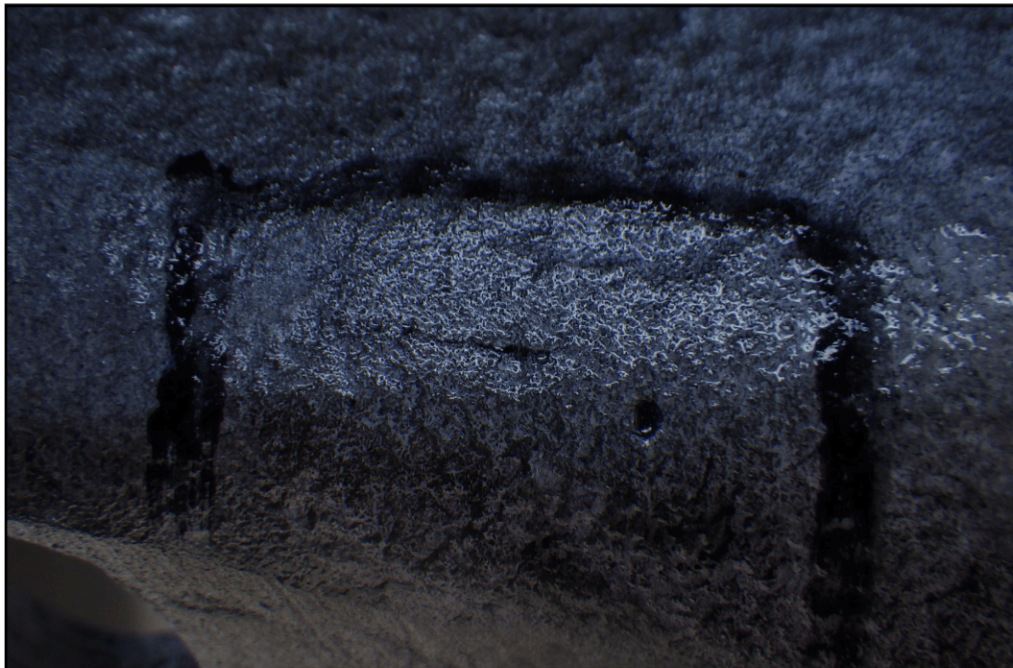
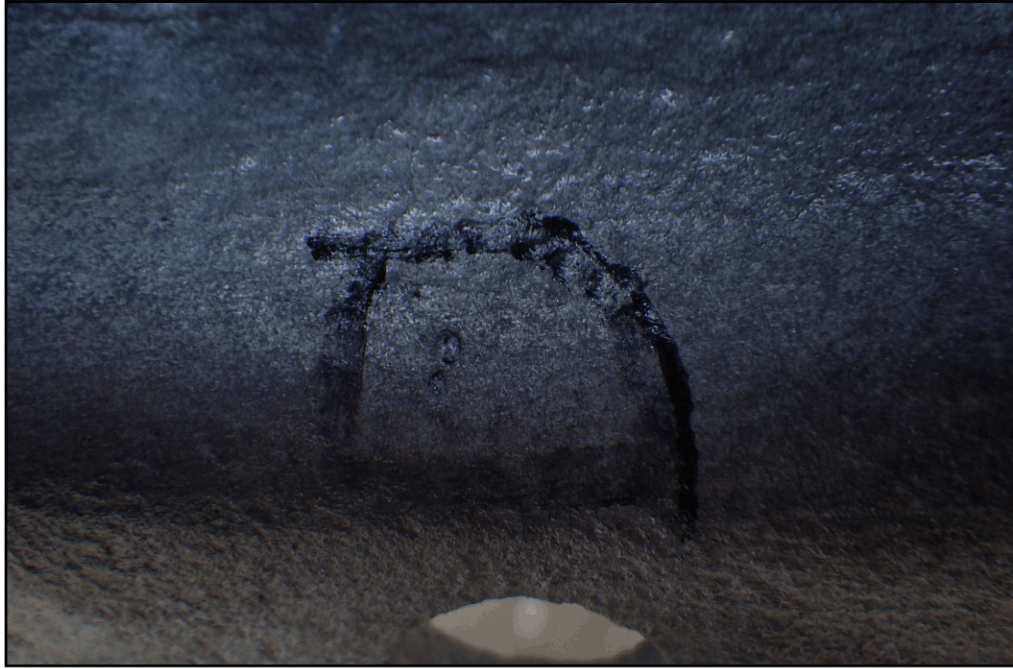
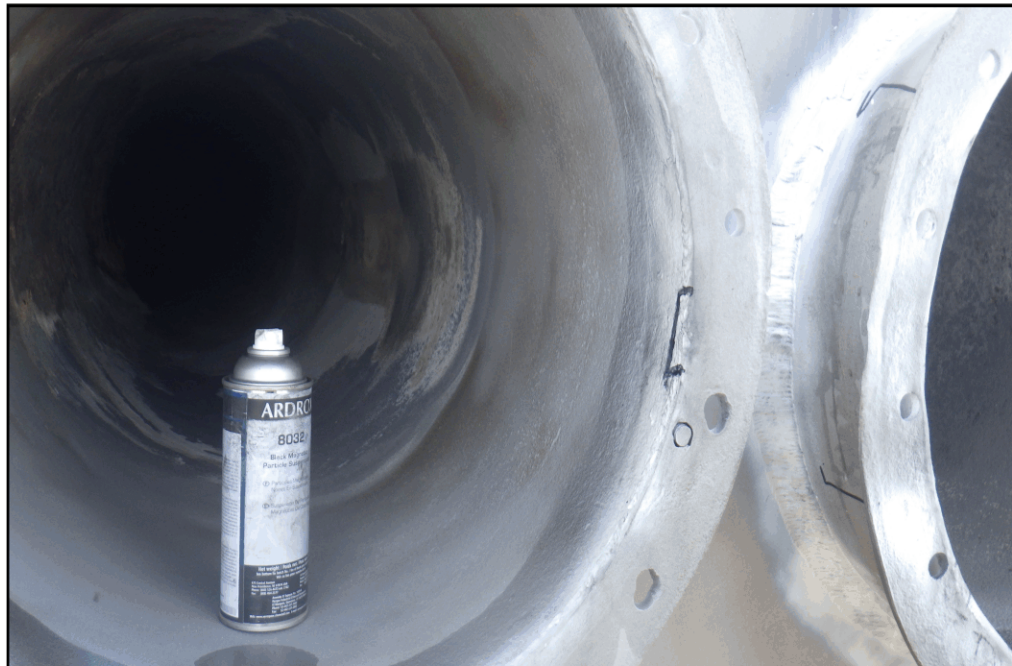
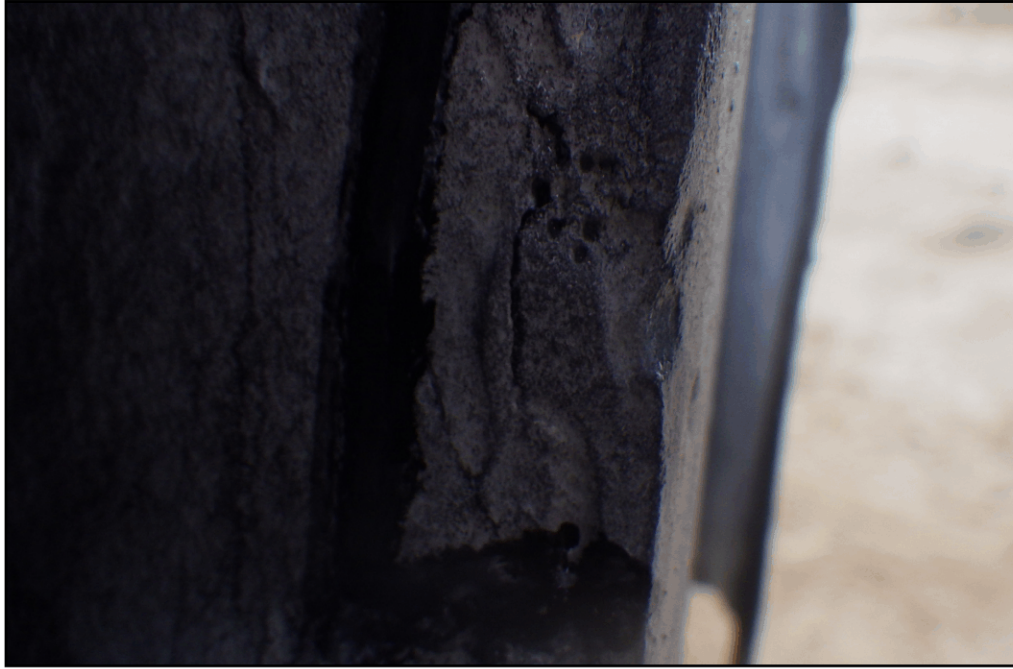
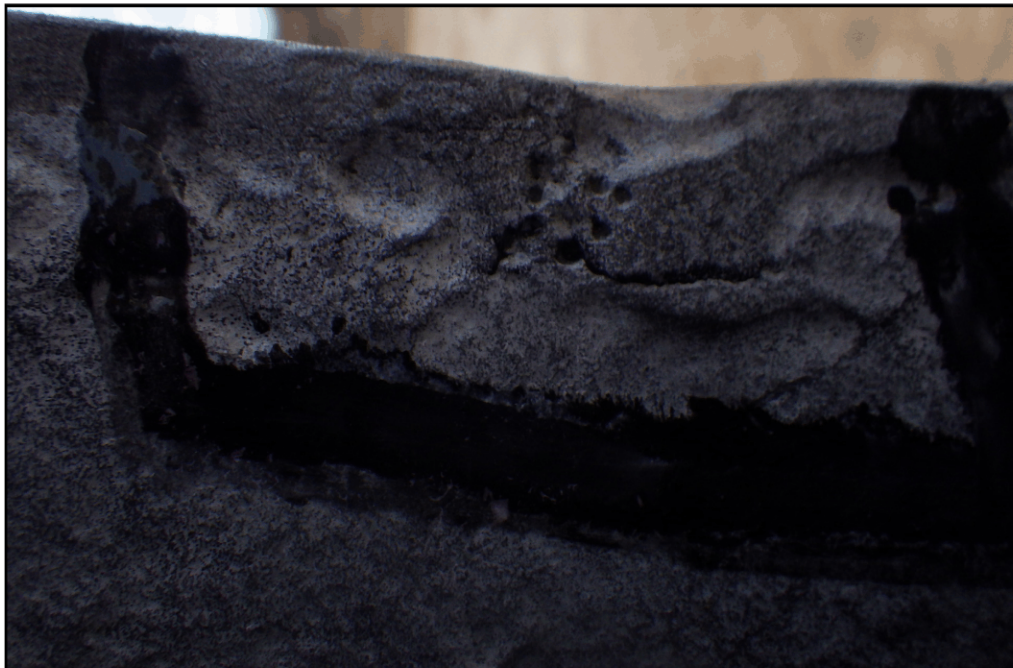
NDE FOUND SEVERAL INDICATIONS ON FLANGE WELDS FOR BURNER AND EXHAUST FLANGES.

<b>SCOPE:</b>	MT INSPECTION OF ALL WELDS.  SURFACE TEMP 25C AEROSOLS: ARDOX 8032 (LOT#65091218)
<b>RESULTS:</b>	MULTIPLE INDICATIONS FOUND. -ONE INDICATION FOUND CAT C WELDS ON BURNER END FLANGE. -7 INDICATIONS FOUND ON INSIDE CAT C WELD ON EXHAUST END FLANGE.  FIRETUBE TO BE REPAIRED.

INDICATIONS

**Comment** FIRETUBE SENT FOR REPAIR.
