Client:  
**CNRL**

## PRESSURE EQUIPMENT DATA REPORT

<b>District:</b>	Medicine Hat		
<b>Facility:</b>	Grand Forks Central		
<b>Location /LSD:</b>	07-32-012-13W4	<b>Operating Province:</b>	Alberta
<b>Equipment Name:</b>	GROUP TREATER		
<b>Equipment Status:</b>	Operating	<b>Orientation:</b>	Horizontal
<b>Skid No.:</b>	GROUP TREATER	<b>Unit:</b>

**VISUAL INSPECTION REPORT**

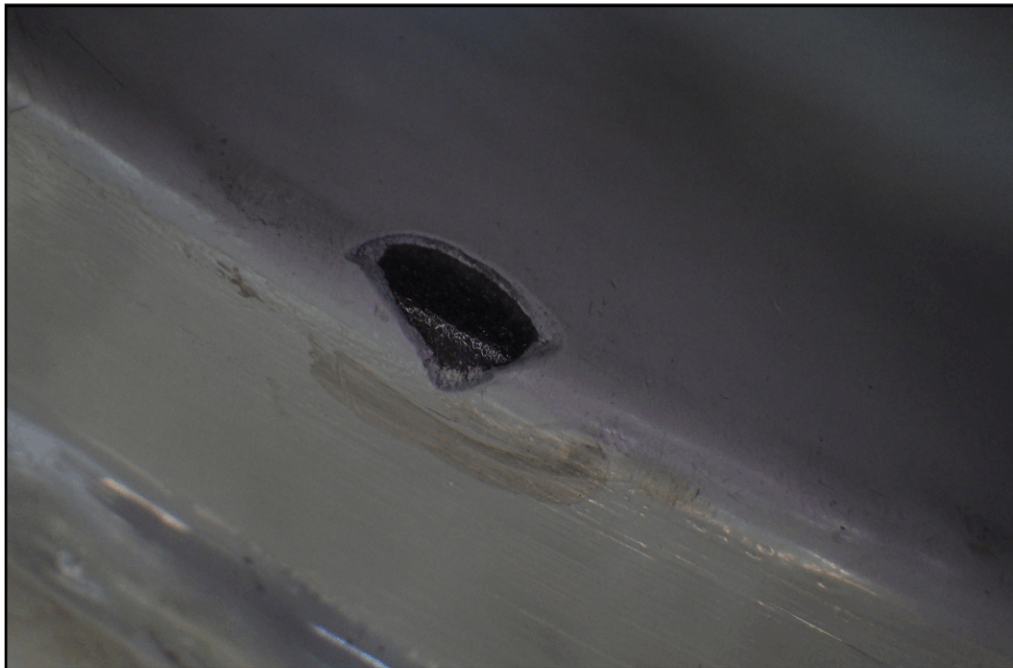
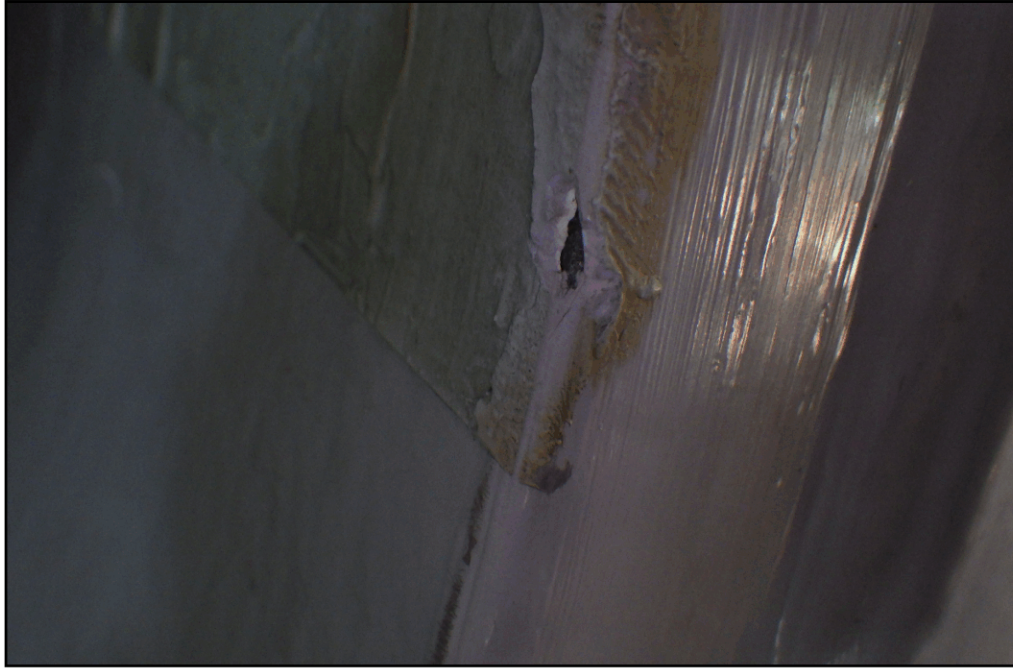
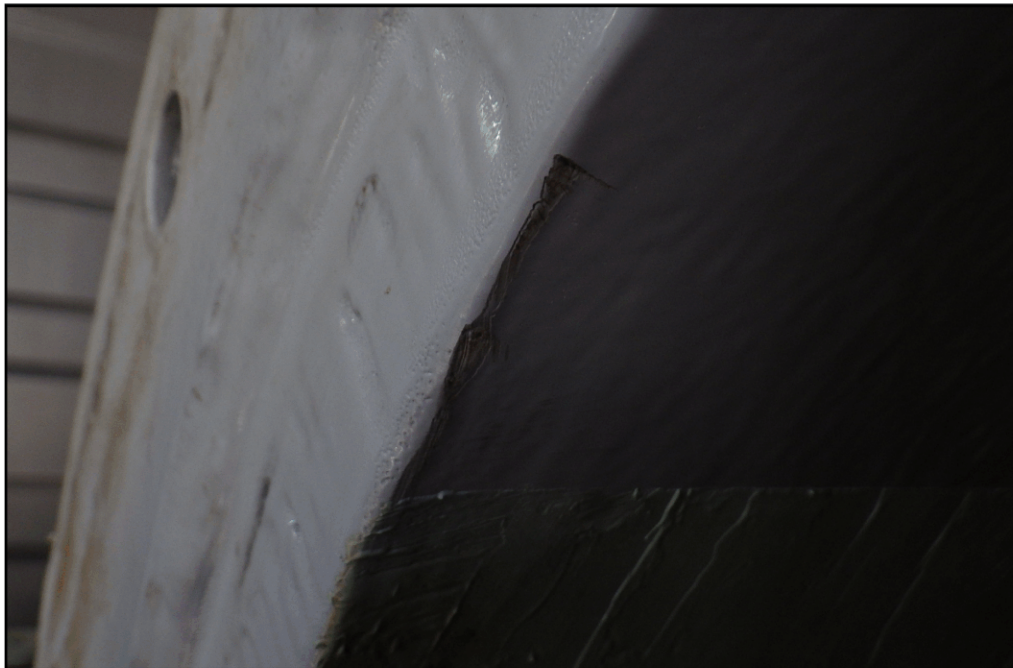
MANWAY COATING CHIPS

VESSEL FIT FOR SERVICE.  
COATING CHIPS REPAIRED BY INSPECTOR.  
FIRETUBE SENT FOR REPAIR.

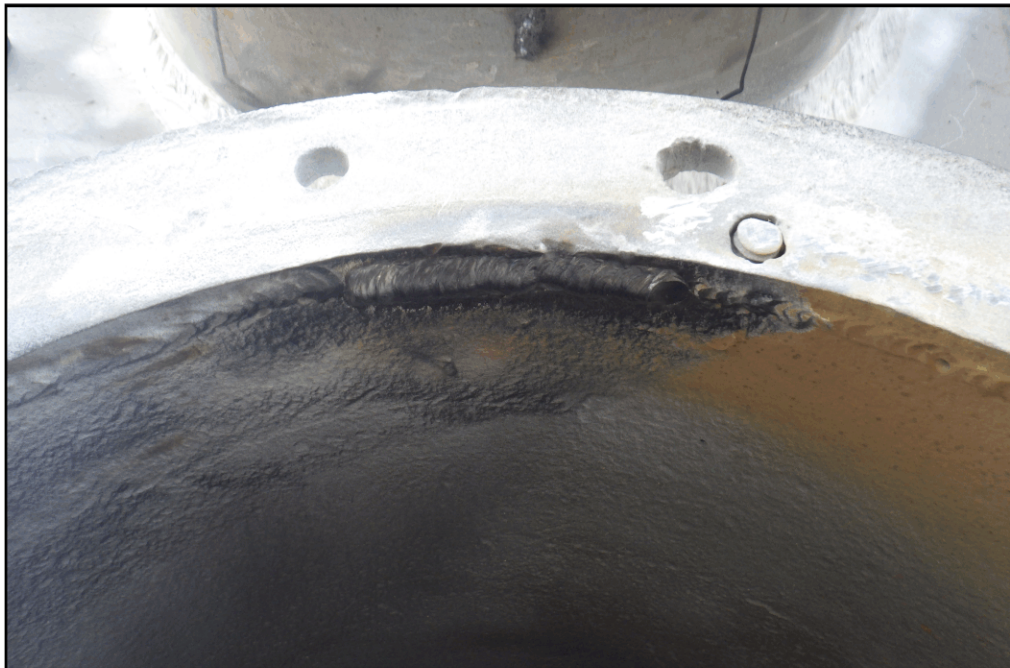
BURNER END FLANGE FACE SHOWING SIGNIFICANT THINNING AT 12 O'CLOCK POSITION. WARPE

REPAIRED BURNER FLANGE

MAY 16: FLANGE REPAIRED.

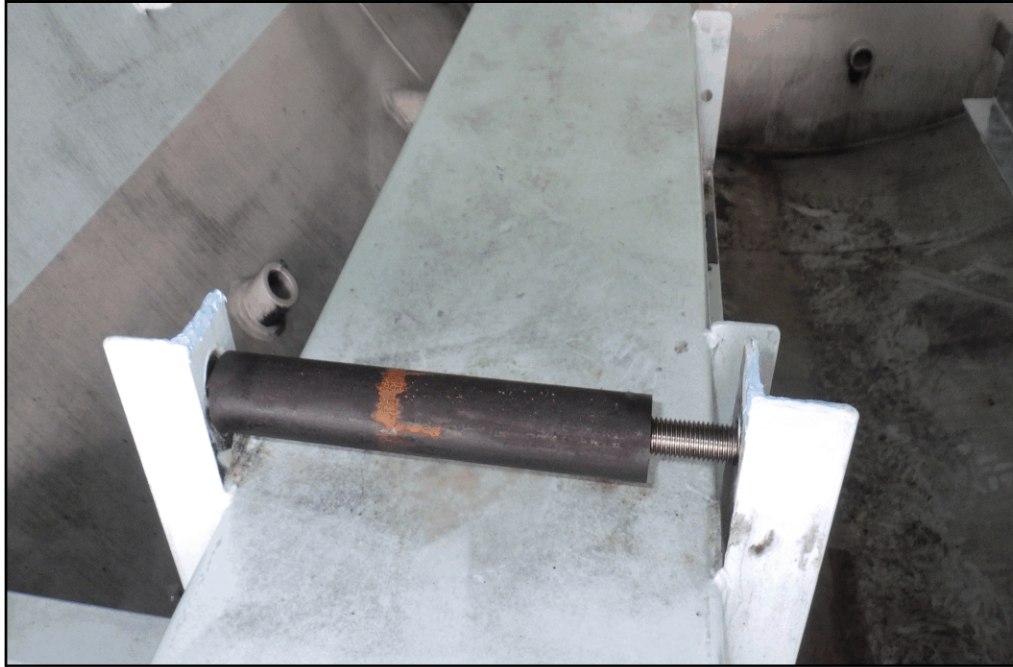
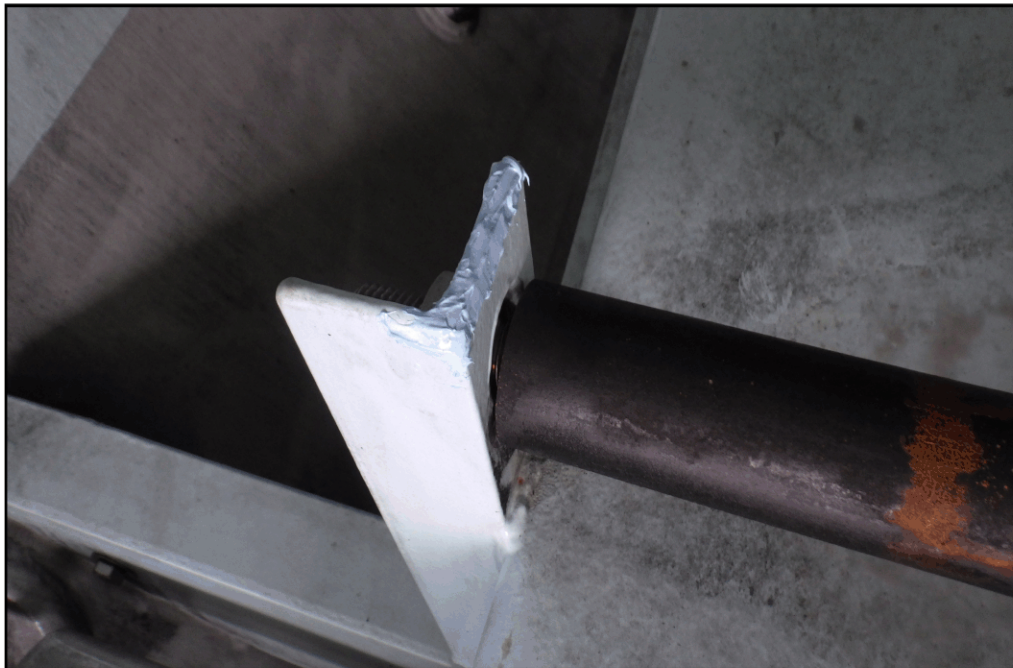
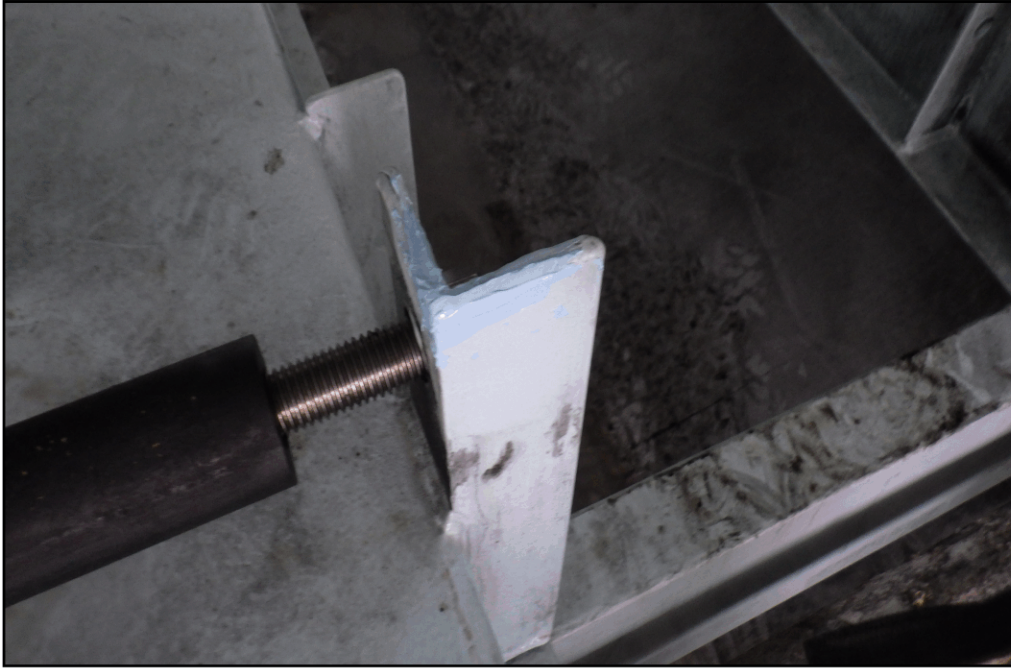
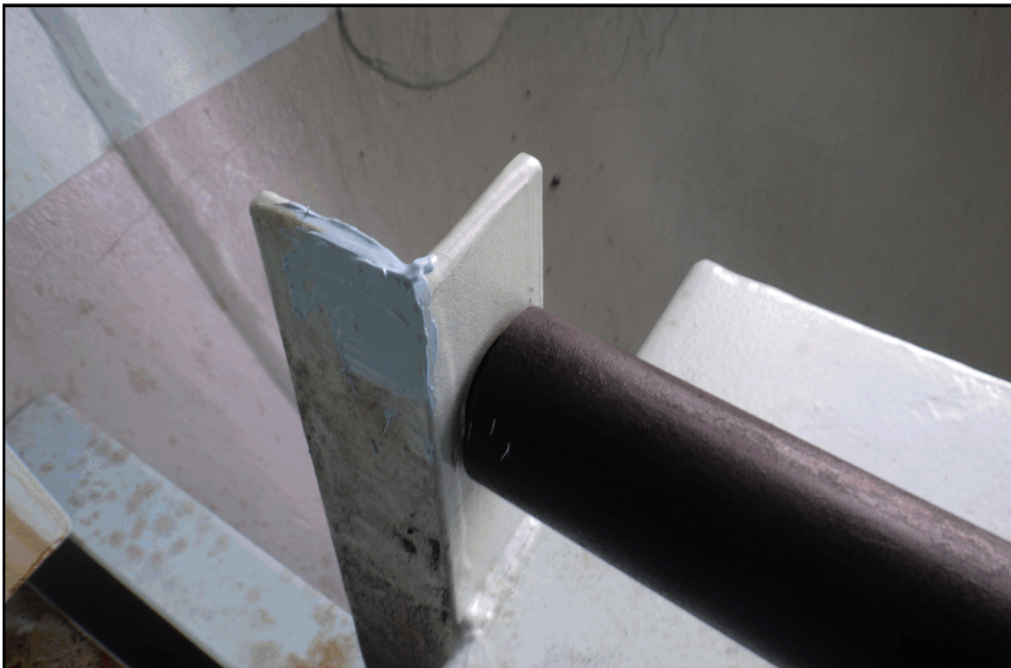
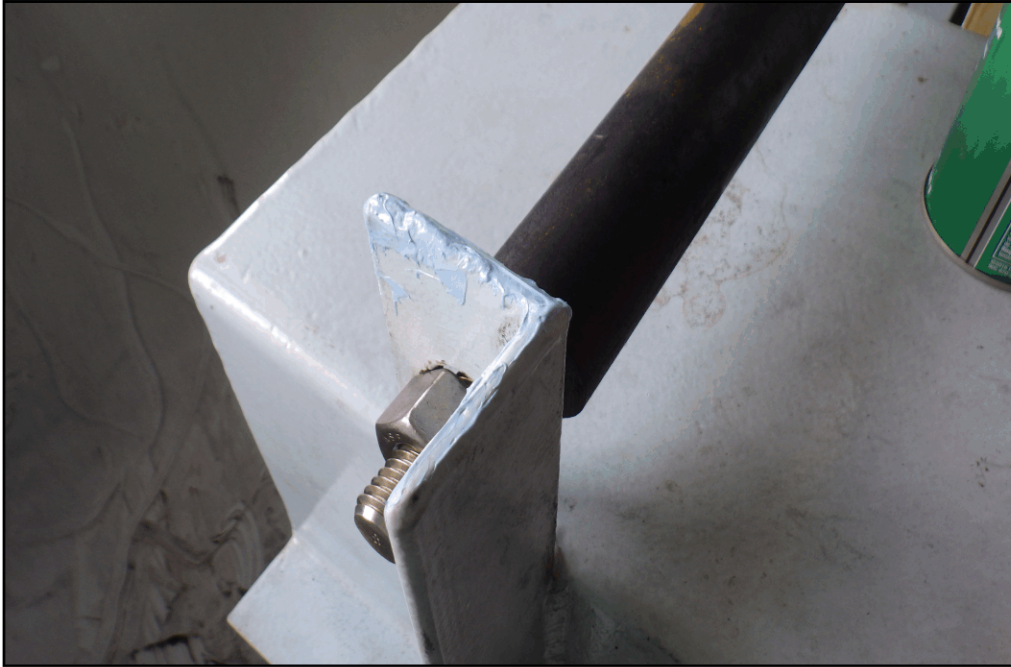
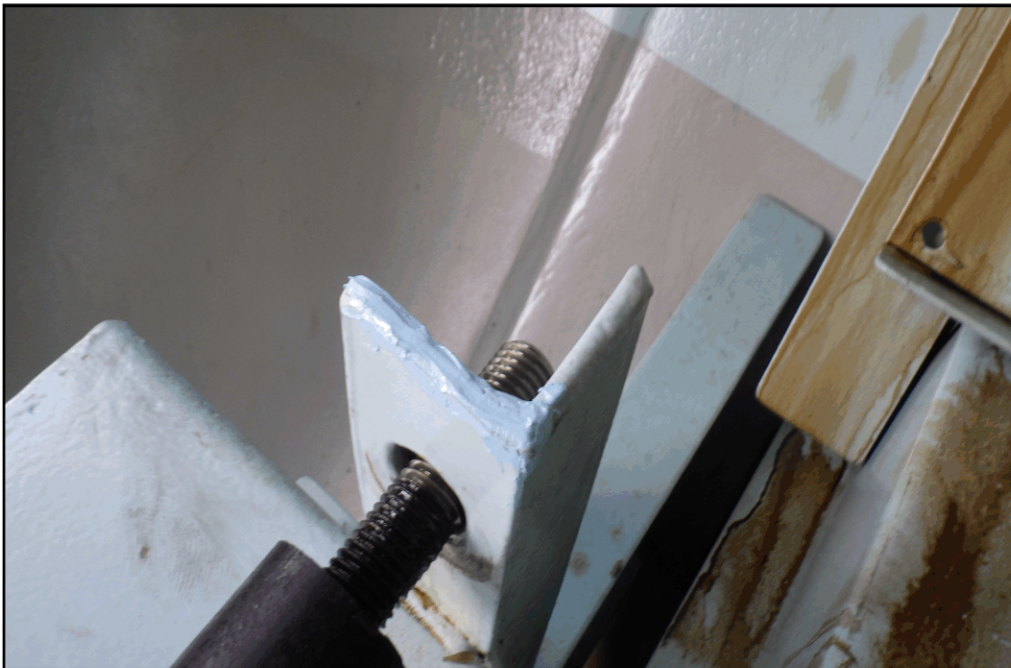
REPAIRED CHIPS ON FIRE TUBE SUPPORTS

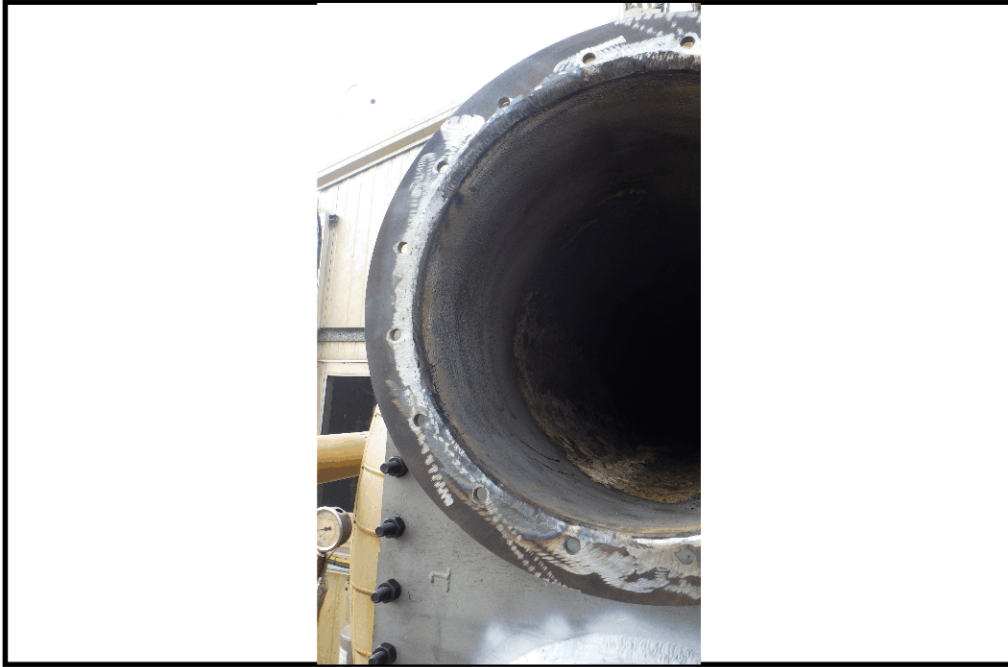
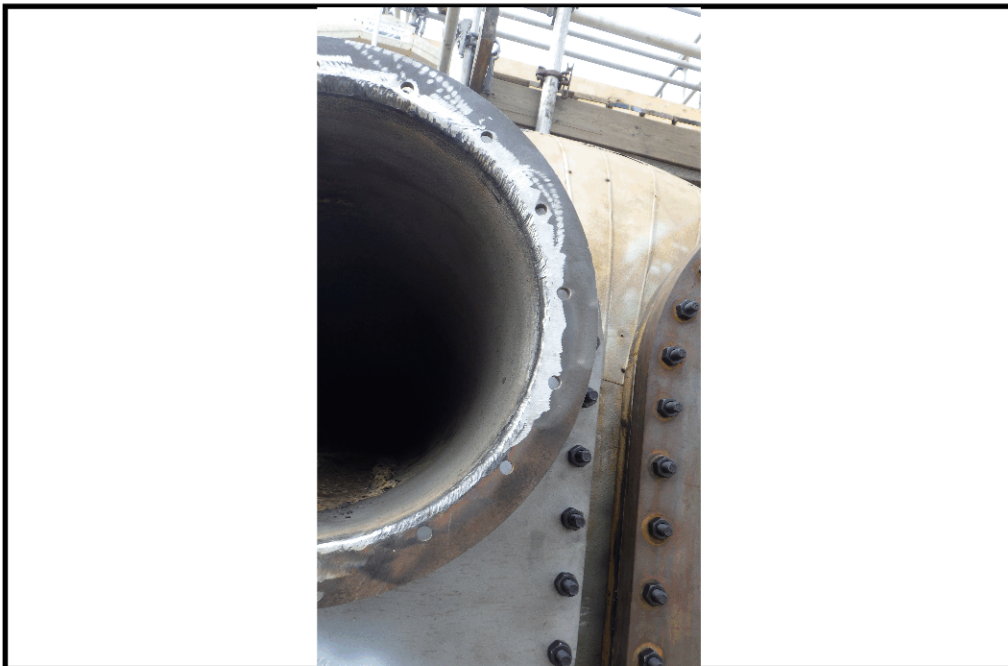
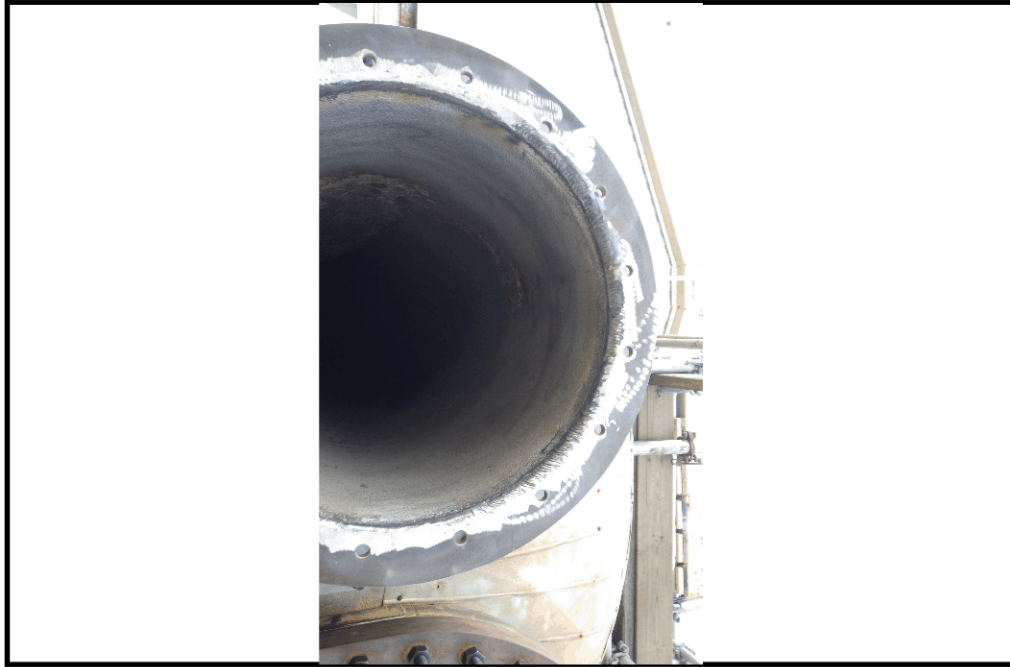
<b>SCOPE:</b>	MT INSPECTION OF ALL WELDS.  SURFACE TEMP 25C AEROSOLS: ARDOX 8032 (LOT#65091218)
<b>RESULTS:</b>	MULTIPLE INDICATIONS FOUND. -ONE INDICATION FOUND CAT C WELDS ON BURNER END FLANGE. -7 INDICATIONS FOUND ON INSIDE CAT C WELD ON EXHAUST END FLANGE.  FIRETUBE TO BE REPAIRED.

REPAIRED EXHAUST FLANGE

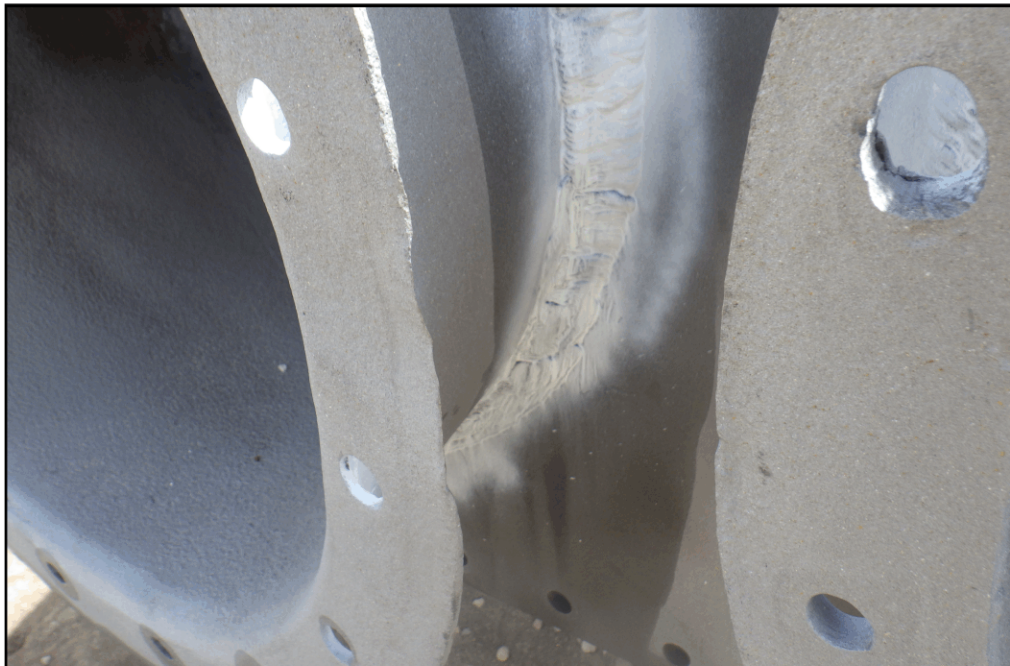
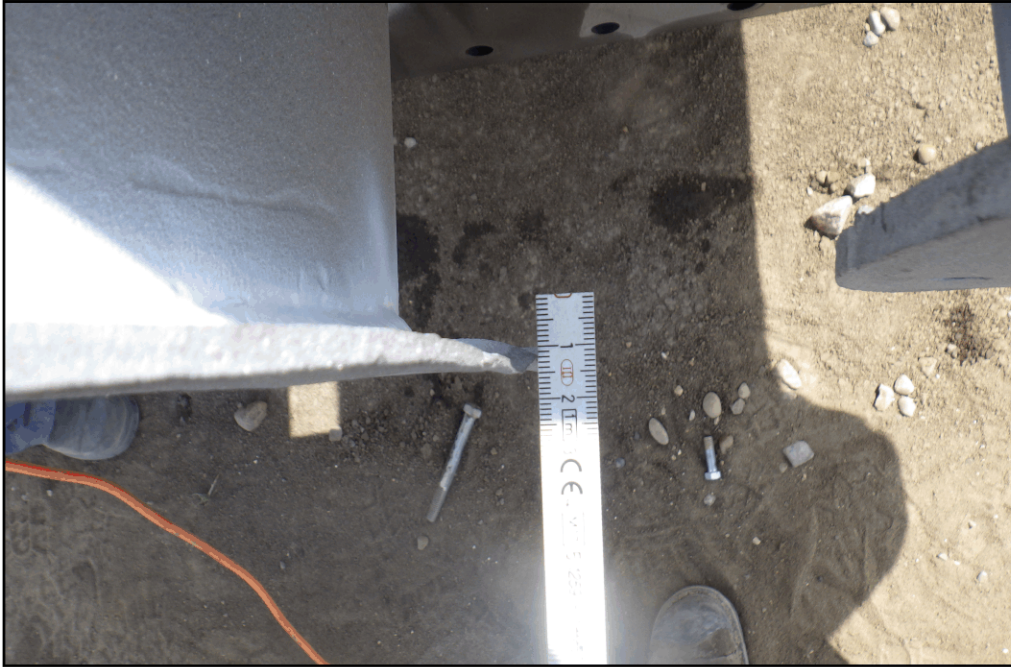
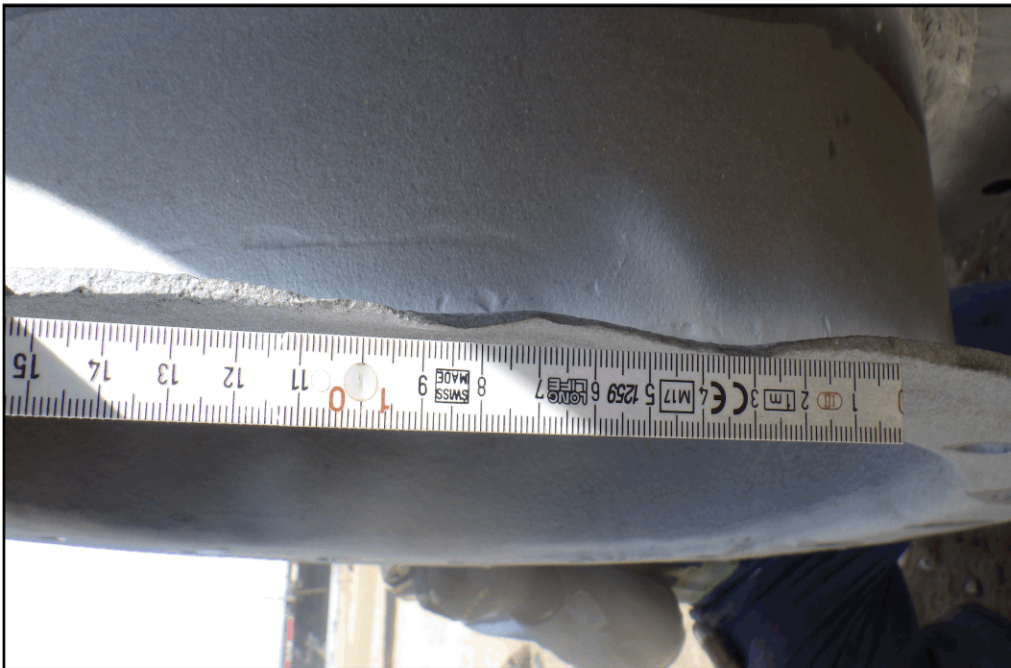
FLANGE THINNING

**Comment** FIRETUBE SENT FOR REPAIR.
