**Canadian Natural Resources Limited
GENERAL PRESSURE VESSEL INFORMATION**

Job # 105.01649

District: Fort St John, B.C.	Skid No.
Facility: Pee Jay Unit #1	Location (LSD): d-39-E / 94-A-16
Vessel Name Equipment Number: Instrument Air Receiver	
Orientation: Vertical	
Status: In Service	Regulatory Inspection

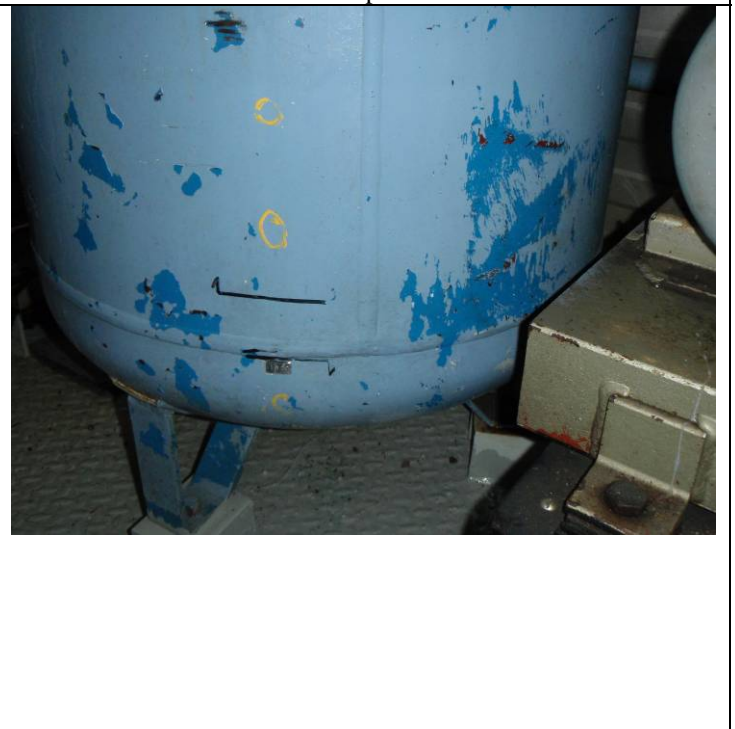
Top layer of paint peeling
