**A0510882 and A0510883 Raw Water Filtration Vessel**

**Coating Inspection**

Coating Inspection  
2 Raw Water Filtration Vessels  
North Brintnell  
11-26-82-21 W~~A~~ M.  
August 16, 2004.

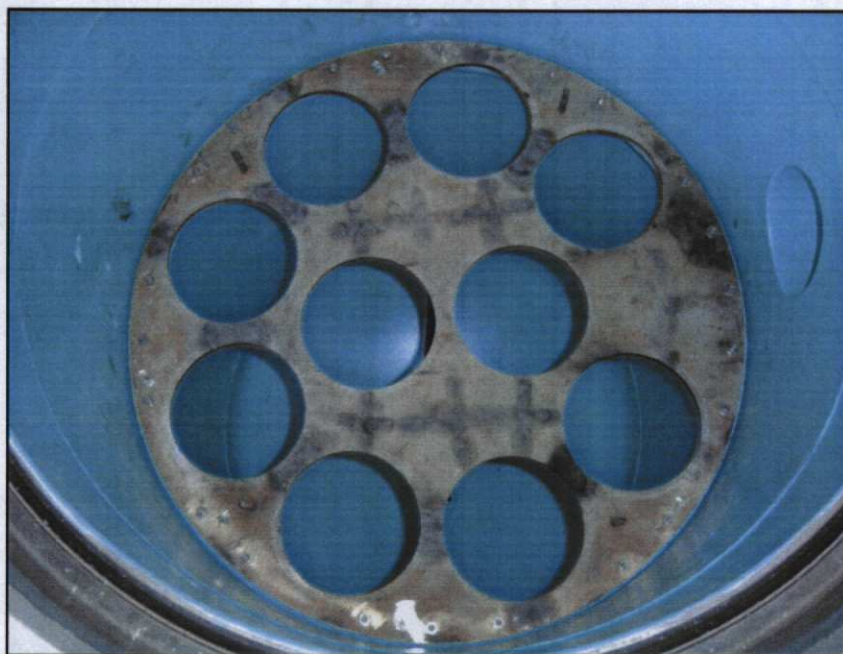
- Vessel 3497-1, which has not been in service to date, had a few chips in the coating caused by the installation of the metal ring, which holds the 10 filters, see Figure 1.
- Coating appearance in Vessel 3497-1 was uniform and consistent with a well-applied coating in that there were no visible defects.
- Charter inspector using the point of a sharp knife was able to pry, with very little effort, the finish coat from the first coat. The lack of bond between first and second coats appears to be an identical condition in both vessels.
- The first coat is well bonded to the substrate.
- Both vessels appear to be in identical condition. The chips were only in the finish coat (color green) and cleanly released from the (light grey) first coat. The backside of the released chips showed no primer attached.

FIGURE 1. VESSEL 3491-1: SHOWS BAG HOLDER THAT CHIPPED INTERNAL OF VESSEL.

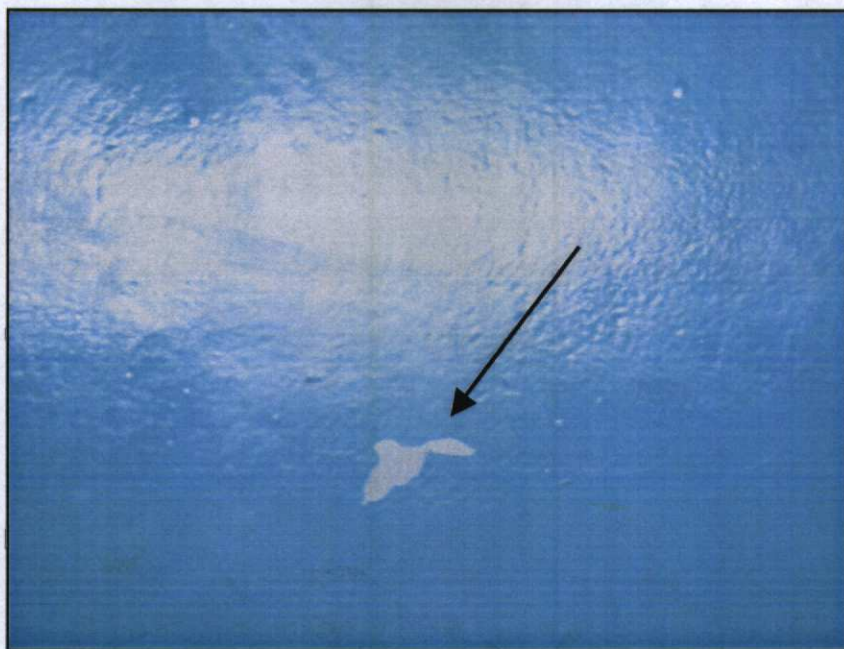
FIGURE 2. CHIP CAUSED BY INSTALLATION OF METAL RING. THE CHIP DOES NOT EXTEND TO THE METAL, RATHER IS A CLEAN BREAK AT THE INTERFACE BETWEEN THE FIRST AND SECOND COATS. THIS AREA COULD BE EXPANDED BY PROBING WITH THE TIP OF A SHARP KNIFE AND INDICATED THAT THE POOR BOND BETWEEN COATS WAS GENERALIZED IN NATURE.

1.4 RECOMMENDATION: All of the available evidence points to an inter-coat adhesion problem existing prior to placing the coating into service. Review Q.C. documents of applicator -- determine lack of bonding between finish coat and primer.

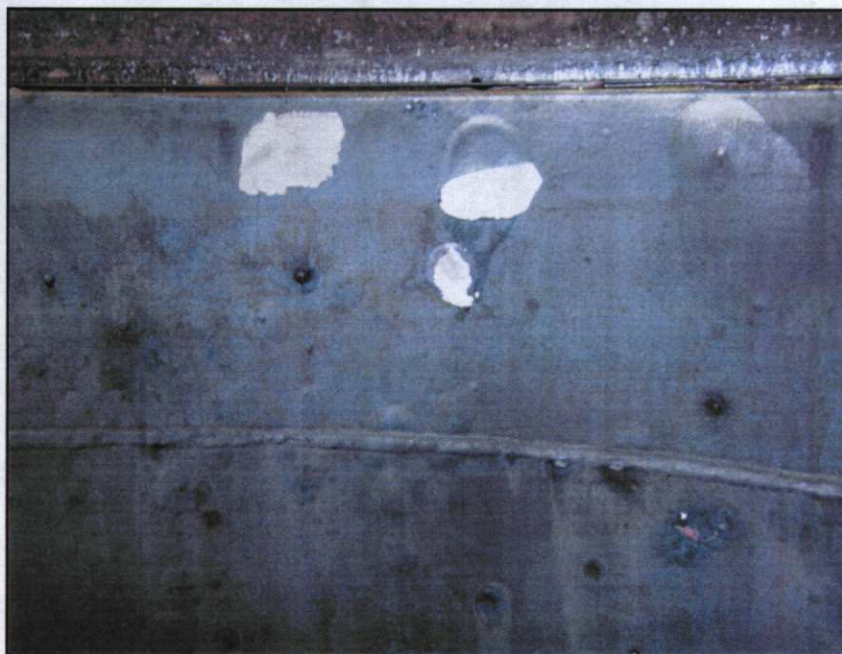
- This vessel was exposed to the service environment for less than two (2) weeks. The coating surface was discolored and the coating had blistered throughout.
- The blisters were found to extend to the first coat in all cases. The coating system consisted of a two-coat application with the first coat being light grey in color and the second coat, (finish coat) being green discolored by the service to a grey-brown.
- Upon removing the finish coat and viewing the back of the coating chip there was no ~~primer~~ <sup>first coat</sup> attached.
- The first coat in all cases was well bonded to the metal and did not give any evidence of having been deteriorated by the service. <sup>first coat</sup>
- Coating thickness readings indicate that the ~~primer~~ <sup>first coat</sup> was 4-5 mils thick and the finish coat was applied to 5-7 mils. Total coating thickness was at 10-14 mils d.f.t.

FIGURE 3. VESSEL 3497-2: SHOWS BLISTERS THAT OCCURRED BETWEEN THE FIRST AND SECOND COATS.

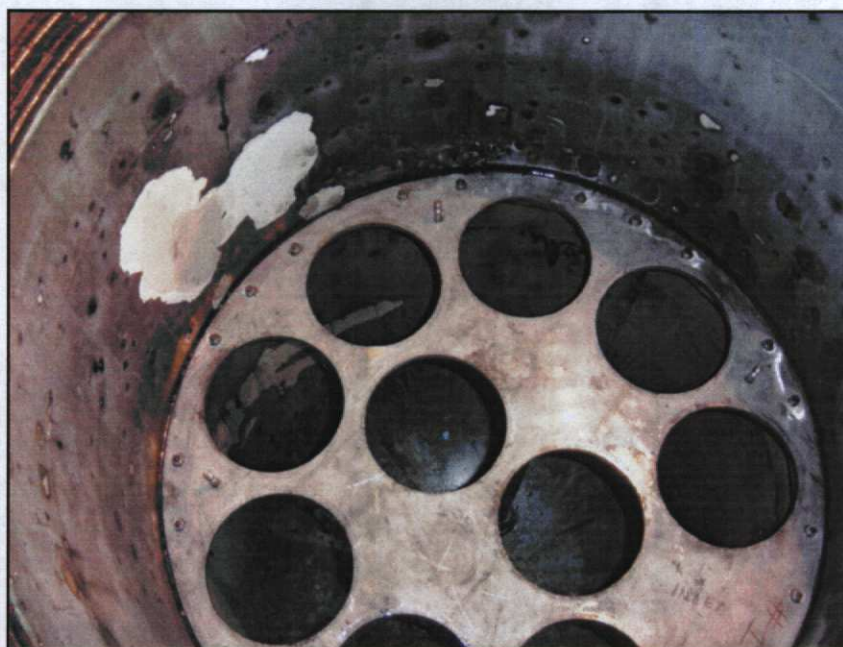
FIGURE 4. VESSEL 3497-2: SHOWS DISCOLORATION DUE TO SERVICE AND THE EXTENT OF THE POOR ADHESION BETWEEN BLISTERED FINISH COAT AND WELL-BONDED FIRST COAT.

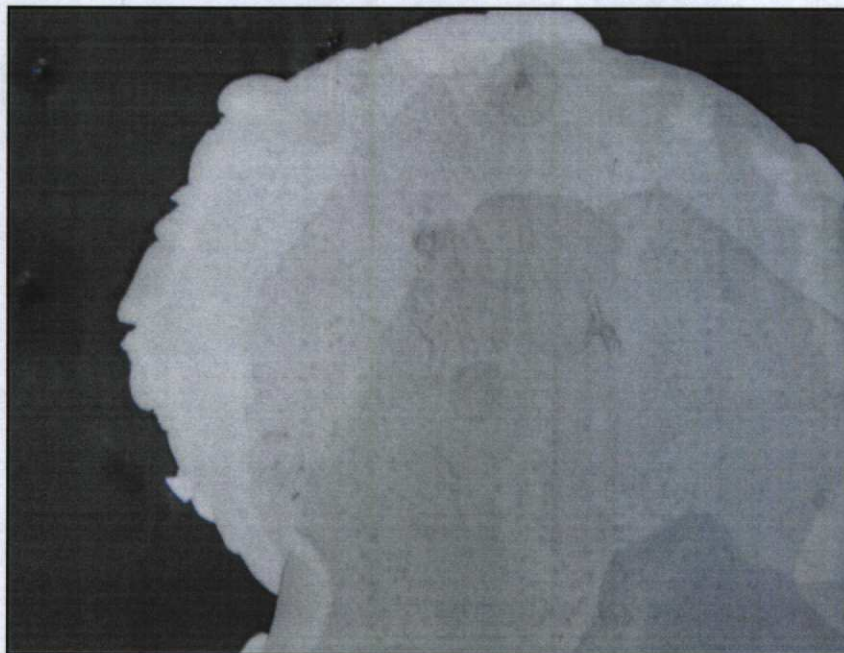
FIGURE 5. VESSEL 3497-2: SHOWS INTACT FIRST COAT BENEATH REMOVED BLISTER. THE AREAS OF DARKENING LIKELY CORRESPOND TO THE INGRESS OF FLUIDS DURING SERVICE EXPOSURE.
