PRESSURE VESSEL VISUAL INSPECTION REPORT

156960-MD-08 10/16/2012 2 of 14

External Visual Observations

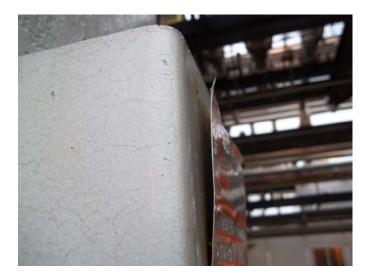
The nameplate has one broken rivet

02 broken rivet

Remove/ replace insulation on piping Replace nameplate rivet Remove the moss and treat the area Replace temp gauges if temperature exceeds gauge rating Clean and touch up the coating to aid in the protection against corrosion

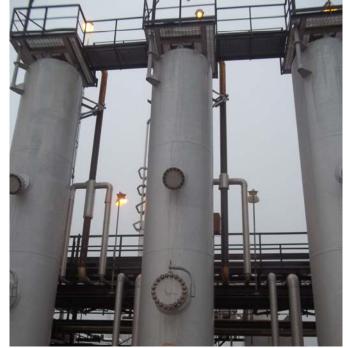
03 overview

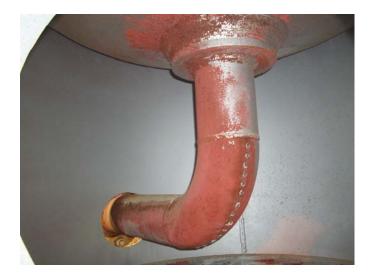
The coating is flaking and chipped throughout exposing the base metal to minor surface corrosion with no evidence of pitting.

04 surface corrosion

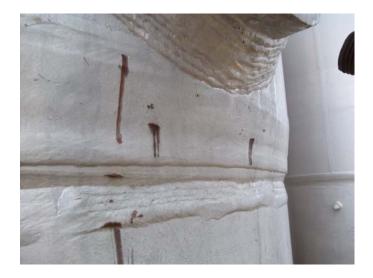
There is mechanical damage noted thru out the surfaces on the shells, (it appears as a tooling marks from erection) There is also mechanical damage on the top head below the paint

05 scratched paint

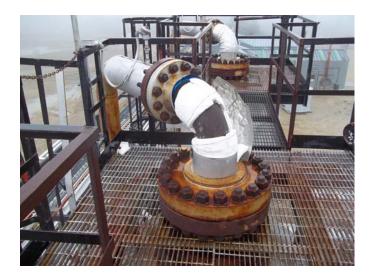
The outlet piping has a small section of cladding/insulation removed, the insulation is exposed, discolored and deteriorating which may result in CUI to the piping system

06 damaged insulation

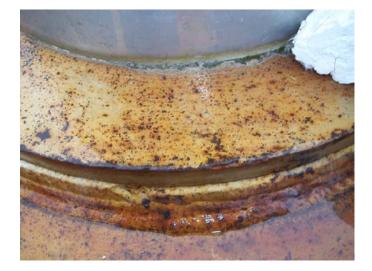
There is moss growth on the top 8" inlet piping cladding interface

07 moss growth

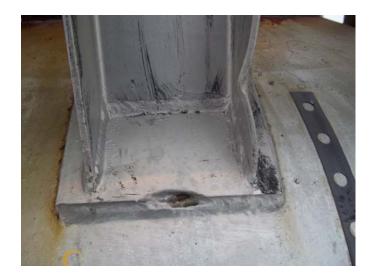
The top platform support beam is bent on the West side

08 mechanical damage on support

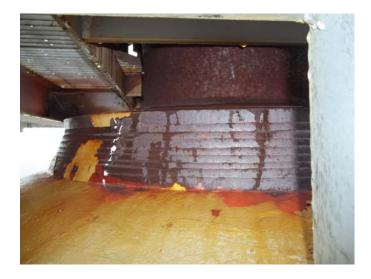
09 surface corrosion

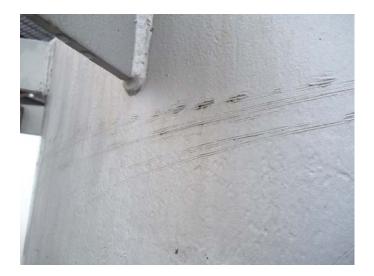
10 mechanical damage on shell

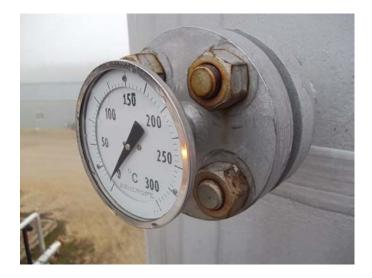
The 0-300 C temperature gauges are not within design temp range and the 0-500 C gauge needle is at the 500 C mark

11 not within range

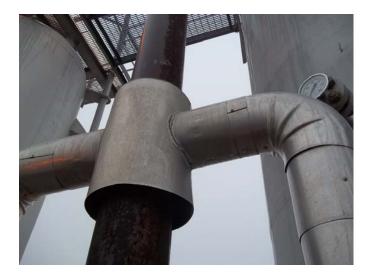
12 caulking seal deterioration
