156960-MD-07 Report #: Inspect Date: 10/16/2012 1 of 14

Criticality Designation	:	Yellow	/				
Insp. Comp: Matrix_Ins	pection District: (	Grande Prairie - Nort	th	Field:	Chi	ncaga	
Location: 01-24-096	-05W6 Unit / Skid #:	N/A		LSD:	01-24-0	096-05W6	
Jurisdiction #: A01468	344 Equip Tag #:	V-301C		Serial #:	79-0	87-05C	
CRN #: D 319			Y	ear Built:	1	979	
Manufacturer: KML Manufact		ipment Description:					
Status: Out of Service		Type: Vessel: Tow			Service:	Sweet	
MAWP Shell: 8619 kPa		Volume: N/A		Co	ode Stamp:	⊠Y □N	
MAWP Tube:	@ Height	t/Length: 8992	mm			$\square$ Y $\boxtimes$ N	
MDMT: -20 °F	RT: RT-1 Size/Di	iameter.: 1677 ı	mr I.D.		PWHT:	$\boxtimes$ Y $\square$ N	
Support Skirt	Vessel on Origina	al CNRL Inventory Lis	st: X Y N		Manway:	$\boxtimes$ Y $\square$ N	
C.A.: 0.063 in	. Coated: N/A Cla	ad: <u>N/A</u> J.E	E.: <u>1.00</u> Remo	ote Acces	s: 🗌		
Component	Material	Nominal Thk	Diameter (	OD/ID	Tube Side	Shell Side	
1 Main - Shell	SA-516-70	88.500 mm	1677.000 mm	ID		$\boxtimes$

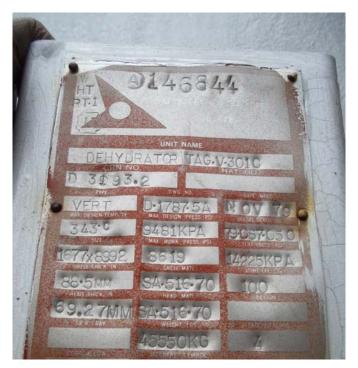
01 nameplate

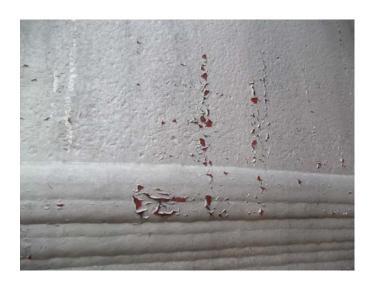
03 paint deterioration

Clean and touch up the coating to aid in the protection against corrosion

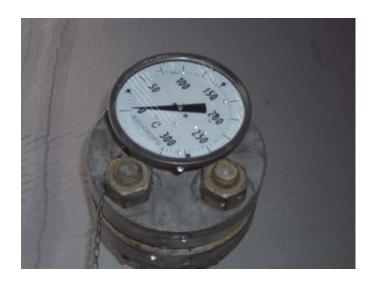
The two 0-300 C temperature gauges are not within design temp range and the 0-500 C gauge needle is at the 500 C mark

04 not within range

Consider replacing temp gauges if temp is expected to exceed 300 C

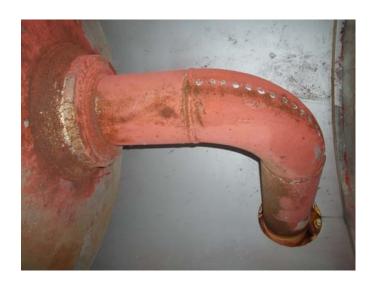
05 surface corrosion

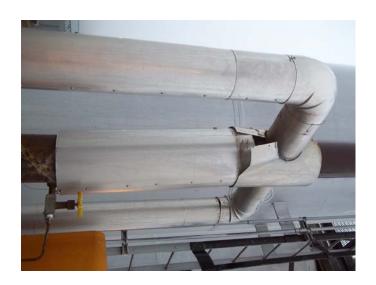
The outlet piping has a small section of cladding/insulation removed, the insulation is exposed, discolored and deteriorating which may result in CUI to the piping system

06 damaged cladding

Remove/ replace insulation on piping

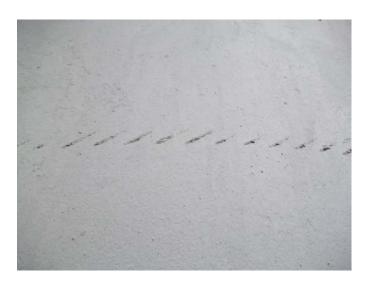
There is mechanical damage noted thru out the surfaces on the shells

07 mechanical damage

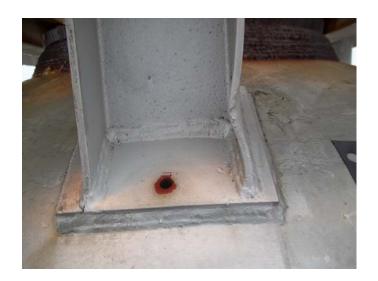
The top platform support beam is bent on the West side

08 bent platform support

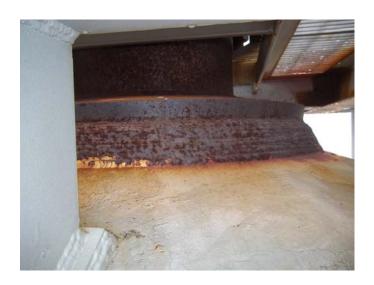
09 surface corrosion

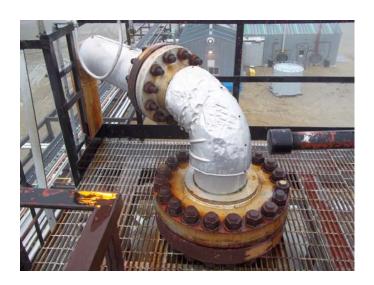
10 damaged cladding

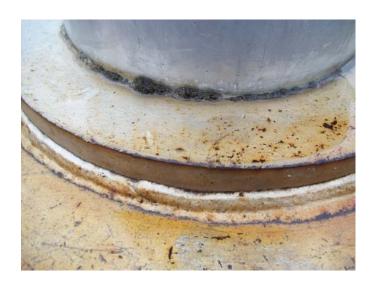
There is moss growth on the top 8" inlet elbow cladding interface that may result in MIC

11 moss growth

Remove moss and treat area

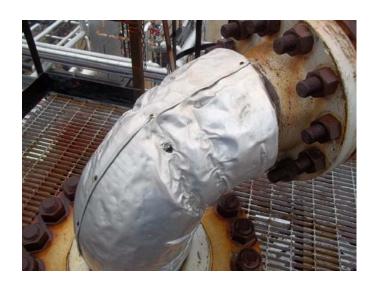
12 punctured cladding
