# Field Inspection Report

Vessel # 146808

| <b>Client</b> | Canadian Natural Resources Ltd. | | | <b>Inspection Date</b> | 2003-07-22 | | |
| <b>Equipment</b> | Amine Reboiler | | | <b>Location</b> | Westlock | | |

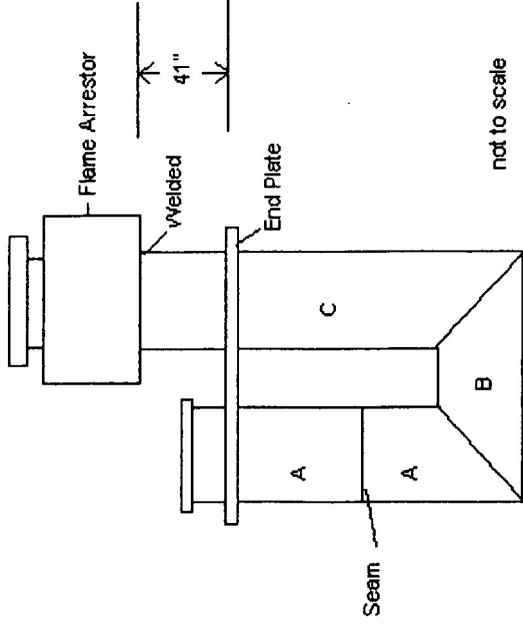
not to scale

A. Stack Side "A" - The surface is rough all throughout about/less than 0.010" depth. The welds are visually in good shape.  
B. Section - Rough surface almost same as in 'A'  
C. Section, Burner Side - Scattered corrosion pits mostly at 6 o'clock position about half of the tube length opening. Pit length approximately 0.060" up to 3/8" diameter.  
Random UT Wall Thickness Readings:  
Measurements in inches:  
Test Point A - 0.280 to 0.292  
Test Point B - 0.297 to 0.316  
Test Point C - 0.290 to 0.295  
End Plate - 0.618 to 1.625  
See attached drawing for test point orientation.

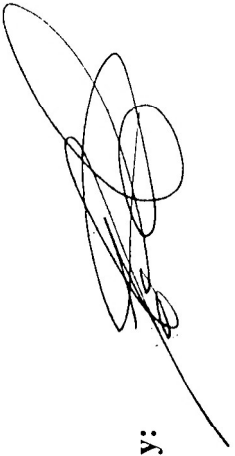
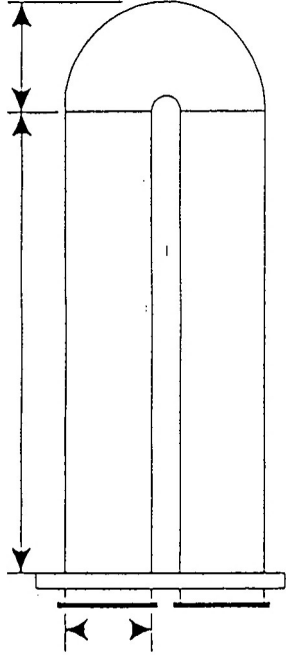
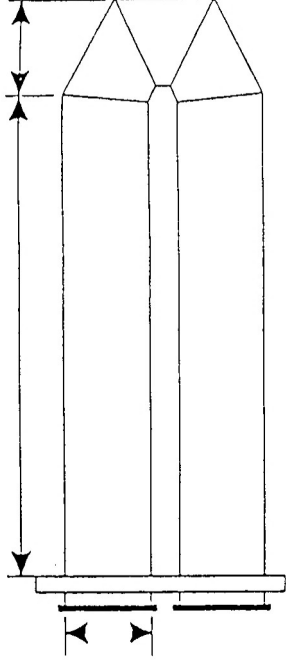
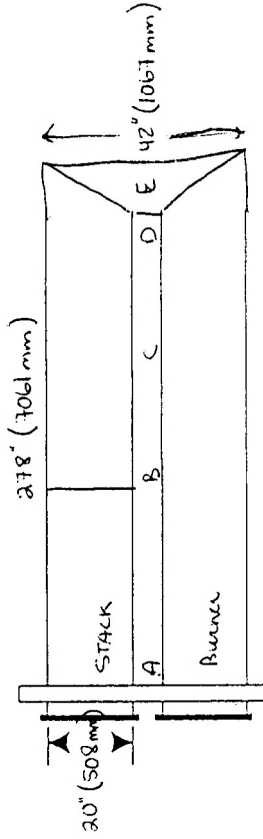
| File Number | 01-275 | Firetube Number | 4 West |

(West) right tube – Continuous pitting throughout burner leg. Deepest 5 pits at 27” from flange at 2.29 mm deep. Pits noted at 6’ mark measure 1.65 mm deep. Average pit depth measured 1.52 mm deep.

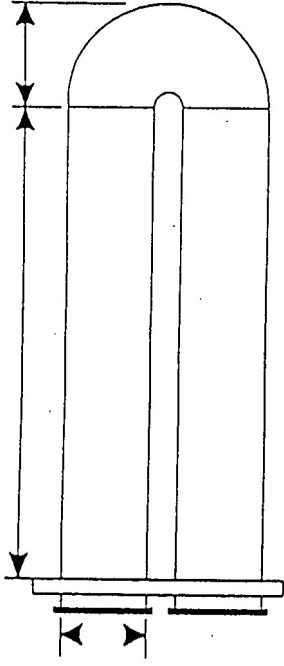
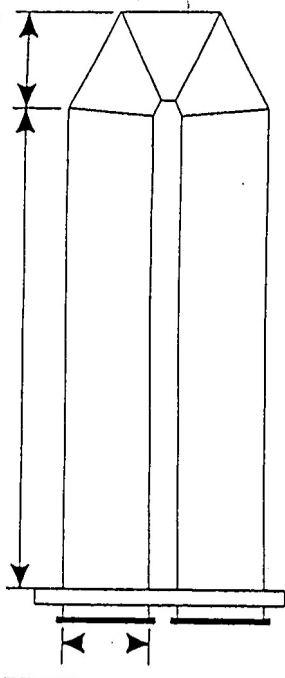
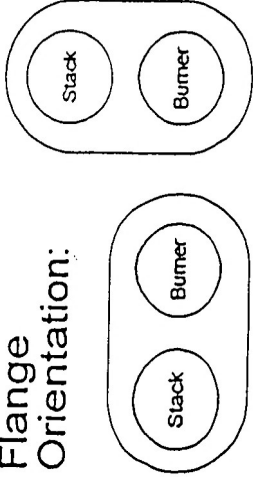
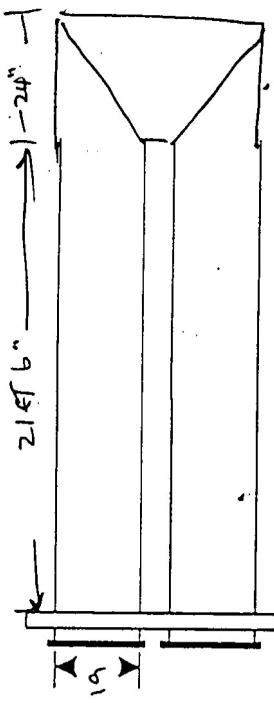
| Inspection Date | Inspector | (A) 146808 |

STACKS REMAIN AS-BUILT WITH NO VISIBLE CORROSION (NOT #2)  
- SAME AS #2 WITH CORROSION TO MAX 0.030"

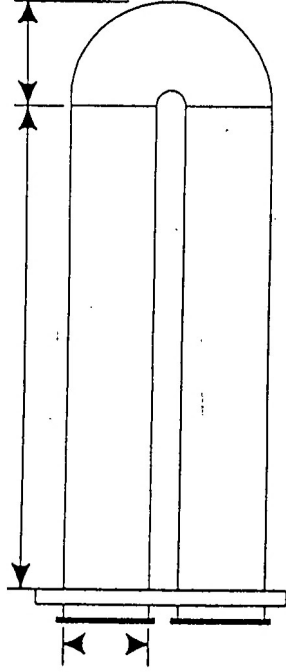
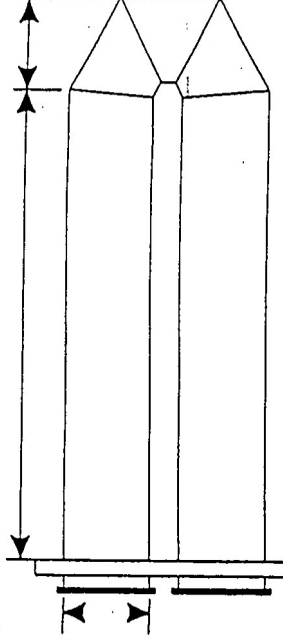
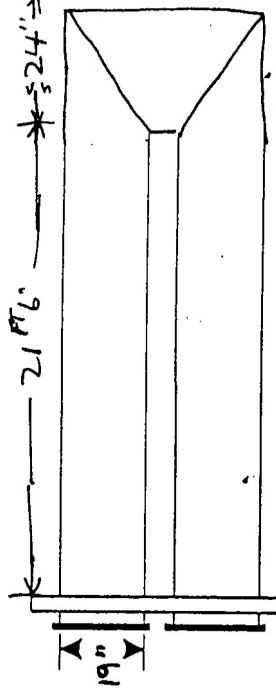
① 146808

- Burner tube parted at random to max of 0.100 (approx 6' from flange blow pos, rest as a tube to max of 0.050" (nom. approx at 325" at random int. cuts)  
- Tubes appear to have been magnified.

NOTE: NO CORROSION SINCE 5-27-97

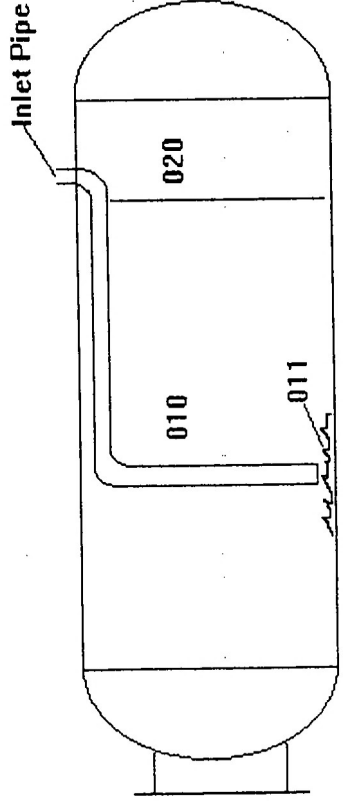
VESSEL SKETCH:

| AREA | COMMENTS |
|---|---|
| 010 | Visually inspected. Shell in good condition. |
| Firetubes | Visually inspected. Both tubes show extensive corrosion on the external surface, mainly on the burner leg. The right hand tube is worse than the other, with pits up to 3mm deep. Extensive pitting was found on the internal surface of the LH tube, after removal of accumulated scale. This pitting is also in the order of 3mm. |

1. Reinspect in 12 months.
2. Plan to replace or extensively repair both firetubes at the next shutdown.
3. Investigate the feasibility of firing both firetubes at reduced rates rather than just one, in order to balance the heat input into the reboiler.
4. If balanced firing is not possible, use the left hand firetube until the next shut down.
5. Re-evaluate the corrosion on the shell at the next shut down.
