| GENERAL INSPECTION FORM | | | | | | |
| Facility: South Wapiti Gas Plant | | | Location (LSD) Surface: 16-36-67-09 W6M | | | |
| Vessel Name & Equipment Number: Inlet Separator | | | PSV Only-Installed on piping: <input checked="" type="checkbox"/> | | | |

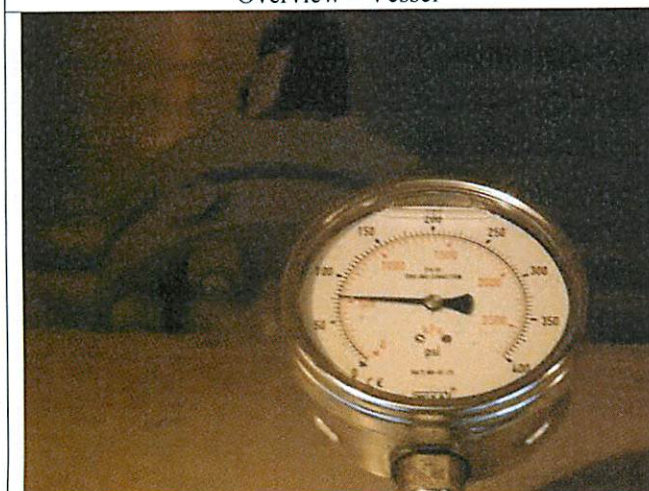
| External Inspection Items | G | F | P | N/A | Comments |
|---|---|---|---|---|---|
| <b>Gauges</b> Ensure gauges/gauge glass(es) are visible, working, no leakage, and suitable for range of MAWP/ Temp. | X | | | | Pressure gauge: 0 to 400 psi. Not within range of MAWP.<br>Temp gauge: -40 to 70°C. Within range of MAWT.<br>Liquid level attached.<br>All gauges are clean and clear. No leaks. |

Pressure gauge – Not within range of MAWP

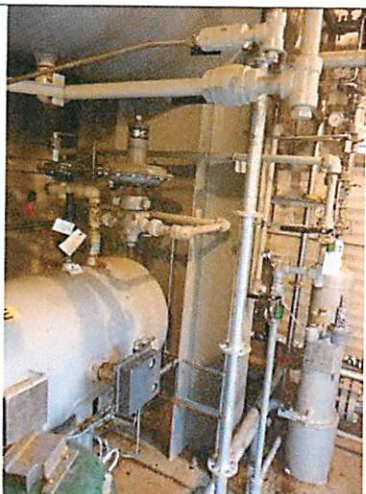
Saddle support

| External Inspection Items | G | F | P | N/A | Comments |
|---|---|---|---|---|---|
| <b>Skirt/ Saddle</b> Assess condition of paint, fire protection, concrete. Look for corrosion, buckling, dents, etc. Look at vessel surface area near supports. Verify no signs of leakage at attachment to vessel and attachment welds are acceptable. Is ground wire attached? Adequate access for UT inspection? <b>Note:</b> For horizontal vessels mounted on saddles ensure anchor bolting loose on one end to allow for expansion/contraction after installation. | X | | | | Saddle is bolted to skid structure<br>No evidence of corrosion at shell to skirt weld – no leaks.<br>Paint in good condition – no exposed metal.<br>No distortion. No buckles.<br><br>Saddle has ground wire attached. |

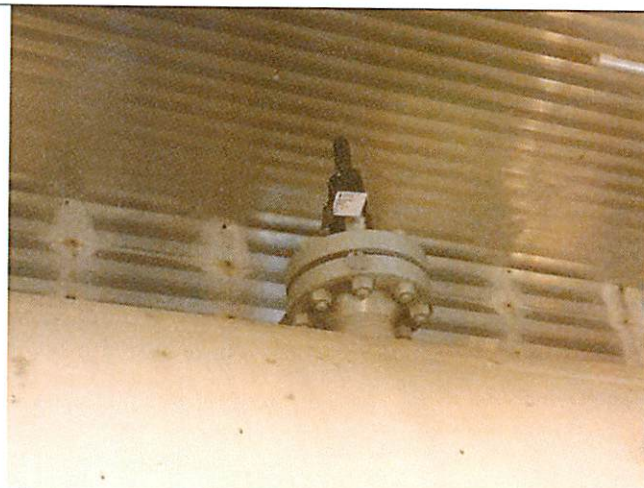
PSV location

| PSV Configuration Items | Y | N | N/A | Comments |
|---|---|---|---|---|
| Is the PSV inlet/discharge braced/supported by piping, brackets etc? | X | | | PSV is securely anchored |

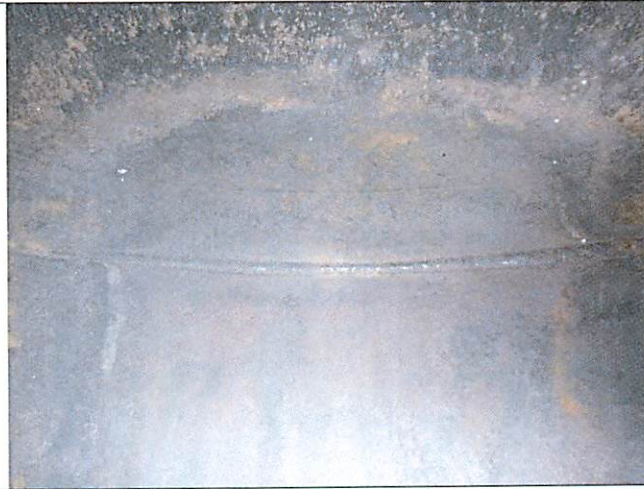
Manway head to shell weld 6:00 position

| Internal Inspection Items | G | F | P | N/A | Comments |
|---|---|---|---|---|---|
| <b>Welds</b> Inspect all welds, including attachment welds. Record all service-related damages and if there is any discuss with Chief Inspector before closing. | X | | | | Welds are in good condition – no pitting or corrosion identified. |

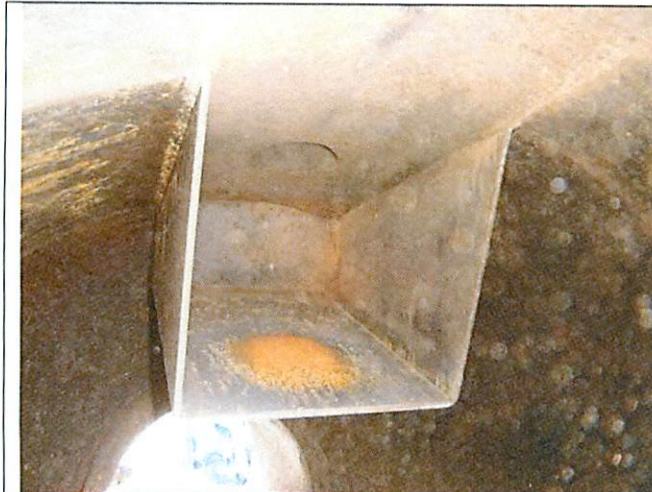
| Internal Inspection Items | G | F | P | N/A | Comments |
|---|---|---|---|---|---|
| <b>Baffles, deflector plates, etc.</b> If present, describe condition. Look closely at welds attached to vessel wall. | X | | | | Inlet deflector and surge weir– All in good condition, intact and in place. No damage. |

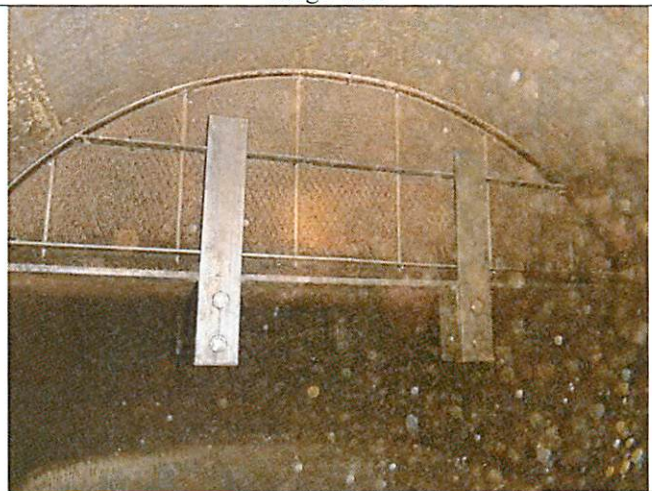
Demister pad and cage

| Internal Inspection Items | G | F | P | N/A | Comments |
|---|---|---|---|---|---|
| <b>Demister pad</b> Is it in place? Is it clean? If any corrosion is apparent in vessel, lift pad and check top head for corrosion. | X | | | | Generally in good condition – intact and in place<br>No damage to demister cage and screen. |

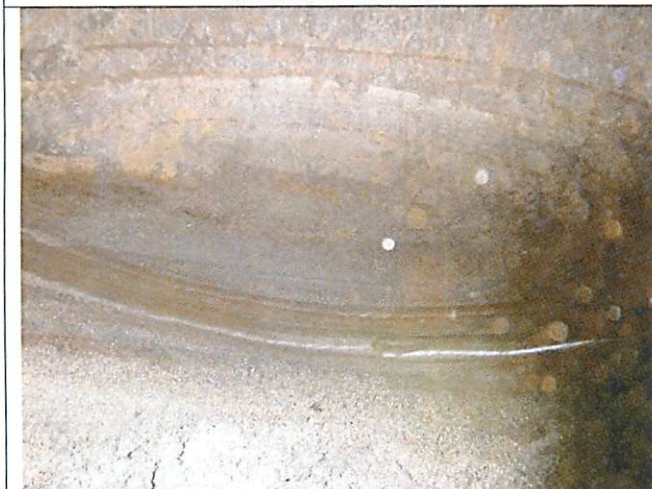
Head to shell weld – no issues
