| Canadian Natural Resources Ltd.<br>GENERAL PRESSURE VESSEL INFORMATION | | | | | | | Job# 105.01000 |
| Facility: <b>BEG Main Compressor Station</b> | | | | Location (LSD): <b>b-13-B / 94-G-01</b> | | | |
| Vessel Name Equipment Number: <b>Fuel Gas Scrubber</b> | | | | | | | |
| Status: <b>In Service</b> | | | | Regulatory Inspection | | | |

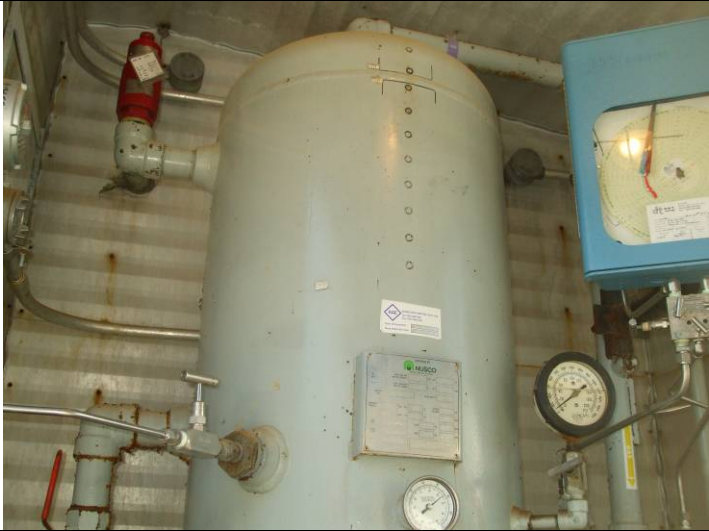
Vessel overview

| External Inspection Items | G | F | P | N/A | Comments |
|---|---|---|---|---|---|
| <b>External Condition</b> Assess paint condition, areas peeling, record any corrosion, damage, etc (record location, size and depth of corrosion or damage) | X | | | | Paint is in good overall condition – No chipped or exposed metal - no previous corrosion. |

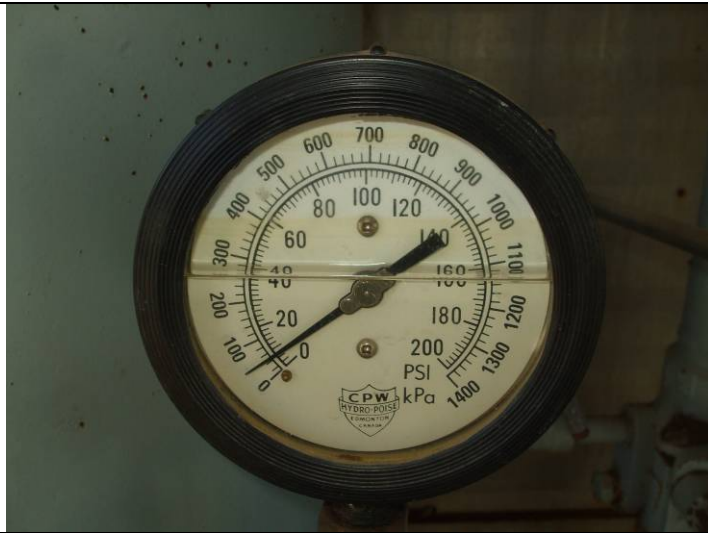
Pressure gauge

| External Inspection Items | G | F | P | N/A | Comments |
|---|---|---|---|---|---|
| <b>Gauges</b> Ensure gauges are visible, working, no leakage, and suitable for range of MAWP/ Temp. | X | | | | Gauge is visible, appears to be functional, no leaks and suitable for range of Temp.<br>Pressure gauge 0 to 200 PSI / 10 PSI @ gauge.<br>Temperature gauge -40 - 120 deg F / 75 deg F @ gauge. |

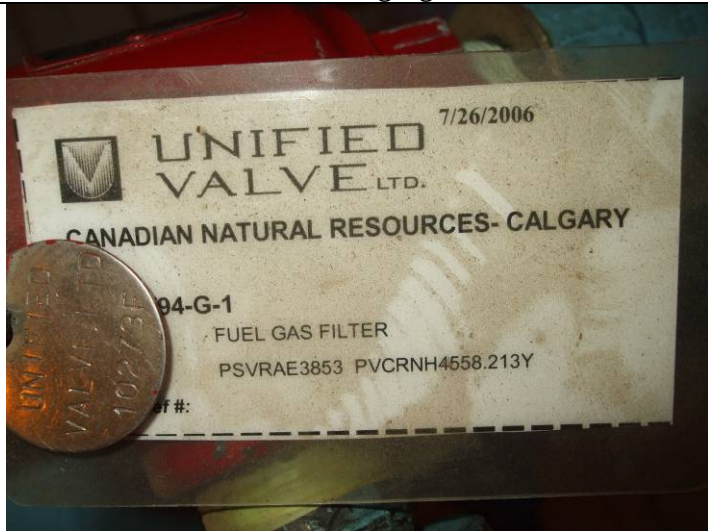
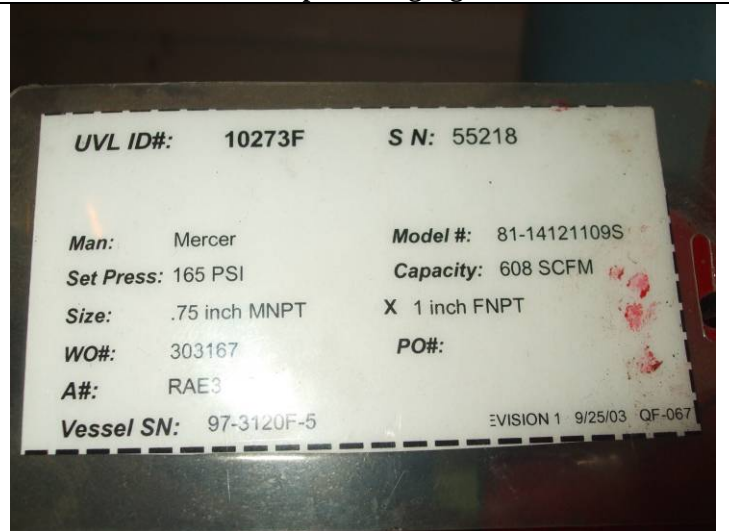
PSV service tag

| External Inspection Items | G | F | P | N/A | Comments |
|---|---|---|---|---|---|
| <b>PSV</b> Ensure PSV is set at pressure at or below that of vessel. | X | | | | Located on upper shell – set below the fuel gas scrubbers MAWP.<br>Discharge piping is larger than the inlet to PSV.<br>No block valve present.<br>Seal is intact. PSV vents to flare. |
