**Canadian Natural Resources Limited  
GENERAL PRESSURE VESSEL INFORMATION**

**Job # 105.00157**

| Facility: <b>Saddle Hills Gas Plant</b> | | | | Location (LSD): <b>10-11-75-07 W6M</b> | | |
| Vessel Name Equipment Number: <b>Cansweet Tower</b> | | | | | | |

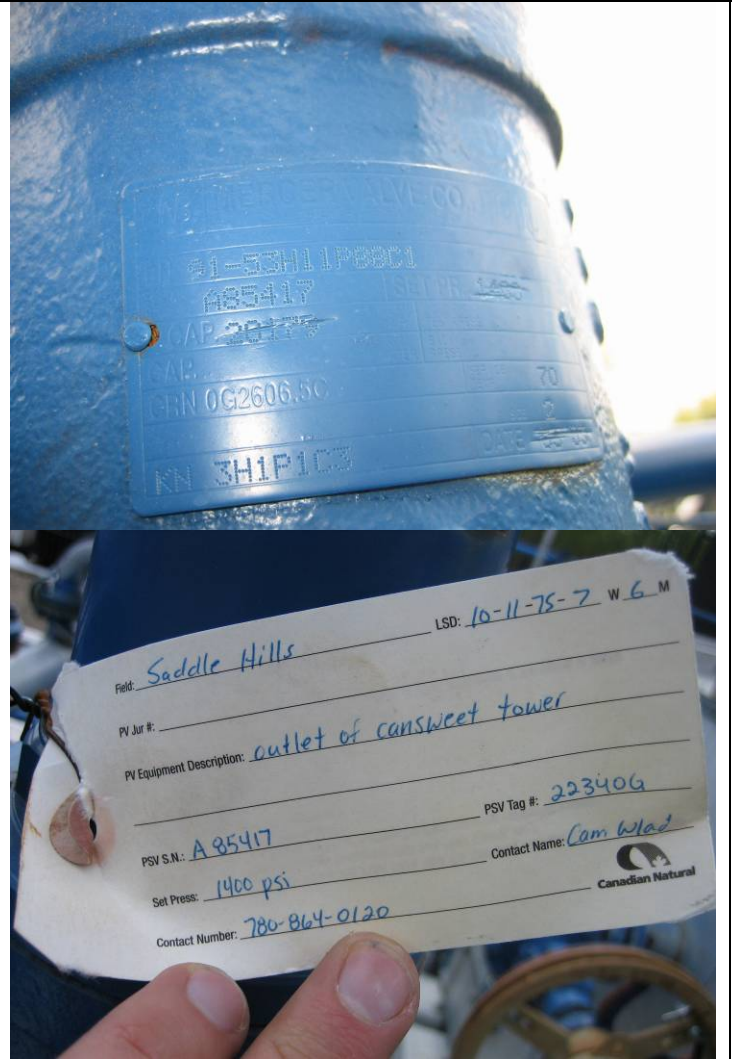
PSV Tag

| External Inspection Items | G | F | P | N/A | Comments |
|---|---|---|---|---|---|
| PSV Ensure PSV is set at pressure at or below that of vessel. Discharge piping is same size as inlet to valve and is properly supported and routed. Ensure no block valves between PSV and vessel or if there are they are locked open. | X | | | | PSV is set below MAWP of vessel. PSV Discharge piping is larger than inlet piping and is properly supported and routed. No block valves present. PSV Seal is intact<br>Location: Outlet piping |
