Canadian Natural Resources Ltd. GENERAL PRESSURE VESSEL INFORMATION Job# 105.00390						
District: Fort St John, BC			Skid No.			
Facility: Ladyfern Compressor			Location (LSD): b-17-I/94-H-01			
Vessel Name Equipment Number: Inlet Separator - Train 3 / V 310						
Orientation: Horizontal						
Status: In Service			Regulatory Inspection			
PRESSURE VESSEL NAMEPLATE DATA						
“A” or “G” or “S” (Sask.) or BC Registration Number. RAE# 5248			CRN Number: P-2191.21			
Vessel serial number: 01150-201			Size: 66” X 314”			
Shell thickness: 88.9mm			Shell material: SA-516-70N			
Head thickness: 82.6mm			Head material: SA-516-70N			
Tube wall thickness:			Tube material:			
Tube diameter:			Tube length:			
Channel thickness:			Channel material:			
Design pressure	Shell: 13790 Kpa		Operating pressure	Shell: 0 Kpa		
	Tubes:			Tubes:		
Design Temp.	Shell: 118 deg C		Operating temperature	Shell: 0 deg C		
	Tubes:			Tubes:

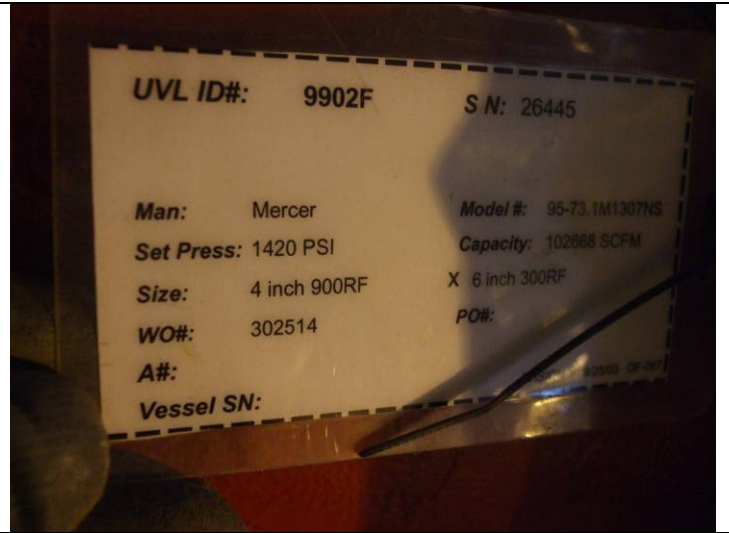
PSV data plate – last service 07-2001

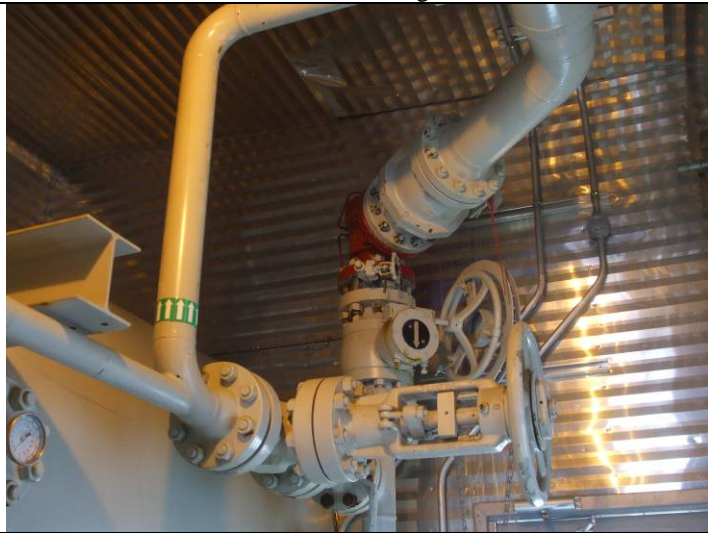
PSV location

Valving Ensure no leaks are visible. Valves are properly supported and chained if necessary.	X				Well supported – no leaks.
PSV Ensure PSV is set at pressure at or below that of vessel.	X				Located on inlet piping - set below the Inlet Separator's MAWP. Discharge piping is larger than the inlet to PSV. Block valve locked open. Seal is intact. PSV vents to flare.
NDE methods Was UT/ MPI done on vessel (MI coordinator to review results)	X				Ultrasonic thickness survey carried out-no metal thickness detected below nominal.
Other					
Recommendations or corrective actions : Vessel is Fit for Service or describe corrective actions required) (MIC to review corrective actions with Operations, discuss with Chief Inspector where necessary, and get remedial action implemented) Recommendations: 1. No recommendations at this time. Summary: This vessel is in good over all condition, visual external and ultrasonic thickness survey carried out-no metal thickness detected below nominal. Vessel is fit for service.
