Canadian Natural Resources Ltd.
GENERAL PRESSURE VESSEL INFORMATION

Job# 105.00390

District: Fort St John, BC		Skid No.				
Facility: Ladyfern Compressor		Location (LSD): b-17-I/94-H-01				
Vessel Name Equipment Number: Inlet Separator						
Orientation: Horizontal						
Status: In Service		Regulatory Inspection				
PRESSURE VESSEL NAMEPLATE DATA						
"A" or "G" or "S" (Sask.) or BC Registration Number. RAE# 5234		CRN Number: P-2191.21				
Vessel serial number: 01150-101		Size: 66" X 314"				
Shell thickness: 88.9mm		Shell material: SA-516-70N				
Head thickness: 82.6mm		Head material: SA-516-70N				
Tube wall thickness:		Tube material:				
Tube diameter:		Tube length:				
Channel thickness:		Channel material:				
Design pressure	Shell: 13790 Kpa	Operating pressure	Shell: 7000 Kpa			
	Tubes:		Tubes:			
Design Temp.	Shell: 118 deg C	Operating temperature	Shell: 20 deg C			
	Tubes:		Tubes:			
X-ray: RT-1		Heat treatment: Yes				
Code parameters: ASME Sec VIII		Coated: No				
Manufacturer: Propak Systems Ltd.		Year built: 2001

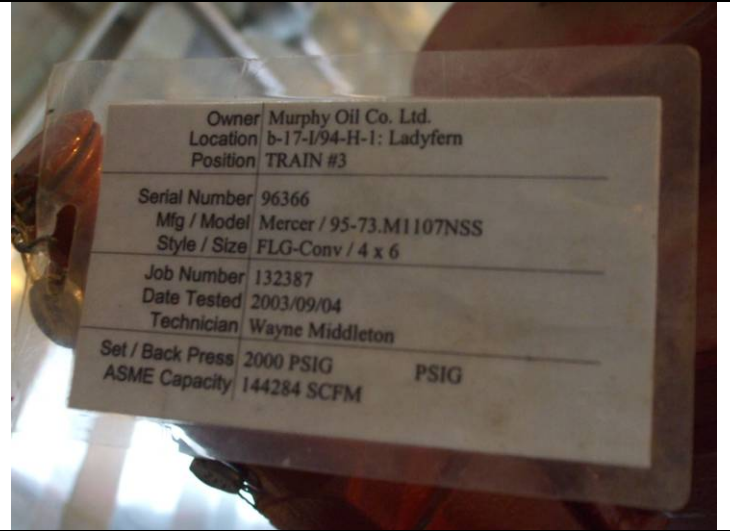
PSV data plate – last service 07-2001

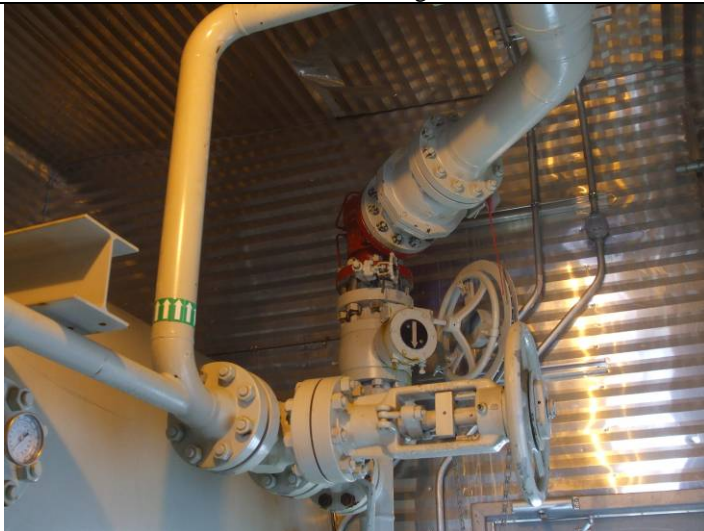
PSV location

Valving Ensure no leaks are visible. Valves are properly supported and chained if necessary.	X				Well supported – no leaks.
PSV Ensure PSV is set at pressure at or below that of vessel.	X				Located on inlet piping - set at the Inlet Separator's MAWP. Discharge piping is larger than the inlet to PSV. Block valve locked open. Seal is intact. PSV vents to flare.
NDE methods Was UT/ MPI done on vessel (MI coordinator to review results)	X				Ultrasonic thickness survey carried out-no metal thickness detected below nominal minus corrosion allowance.
Other					
Recommendations or corrective actions : Vessel is Fit for Service or describe corrective actions required) (MIC to review corrective actions with Operations, discuss with Chief Inspector where necessary, and get remedial action implemented) Recommendations: 1. This PSV has not been serviced since 2004 – Servicing is recommended ASAP. Summary: This vessel is in good over all condition, visual external and ultrasonic thickness survey carried out-no metal thickness detected below nominal minus corrosion allowance. Vessel is fit for service.
