**Canadian Natural Resources Ltd.**  
**GENERAL PRESSURE VESSEL INFORMATION**

**Job# 105.00390**

| Facility: <b>Ladyfern Compressor</b> | | | Location (LSD): <b>b-17-I/94-H-01</b> | | | |
| Vessel Name Equipment Number: <b>Inlet Separator</b> | | | | | | |

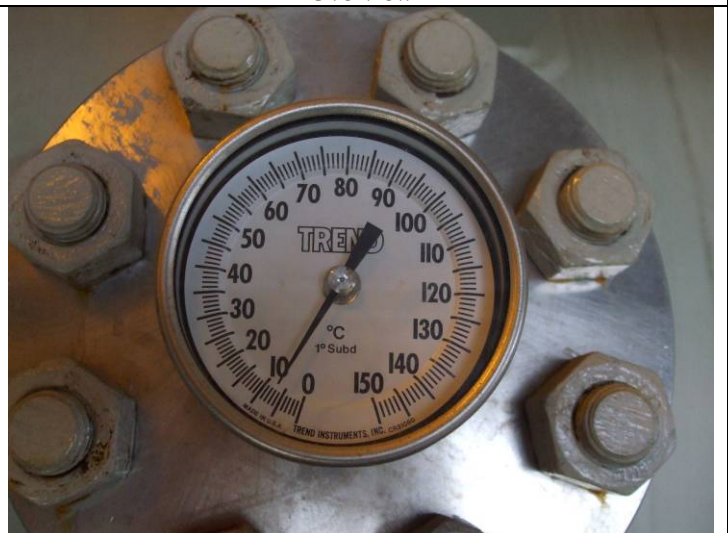
Temperature gauge

| External Inspection Items | G | F | P | N/A | Comments |
|---|---|---|---|---|---|
| <b>Gauges</b> Ensure gauges are visible, working, no leakage, and suitable for range of MAWP/ Temp. | X | | | | Gauges are visible, appears to be functional, no leaks and suitable for range of MAWP/Temp.<br>Pressure gauge: 0-4000 Kpa @ 200 Kpa.<br>Temperature gauge: 0-150 deg C @ 10 deg C. |

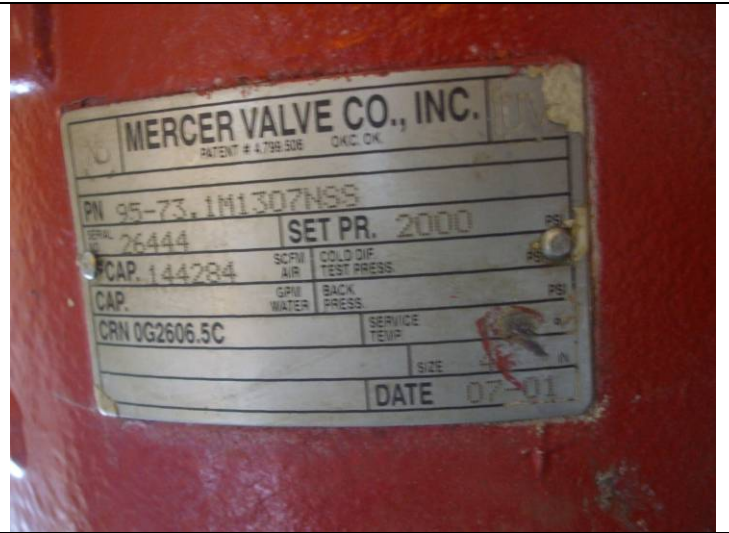
PSV data plate – last service 07-2001

| External Inspection Items | G | F | P | N/A | Comments |
|---|---|---|---|---|---|
| <b>Recommendations or corrective actions : Vessel is Fit for Service or describe corrective actions required)</b><br>(MIC to review corrective actions with Operations, discuss with Chief Inspector where necessary, and get remedial action implemented)<br><b>Recommendations: 1. This PSV has not been serviced since 2001 – Servicing is recommended ASAP.</b><br><b>Summary:</b> This vessel is in good over all condition, visual external and ultrasonic thickness survey carried out-3 inch 90 degree nozzle (UT point 55) metal thickness detected below nominal. Nominal 15.2 mm / min thickness 14.5 mm / T min thickness 5.6 mm.<br><b>Vessel is fit for service.</b> | | | | | |

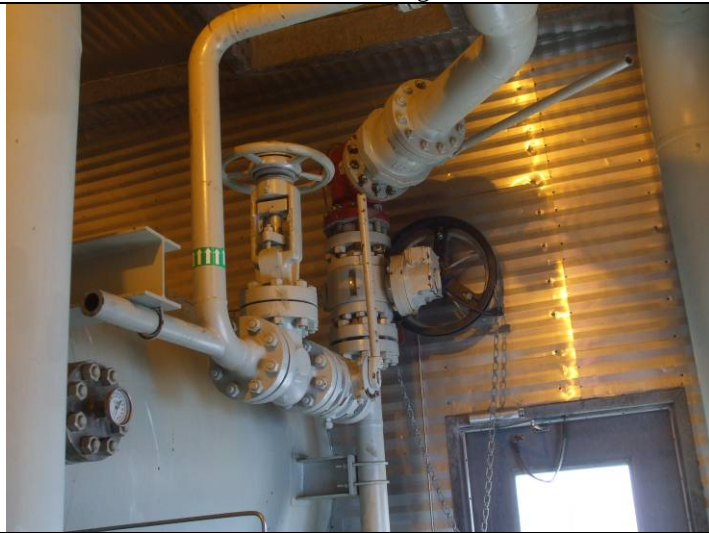
PSV location

| External Inspection Items | G | F | P | N/A | Comments |
|---|---|---|---|---|---|
| <b>PSV</b> Ensure PSV is set at pressure at or below that of vessel. | X | | | | Located on inlet piping - set at the Inlet Separator's MAWP.<br>Discharge piping is larger than the inlet to PSV.<br>Block valves locked open.<br>Seal is intact. PSV vents to flare. |
