Canadian Natural Resources Ltd.
GENERAL PRESSURE VESSEL INFORMATION

Job# 105.00390

District: Fort St John, BC		Skid No.				
Facility: Ladyfern Compressor		Location (LSD): b-17-I/94-H-01				
Vessel Name Equipment Number: HP Flare Knock Out Drum						
Orientation: Horizontal						
Status: In Service		Regulatory Inspection				
PRESSURE VESSEL NAMEPLATE DATA						
"A" or "G" or "S" (Sask.) or BC Registration Number. RAE# 2677		CRN Number: Non-code				
Vessel serial number: KOTK-FL-T75121		Size: 10' X 20'				
Shell thickness: 4.8mm		Shell material: SA-516-70				
Head thickness: 4.8mm		Head material: SA-516-70				
Tube wall thickness:		Tube material:				
Tube diameter:		Tube length:				
Channel thickness:		Channel material:				
Design pressure	Shell: 102.7 Kpa	Operating pressure	Shell: No gauge			
	Tubes:		Tubes:			
Design Temp.	Shell: N/S	Operating temperature	Shell: No gauge			
	Tubes:		Tubes:			
X-ray: Nil		Heat treatment: N/S				
Code parameters: Non-code		Coated: No				
Manufacturer: Bilton Welding & Manufacturing Ltd.		Year built: 2001

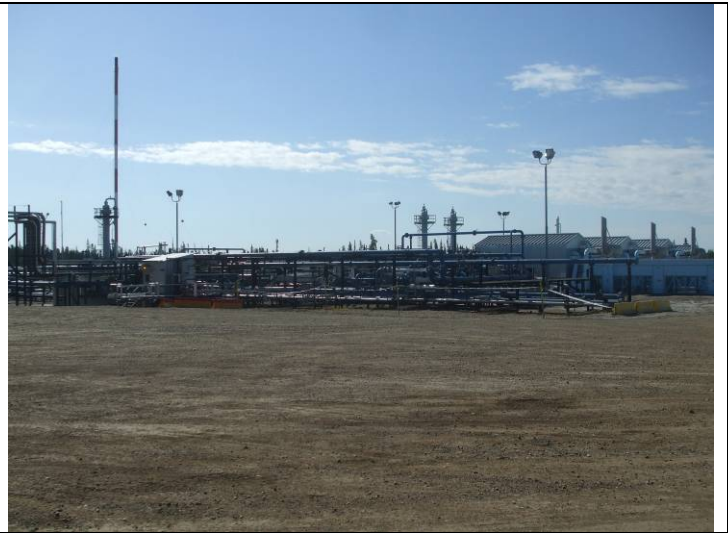
Site overview

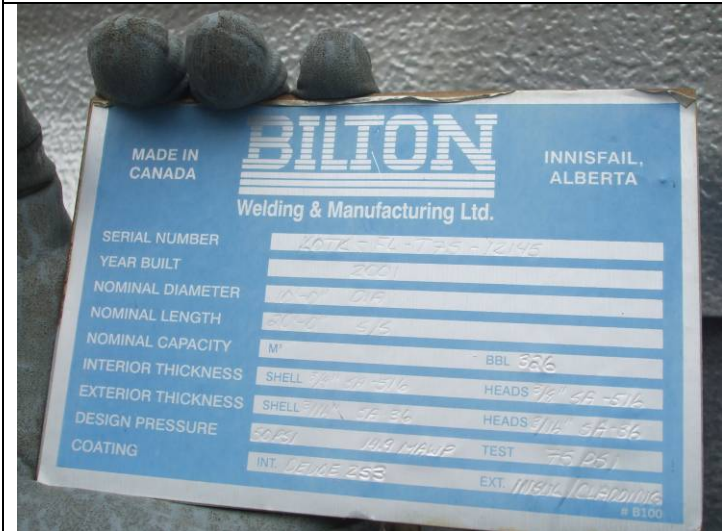
Data plate

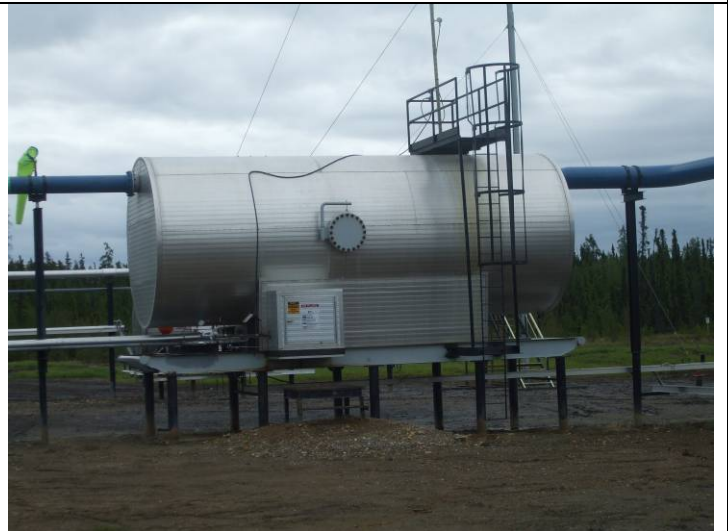
Overview
