Canadian Natural Resources Ltd.
GENERAL PRESSURE VESSEL INFORMATION

Job# 105.00390

District: Fort St John, BC		Skid No.				
Facility: Ladyfern Compressor		Location (LSD): b-17-I/94-H-01				
Vessel Name Equipment Number: LP Flare Knock Out Drum						
Orientation: Horizontal						
Status: In Service		Regulatory Inspection				
PRESSURE VESSEL NAMEPLATE DATA						
"A" or "G" or "S" (Sask.) or BC Registration Number. C# 24158		CRN Number: Non-code				
Vessel serial number: KOTK-FB-T75-10710		Size: 6' X 10'				
Shell thickness: 4.8mm		Shell material: SA-516-70				
Head thickness: 4.8mm		Head material: SA-516-70				
Tube wall thickness:		Tube material:				
Tube diameter:		Tube length:				
Channel thickness:		Channel material:				
Design pressure	Shell: 102.7 Kpa	Operating pressure	Shell: No gauge			
	Tubes:		Tubes:			
Design Temp.	Shell: N/S	Operating temperature	Shell: No gauge			
	Tubes:		Tubes:			
X-ray: Nil		Heat treatment: N/S				
Code parameters: Non-code		Coated: No				
Manufacturer: Bilton Welding & Manufacturing Ltd.		Year built: 2000

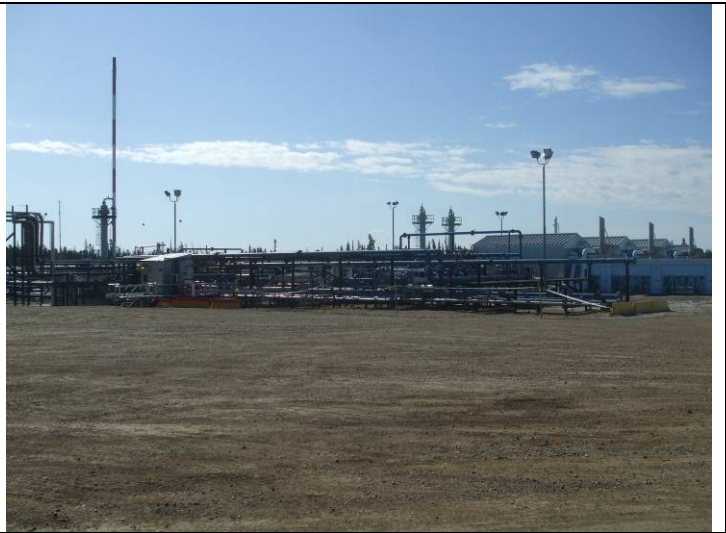
Site overview

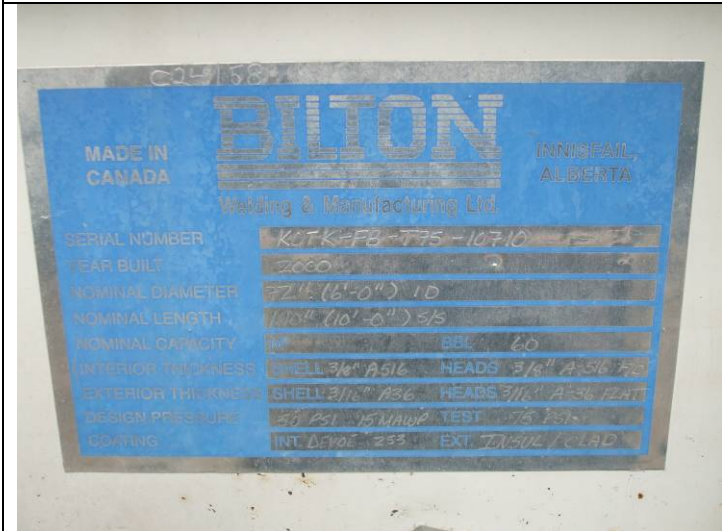
Data plate

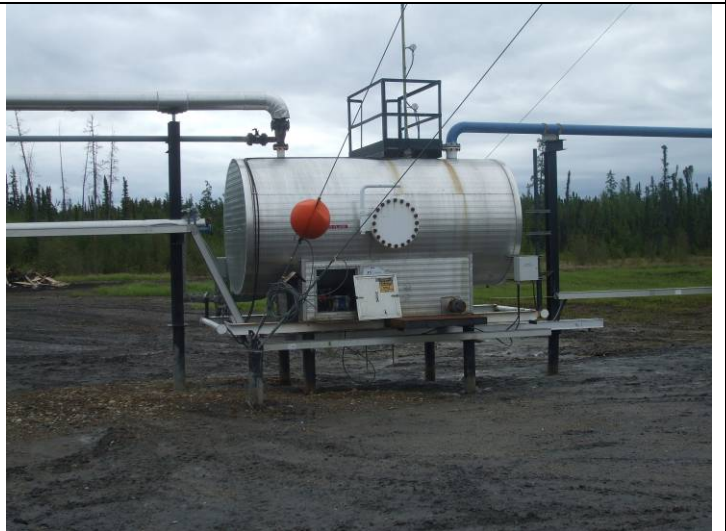
Overview
